## Kakisa Fuel Break Recommendations

On July 16<sup>th</sup>, a field review was completed for Kakisa to ascertain the need and potential location for fuel management areas (FMAs) in order to reduce the risk of an interface fire to the community. Potential locations for landscape fuel breaks were also reviewed in the field. Two maps have been provided: Map #1 shows the location of FMAs and fuel breaks within the interface of the community and Map #2 shows the location of a perimeter fuel break requiring further assessment.

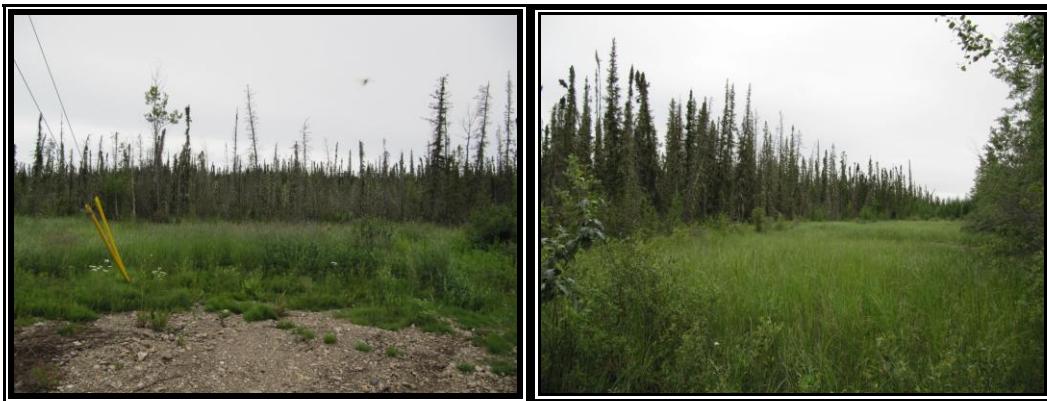
Some of the stands immediately adjacent to the community are dominated by deciduous trees and shrubbery with low density inclusions of coniferous species. Other stands have vegetation complexes influenced by high water tables or marshland and have a high degree of snags. Some of the interface stands have already been fully or partially treated. The current conditions of these stands provide some protection to the community but additional work should be considered to further reduce the risk to the community. The following pictures illustrate some of these adjacent low hazard stands.

Figure 1. Examples of some of the lower hazard stands adjacent to Kakisa.

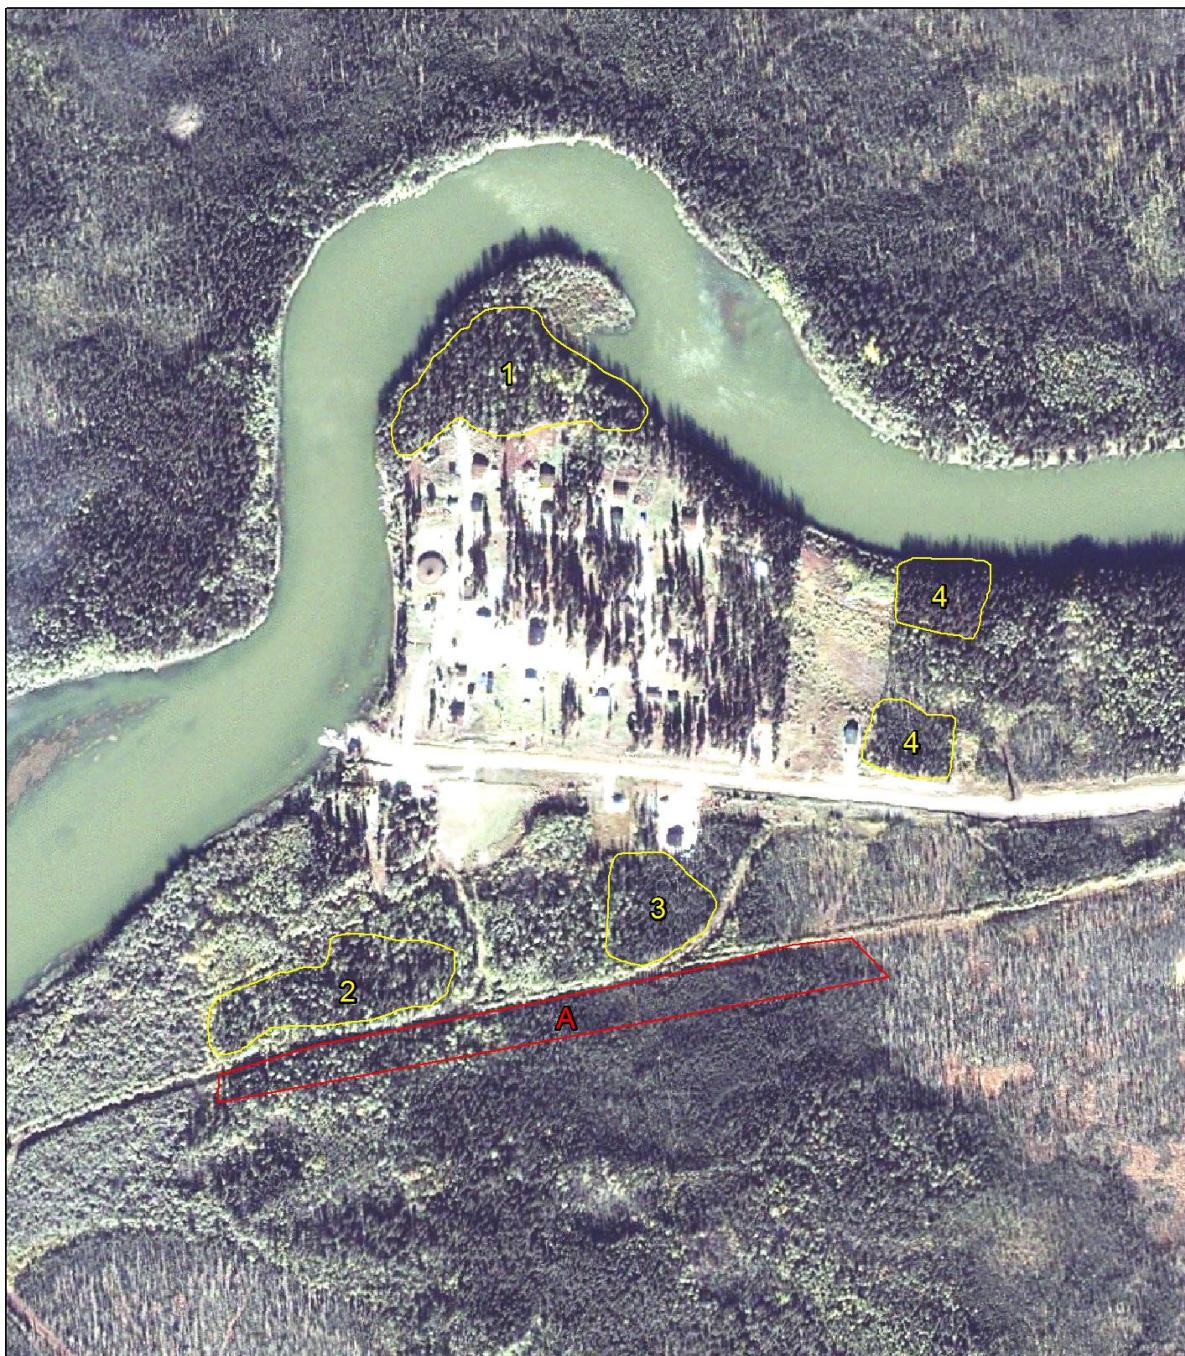
Map #1. Potential FMAs and Fuel Breaks within and around Kakisa.

Four Fuel Management Areas (FMAs) have been delineated on Map #1 with two of these FMAs (#1 and #3) being partially treated already. The other two FMAs (#2 and #4) being proposed are new treatment areas. These FMAs are shown in Map #1. Additionally, Map #1 shows proposed Fuel Break 'A' that should also be considered in order to reduce the risk to the community.

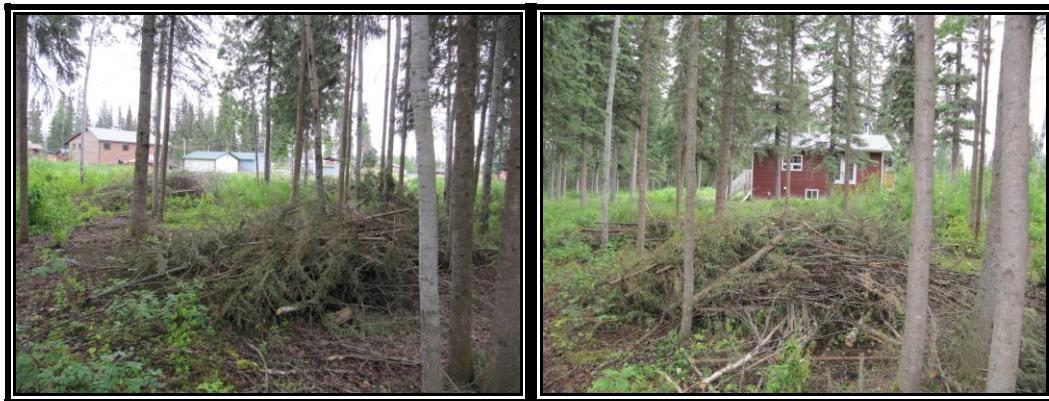
Figure 2. FMA #1 showing residual burn piles still to be burnt.

This stand has already been treated but still has piles of debris within it. Additionally, the density is still too high and should be reduced by removal of up to 50% of the current overstory. The resultant lower density stand will have a more open crown and be more resilient to crown spread.

The more open stand will also allow heat and hot gases to escape from beneath the canopy when the piles are burnt within the stand. If the piles were burnt under the current canopy closure, hot gases and heat would be trapped beneath the canopy and likely result in overstory mortality of the residual trees. Similarly, some of the piles are immediately adjacent to residual tree stems and the radiant heat may result in cambial kill for those stems close to piles. Further thinning should target trees around these piles or, alternatively, the piles in the stand, and further treatment debris, could be removed to a central burn area for disposal.

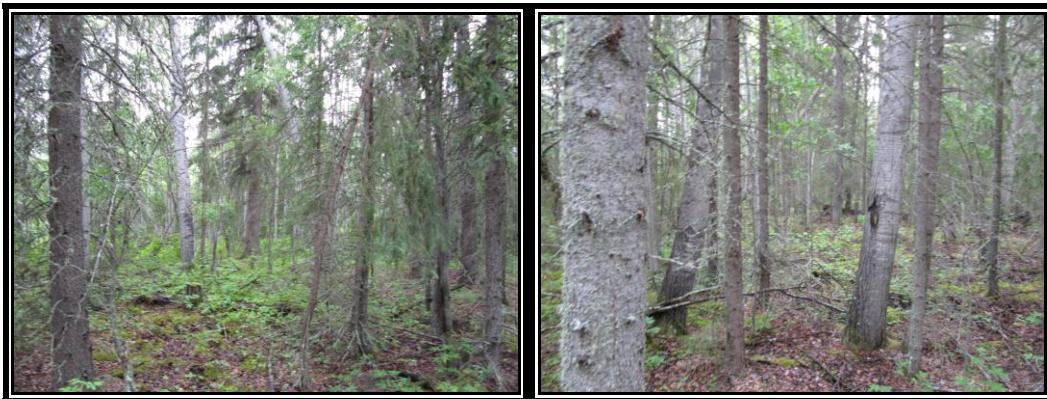
This is a large (~2 ha) dense stand (1500 sph) of mature spruce with a moderately well developed shrub understory and only minor surface fuel loading as seen in the following pictures.

Figure #3. The mature stand of timber within FMA #2.

This stand should be thinned to a density of less than 500 sph using a low thinning strategy while recruiting approximately 100-200 sph in the intermediate layer that have a good success at post treatment survival. Larger pieces removed to meet this Desired Future Ecosystem Condition (DFEC) should be sent to a market if one exists for them. Otherwise, stems should be brought road side and bucked up into fire wood for the community. Surface fuel loading should be piled and burnt in gaps or removed to a central burning area.

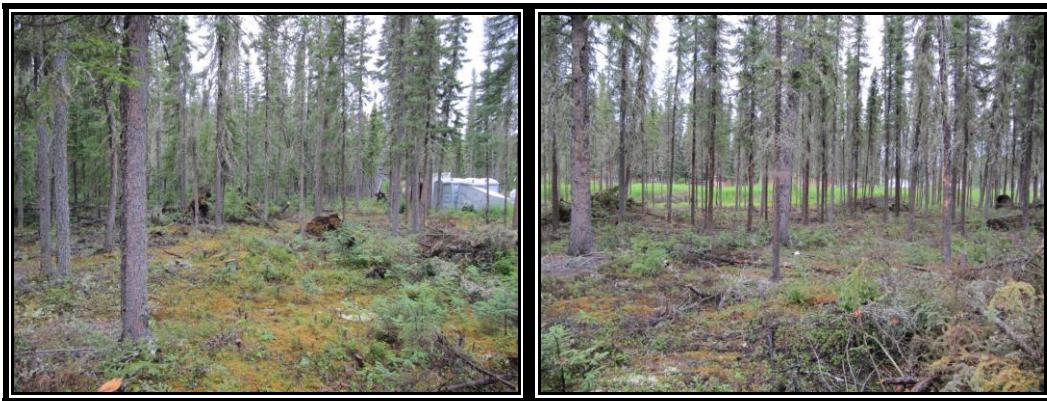
This FMA is located immediately adjacent to a treated area behind the Public Works Yard. The treated area is shown in the pictures below.

Figure #4. The treated stand behind the Public Works Yard.

While this treated stand still needs some piles burnt, it is an appropriate DFEC to emulate for FMA #3. The crew should walk through and review this adjacent treated stand to gain an understanding of what the DFEC for FMA #3 should resemble. Again, treatment debris should be piled and burnt in gaps or removed to a central burning area. Larger material can be shipped to market or cut up for firewood.

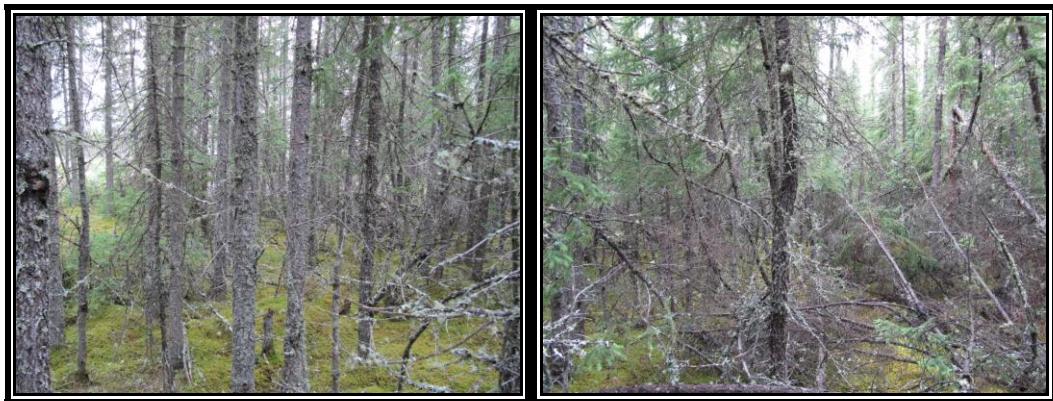
This FMA is comprised of two sections and is located immediately behind the new development area on the eastern boundary of the community. The treatment of this FMA will provide protection to this newer development. The stand is shown within the following pictures.

Figure #5. The current stand condition with FMA #4.

Treatment of this stand should be similar to that indicated for FMA #3 with the DFEC being similar to that found in the aforementioned treatment area behind the Public Works Yard.

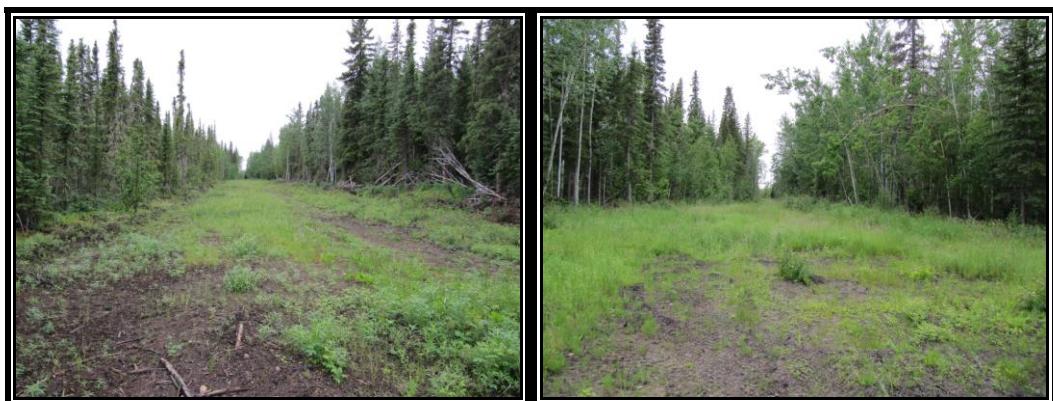
Figure #6. The existing fuel break immediately south of the village.

This fuel break runs the full distance from the lake to the entrance road to the community and, for the most part, it is in relatively good condition. However, as per map #1, its effectiveness could be increased by developing Fuel Break 'A'.

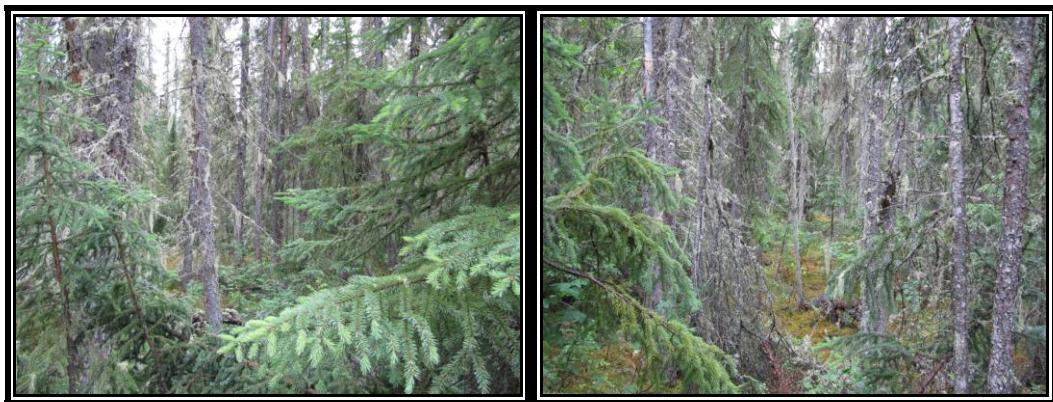
Fuel Break 'A' is a very dense stand of spruce and pine with a moderately high surface fuel loading and a very high degree of ladder fuels as can be seen in the following pictures.

Figure #7. The stand within Fuel Break 'A' showing the high density and high ladder fuels.

The stand within Fuel Break 'A' contains enough fuel loading that, during its burning, radiant heat could easily ignite, or spot into, fuel on the community side of the existing fuel break. This risk would be reduced by treating the stand within Fuel Break 'A' to resemble the stand condition immediately behind the Public Works Yard.

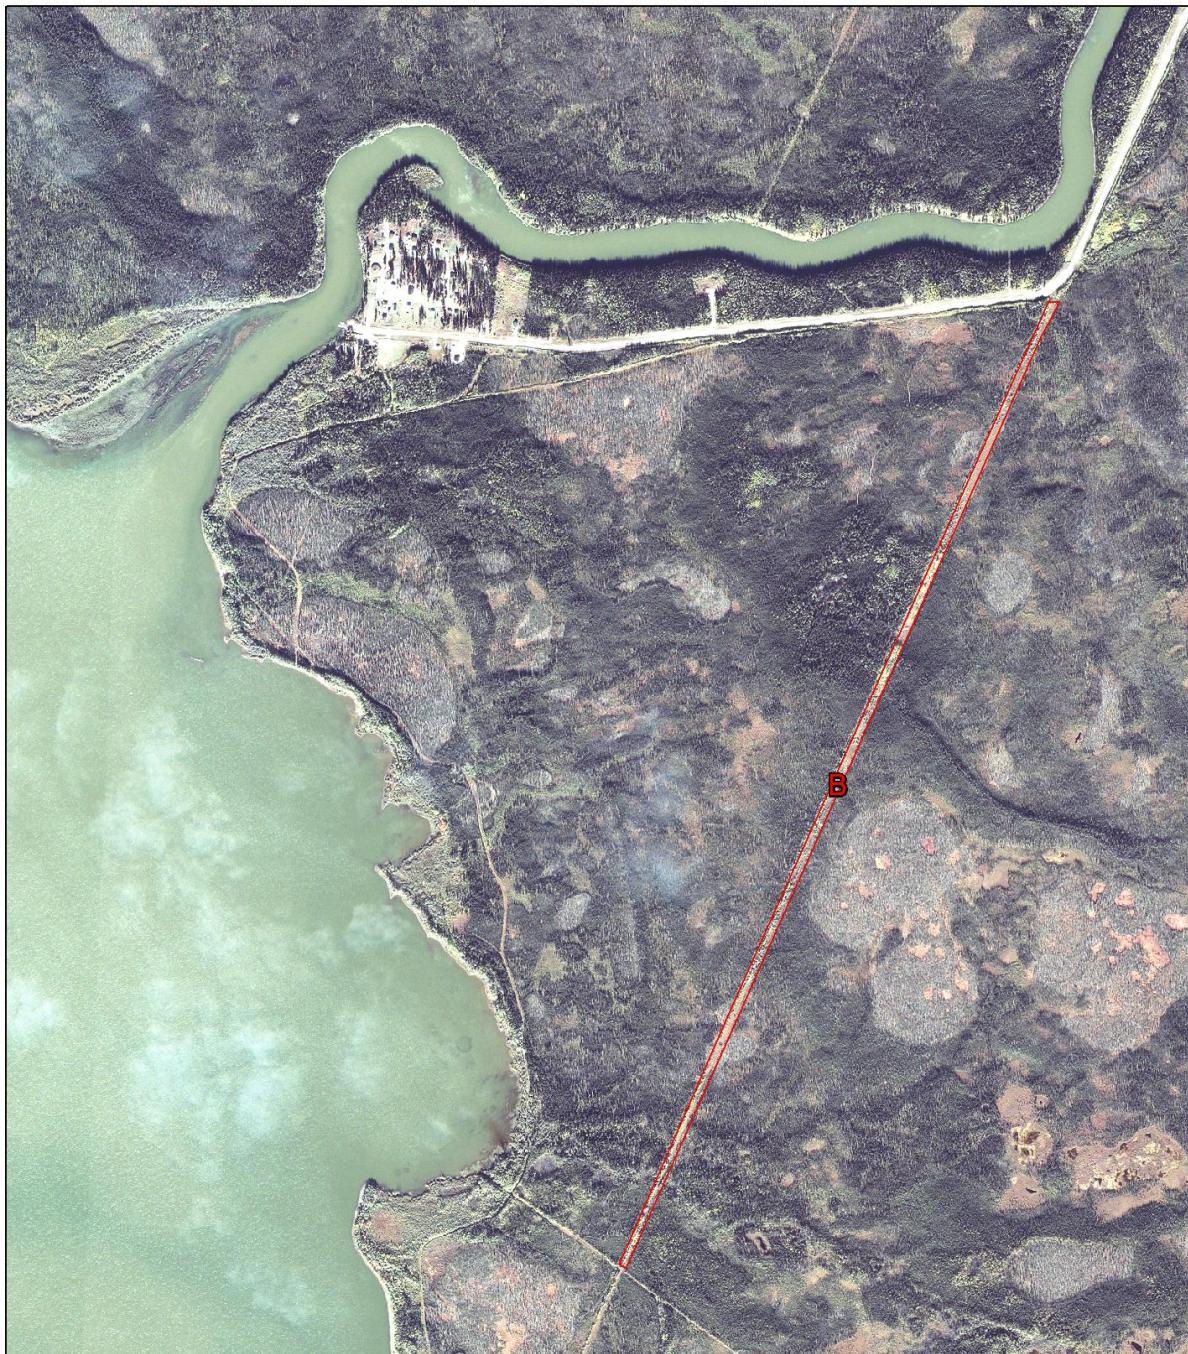
Map #2: Potential location of a landscape level fuel break.

To the south of Kakisa there is an open linear feature that extends from the corner of the entrance road to the east of the community all the way to the lake. Map #2 below shows it's location.

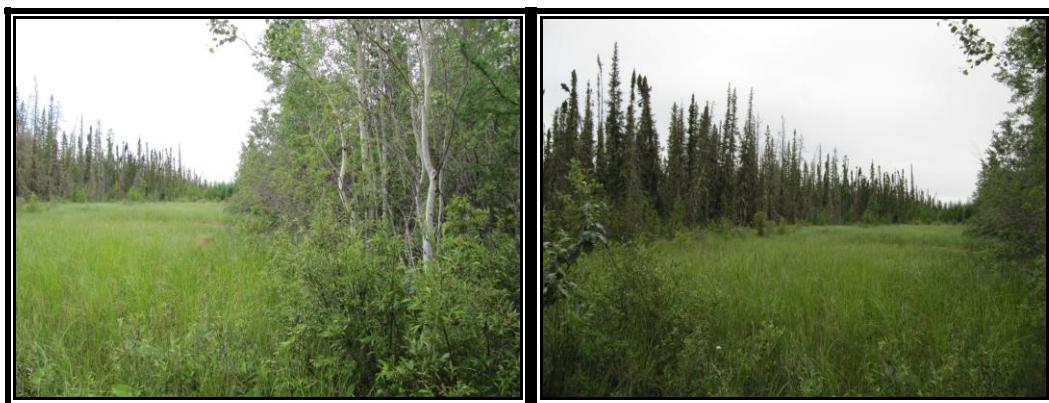
Figure #8. The existing perimeter fuel break south of the village.

The feature, as is, provides a good tactical fuel break to the community in the event a wildfire is approaching from the south. However, it should be explored further as to whether its full extent is in similar condition to that close to the community where it was reviewed. This will likely be most effectively completed on ATV (although wet ground conditions may prevent the use of an ATV), a sled or, if necessary, a helicopter.
