Government of  
Northwest Territories

# Canol Trail Miles 0-8 Remediation Project

ENVIRONMENT AND CLIMATE CHANGE

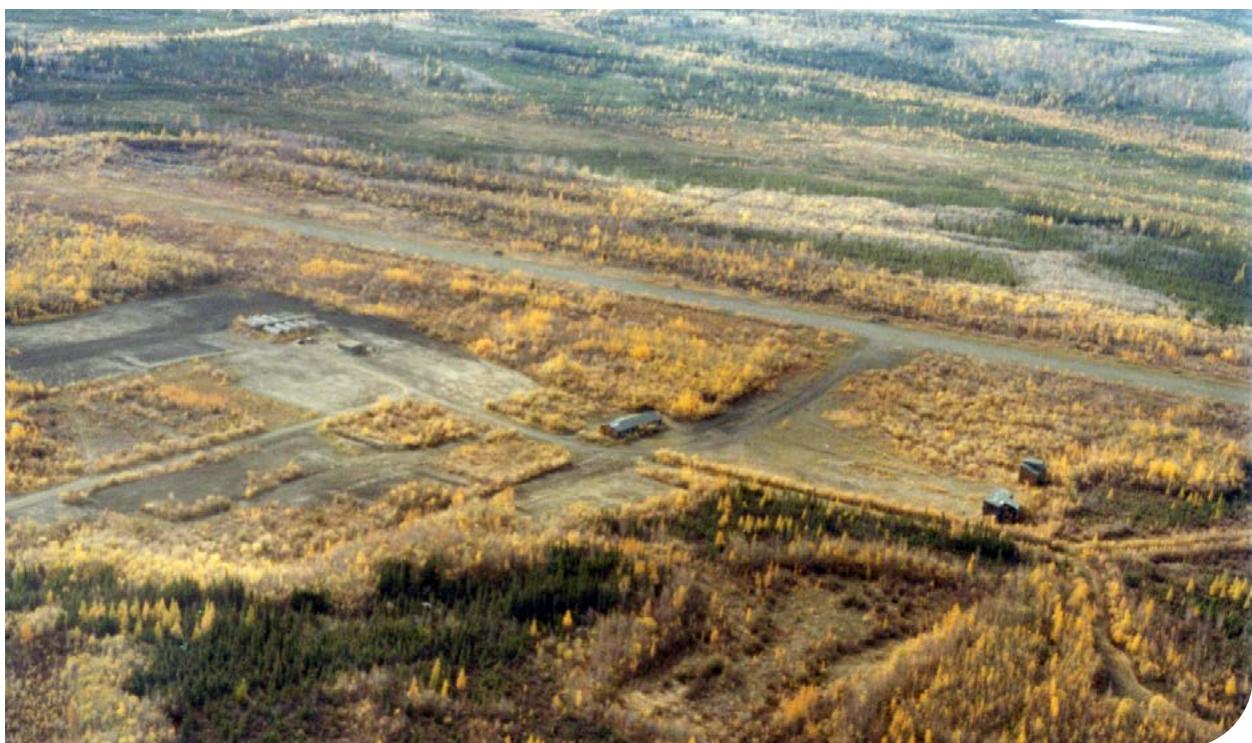
*Remains of Canol Camp shortly after [Imperial Oil remediation], 14 September 1977.  
[Mile 8 - quonsets (left), stables (middle) and nose hangers (right)]*

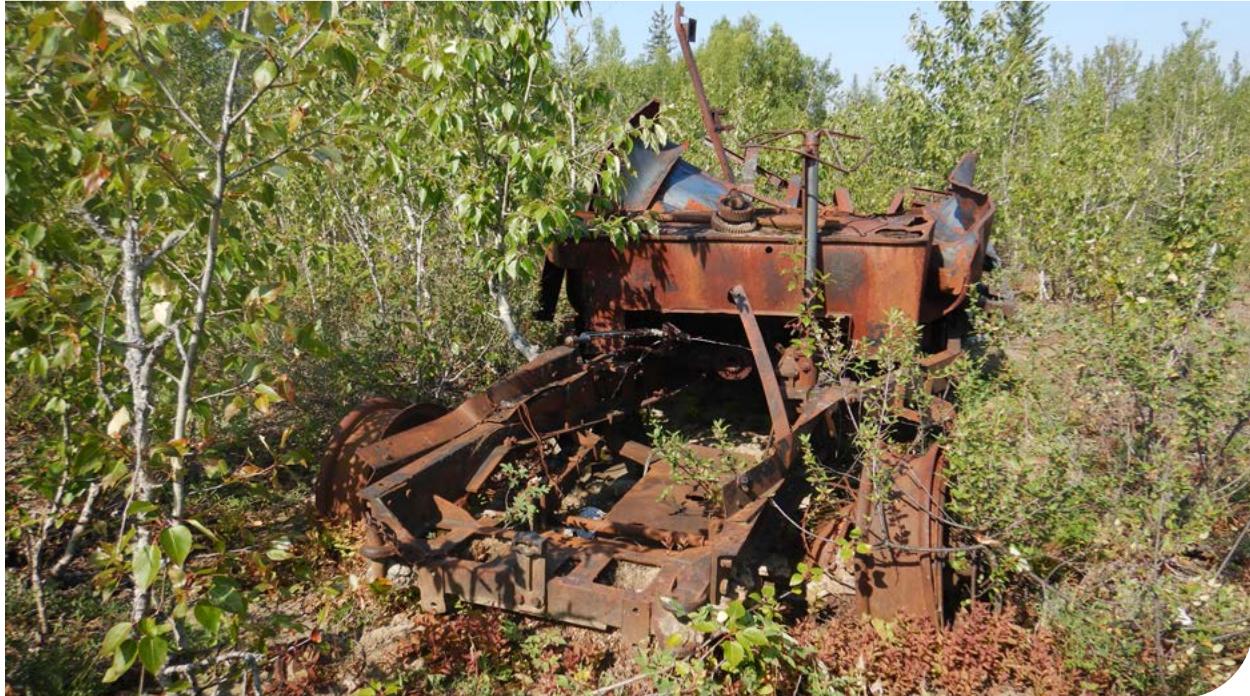
Abandoned equipment at Mile 8.

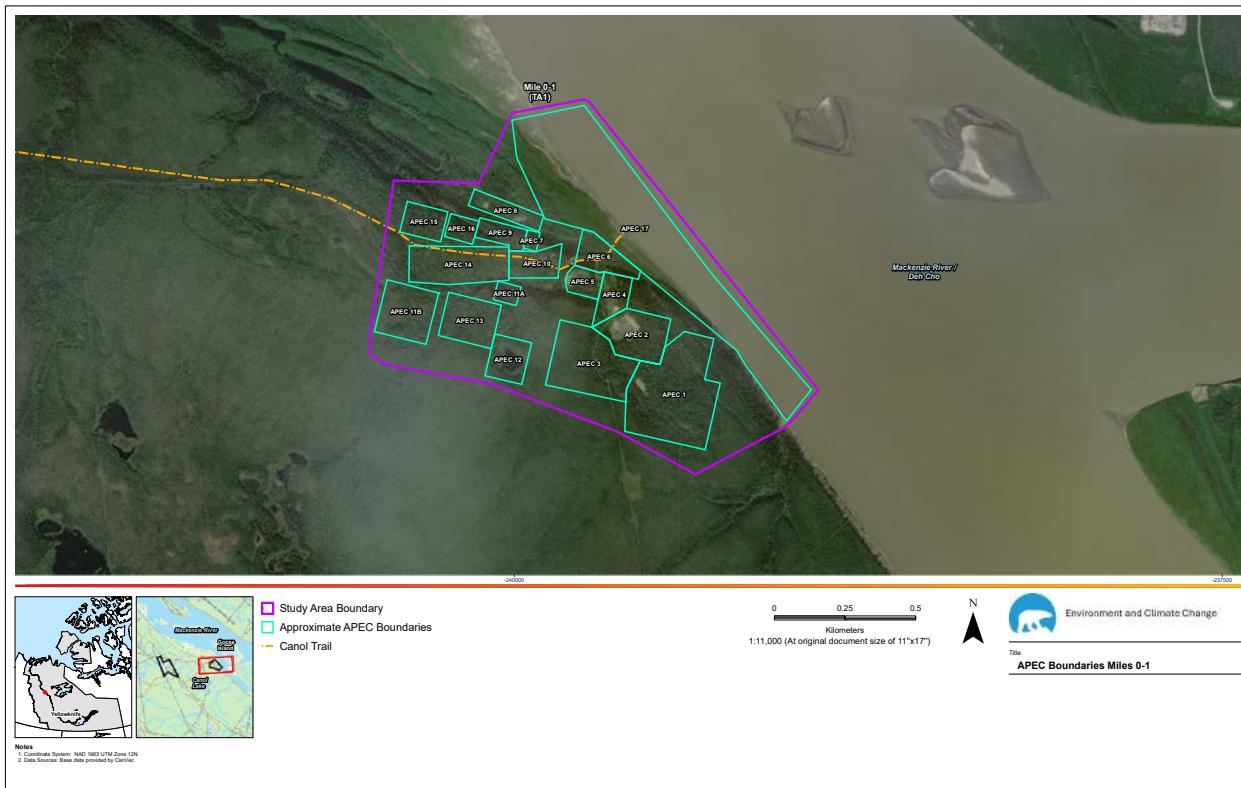
Figure 2: Location of APECs at Mile 0-1.

The Phase I ESA identified 17 APECs at Mile 0-1 and 6 APECs at Mile 8. Examples of the APECs and the potential sources of contamination are provided below.

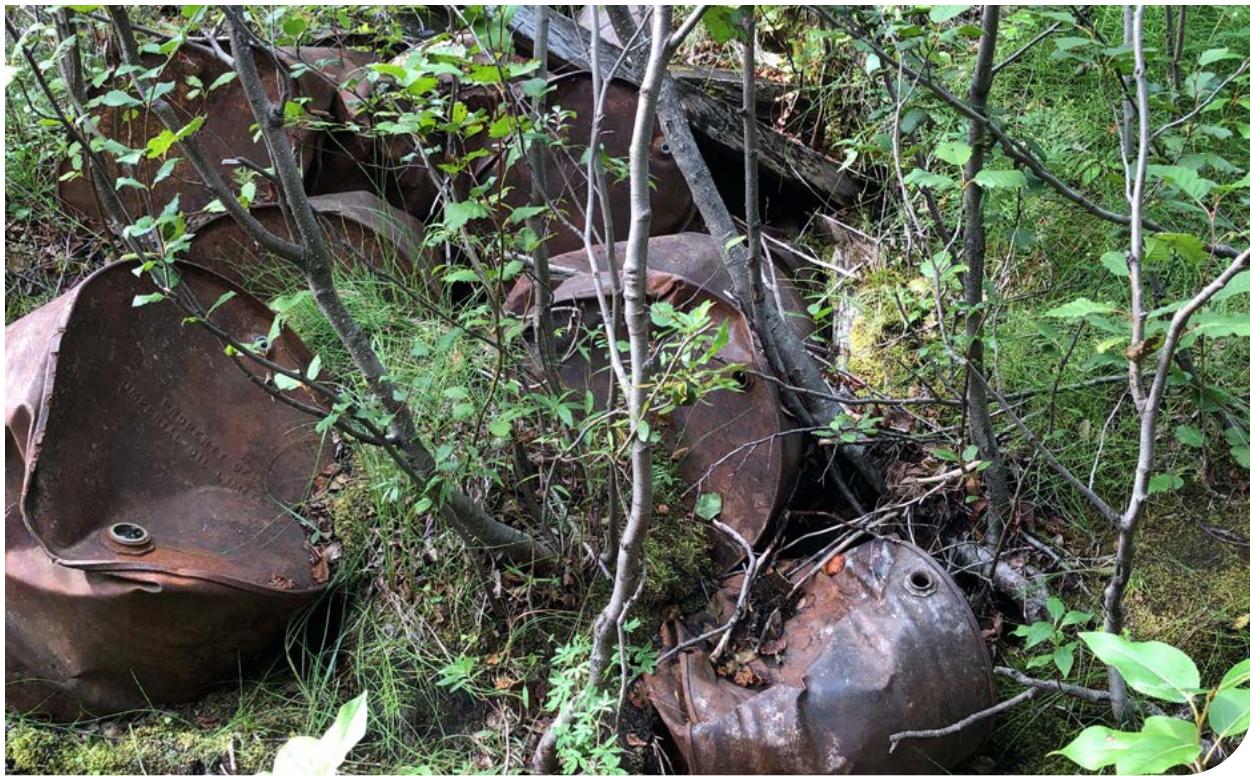
Barrel dump at Mile 8.

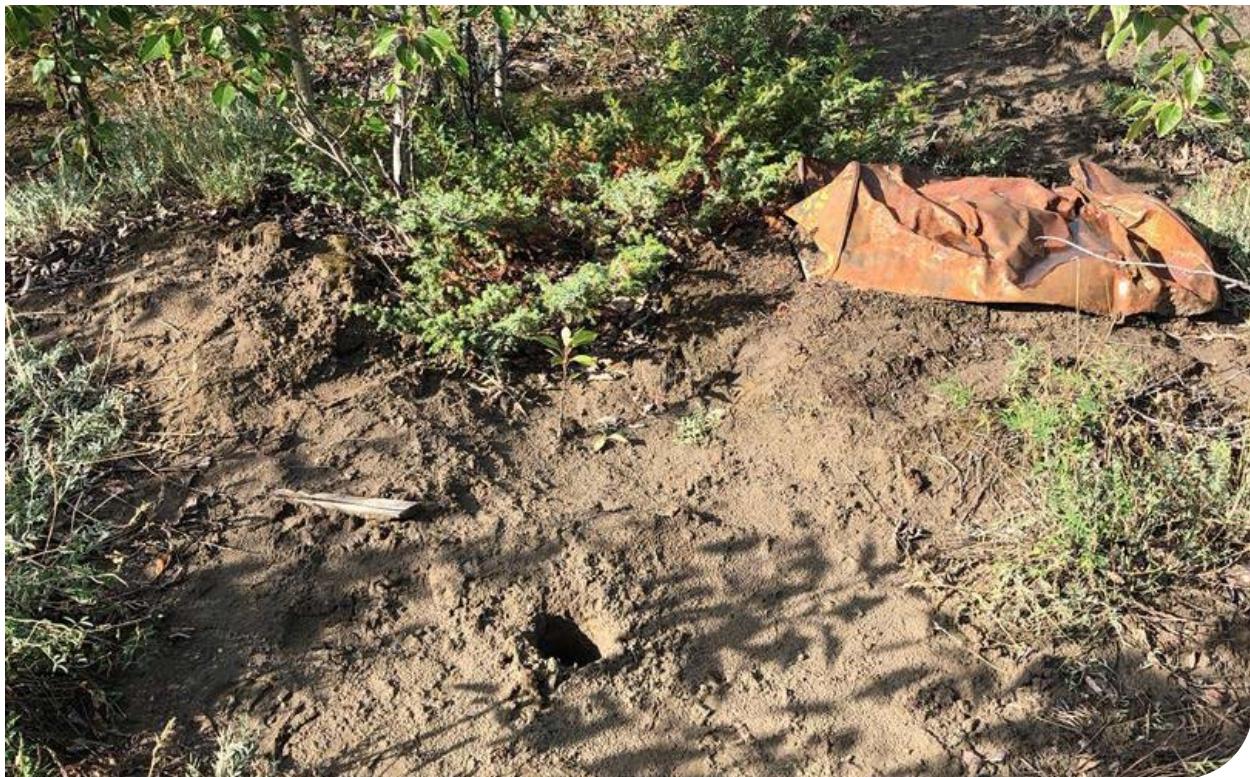
Soil sampling near barrel at Mile 8.

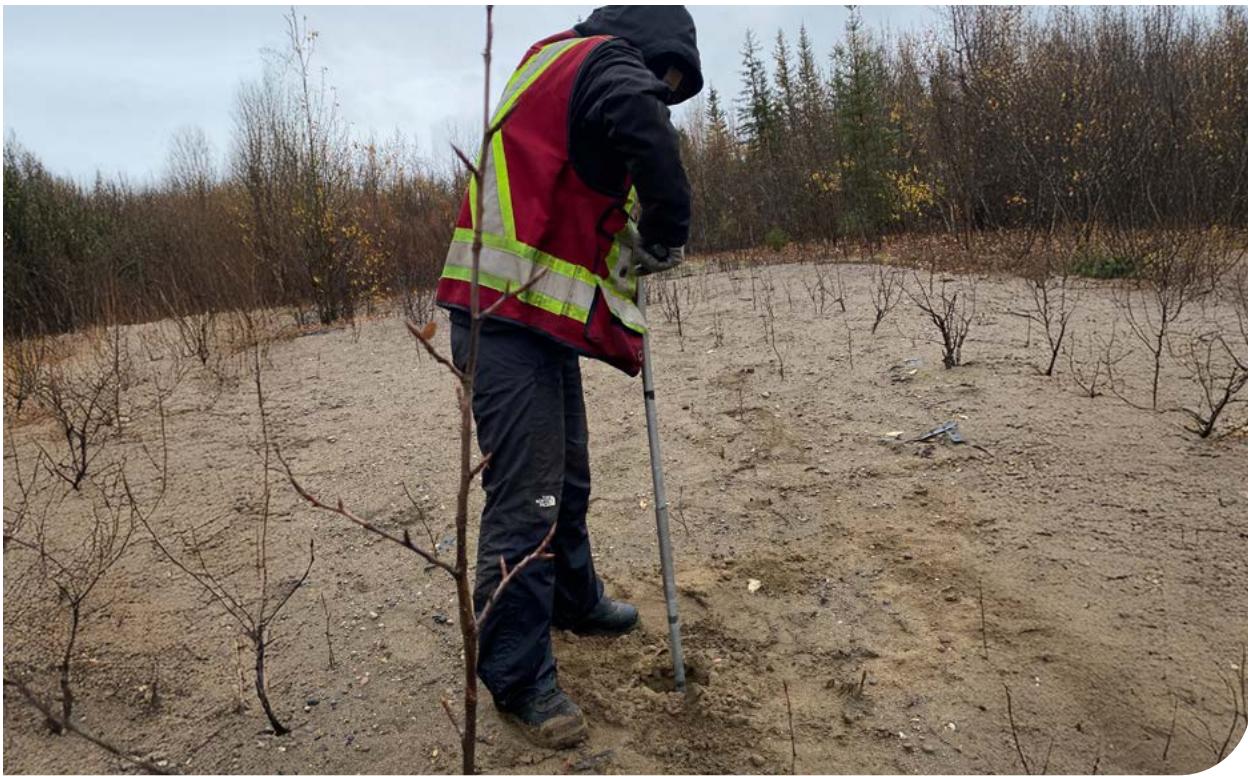
*Soil sampling completed during the 2023 field program.*

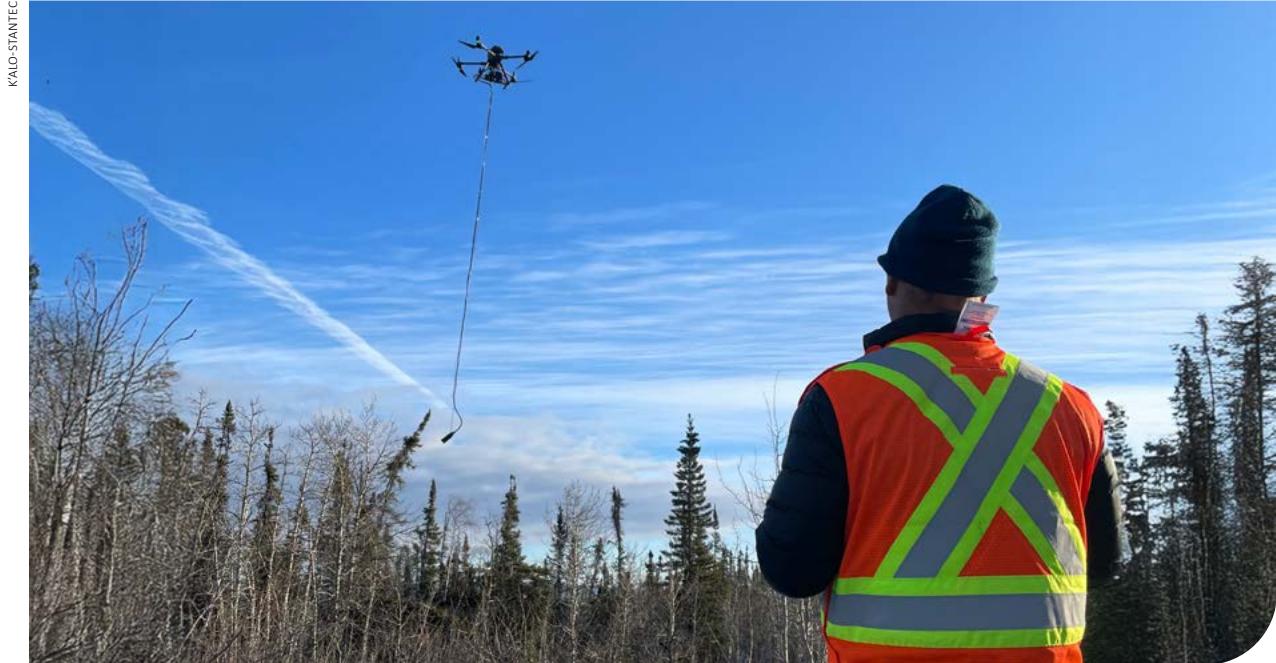
*Drone program in October 2023.*

However, the magnetic survey also identified five areas that were not linked to observations of surficial debris and require additional investigation to confirm the presence of buried debris. These included three areas around the former tank farm area at Mile 0-1 and two areas at the former Camp Area located at Mile 8.

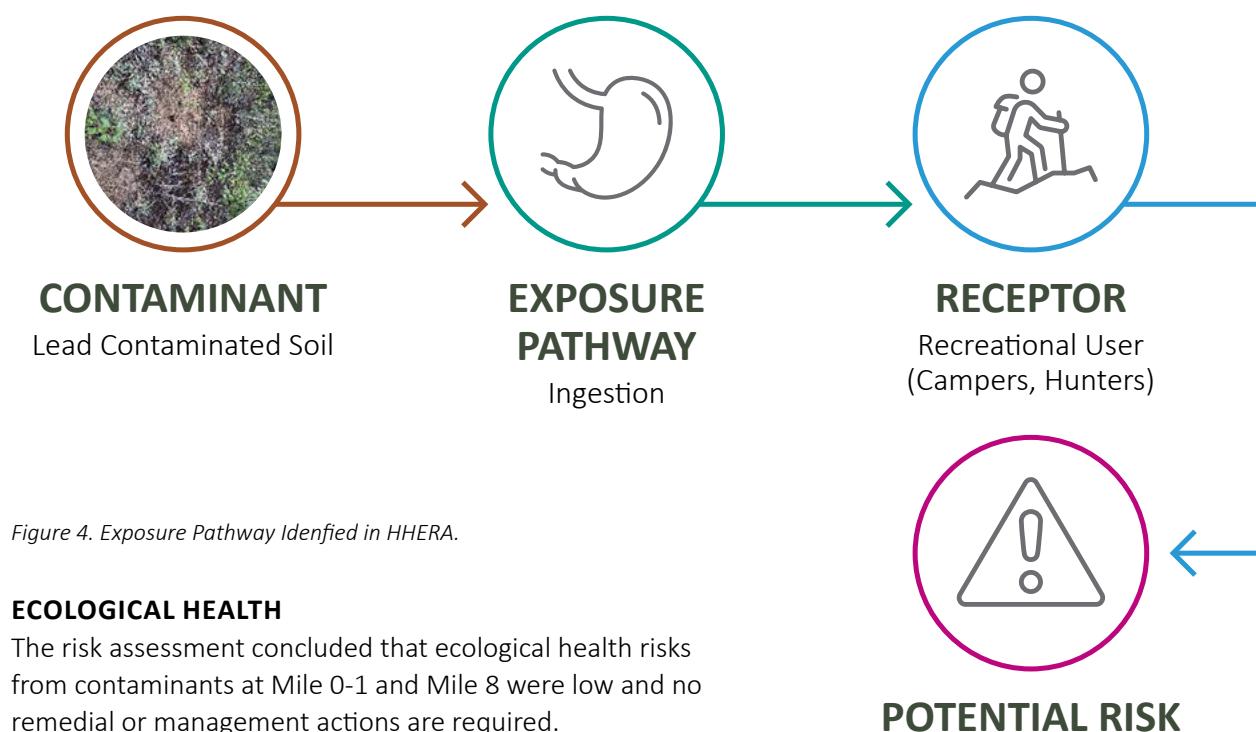
A risk is considered to be present if all three elements (a receptor, a contaminant, and an exposure pathway) are present. Without one of these three elements present, there is no risk.

Figure 4. Exposure Pathway Identified in HHERA.

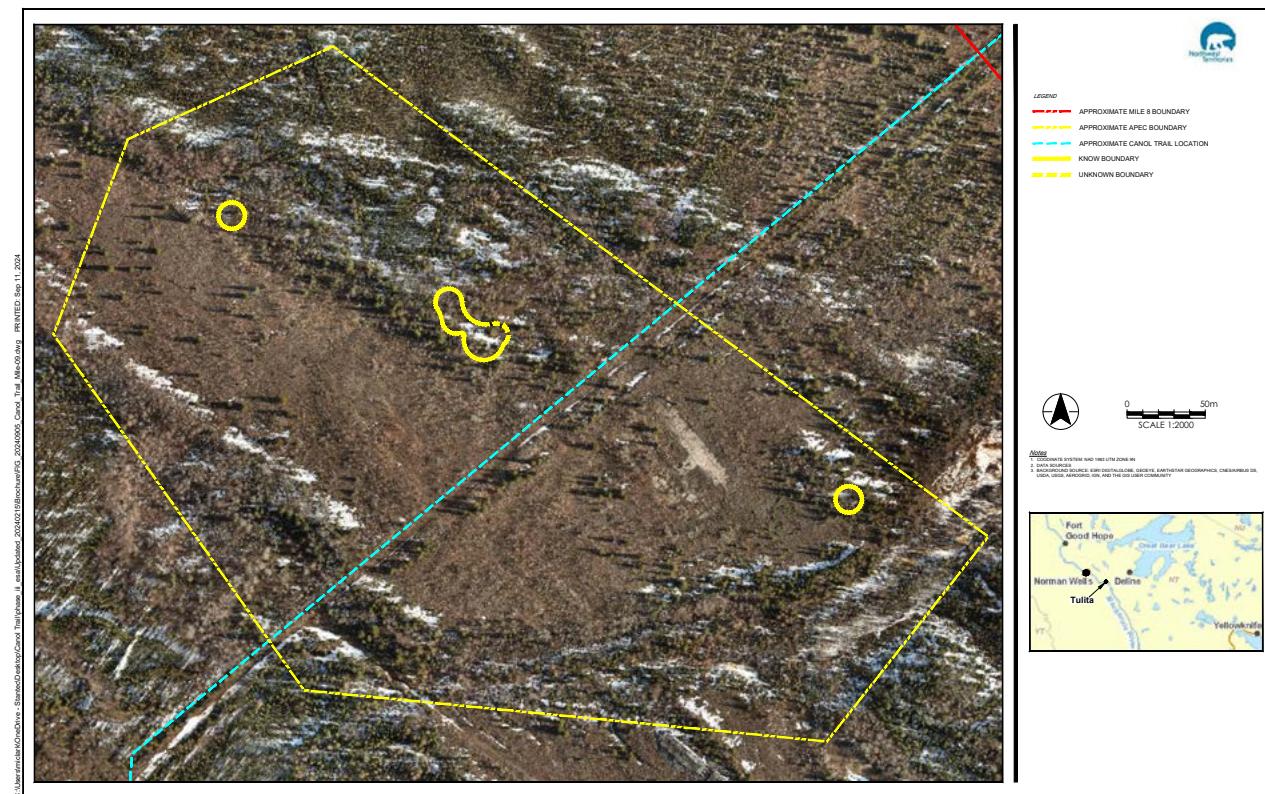
The risk assessments concluded that human health risks from contaminants at Mile 0-1 and Mile 8 were low, with the exception of four areas of lead contaminated soil at Mile 8. The areas of lead contaminated soil pose a risk to the health of trail users that come in contact with the soil. These areas should be remediated or managed.

Figure 5: Three (3) areas of lead contaminated soil in APEC 20 (Camp Area 1).

Locations of the lead contaminated soil are shown in Figures 5 and 6.

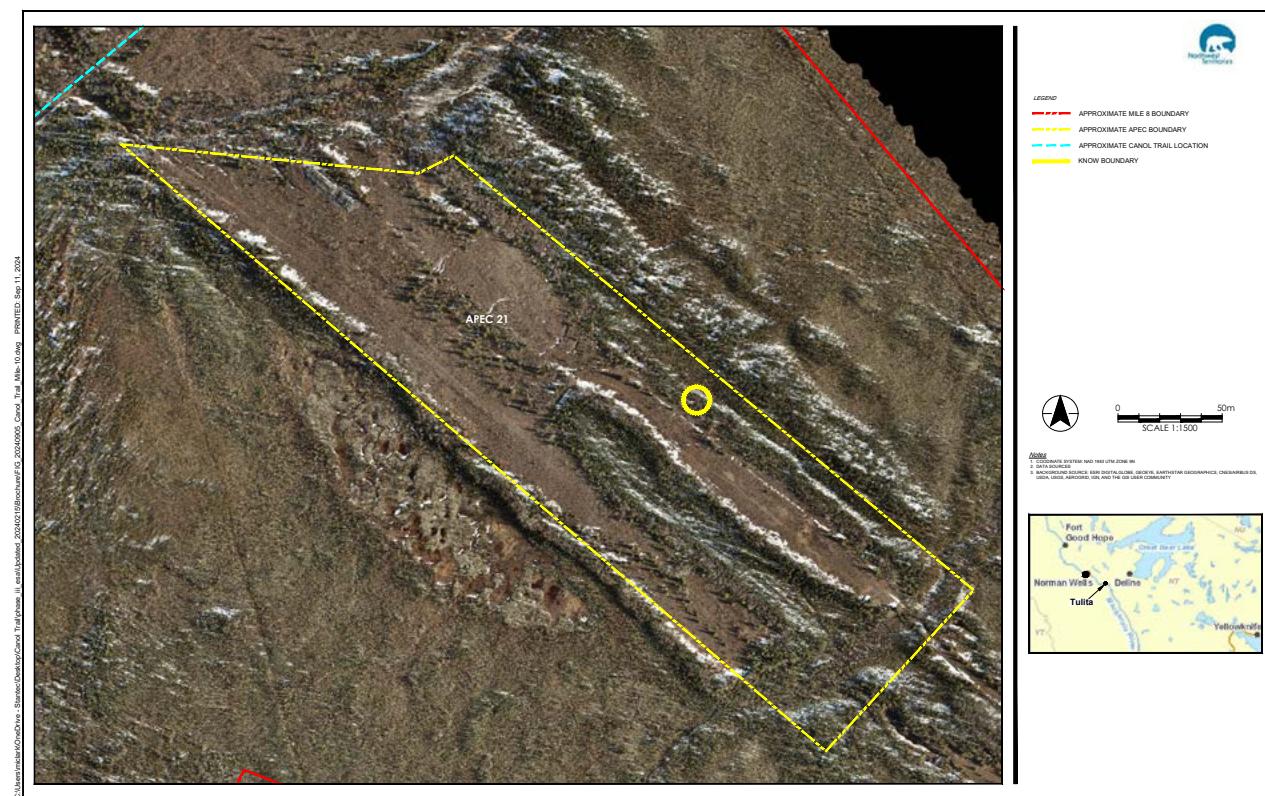
Figure 6: One (1) area of lead contaminated soil in APEC 21 (Camp Area 2).

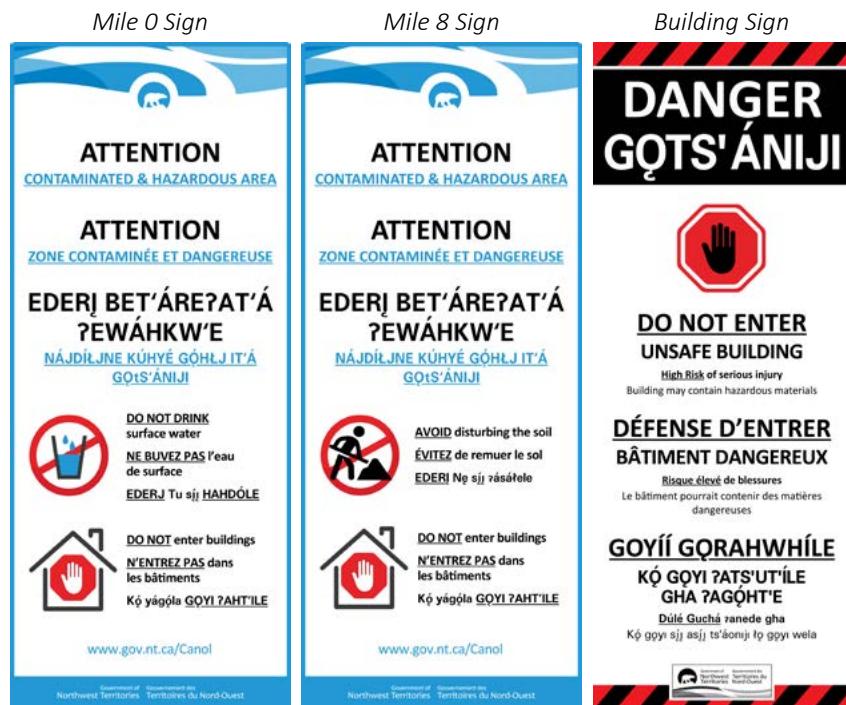
Signage was installed in October 2023. Signage for Mile 0 and Mile 8 was placed along the entrances to the trail. Building signs were affixed to the sides of buildings.

Figure 7: Signage installed on the trail in October 2023.

In response to the 2020 HHERA, the GNWT designed and installed signs at Mile 0-1 and Mile 8 to warn trail users of potential risks at the sites. Three potential risks were identified.
