## **Prairie Creek Mine All-Season Road: Collared Pika Baseline & Habitat Loss Estimates**

PRESENTED TO  
**Canadian Zinc Corporation**

AUGUST 24, 2021  
ISSUED FOR USE  
FILE: ENW.EENW03326-02

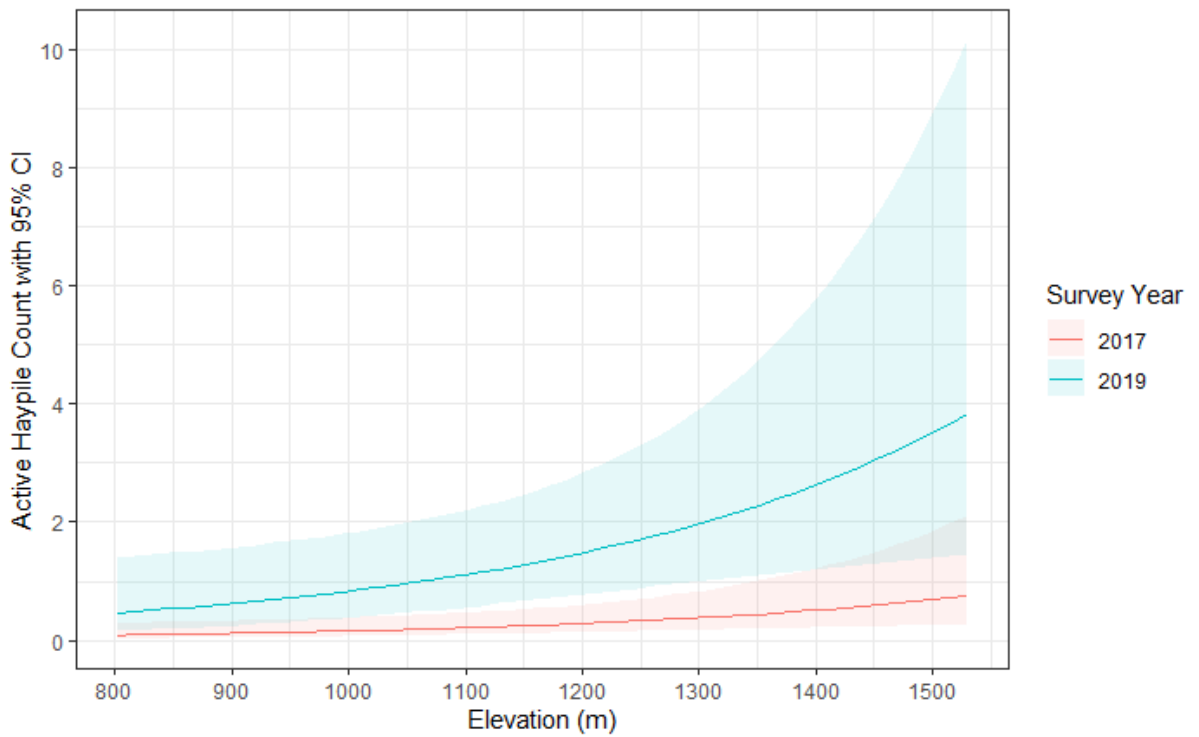
**Figure C:** Estimated Mean Count of Active Haypiles Across Varying Elevations in 2017 and 2019  
(Mean counts are standardized to 0.039 ha survey area)

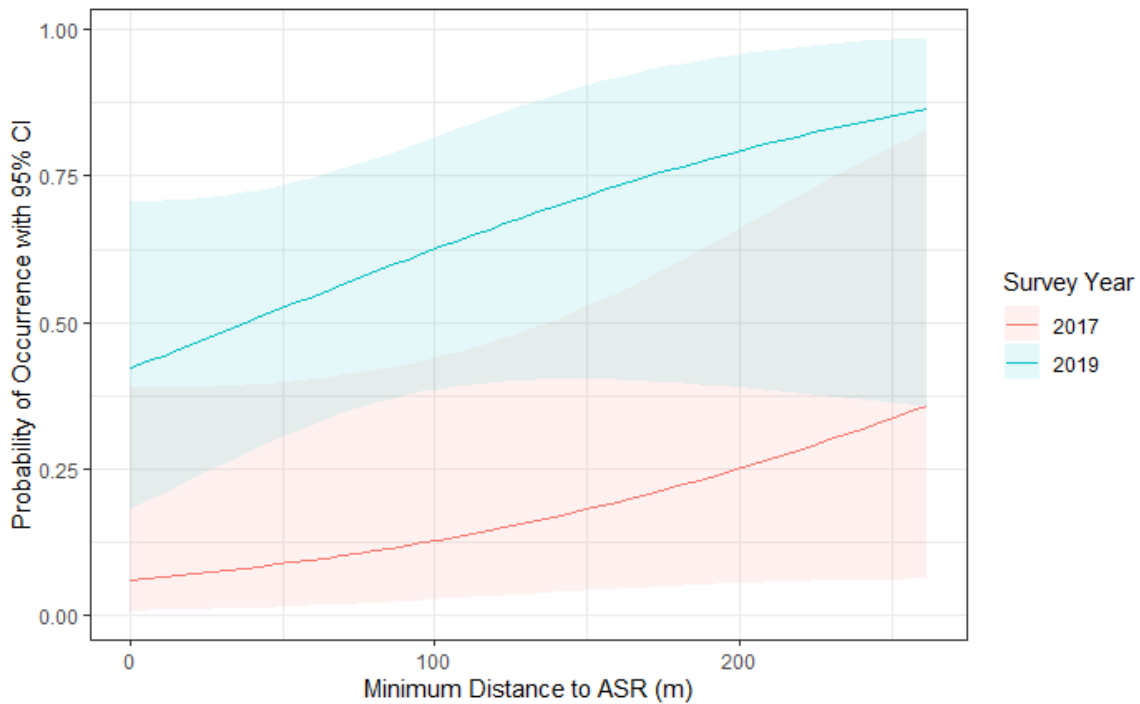
**Figure F:** Estimated Pika Probability of Occurrence Across Varying Distance to ASR in 2017 and 2019

The pika occurrence model shows patterns that are similar and consistent with the active haypile abundance model. Distance to ASR was found to help explain pika occurrence (with moderate confidence) though not active haypile abundance. This pattern can be further explored as new data is collected and will become an important element of future analyses after construction of the ASR.

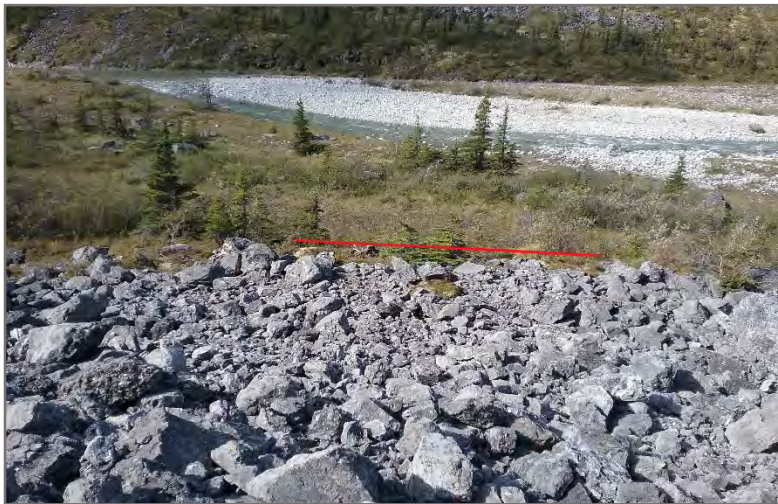
**Photo 1:** Looking across the eastern edge of CZN-32-PK-4 towards the existing 1980s road immediately downslope of the talus site. Red line approximates the nearest edge of the existing road (2.7 m). Note that the existing road is downslope of the talus but is not shown well on this photo.

Meadow at the eastern portion of CZN-32-PK-4 is influenced by the presence of the existing 1980s road. Here the existing 1980s road is providing meadow habitat as it regenerates to willow and grasses (Photos 1 and 5). Since the PWR follows the existing 1980s road, the PWR results in a loss of pika meadow at CZN-32-PK-4. The PWR avoids the loss of talus sites and meadow at all other sites. Refer to Section 3.3.1 for pika habitat loss estimates resulting from the PWR.

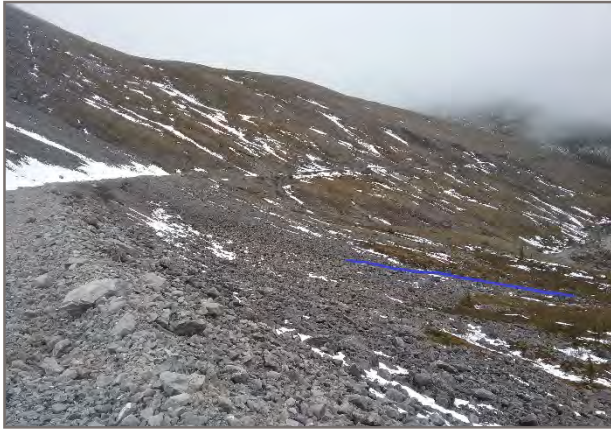
**Photo 2:** On the existing 1980s winter road looking west across CZN-15-PK-1 to the meadow below in valley (meadow on east perimeter of talus site not shown). West boundary of talus site shown as blue line.

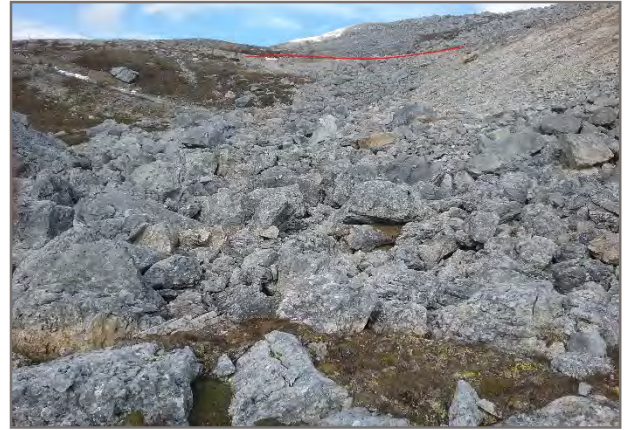
**Photo 3:** Standing at the toe looking upslope across talus site CZN-15-PK-2 (full extent of toe meadow not shown), the existing 1980s winter road (red line), and the meadow along the eastern perimeter of the talus site.

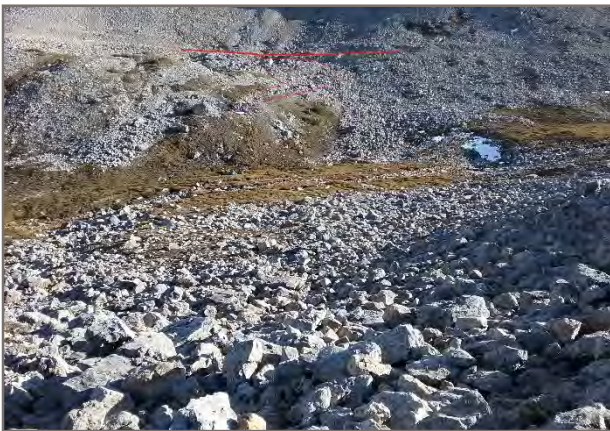
**Photo 4:** Looking north across the meadow in the valley, CZN-16-PK-3, and existing 1980s winter road (red line).

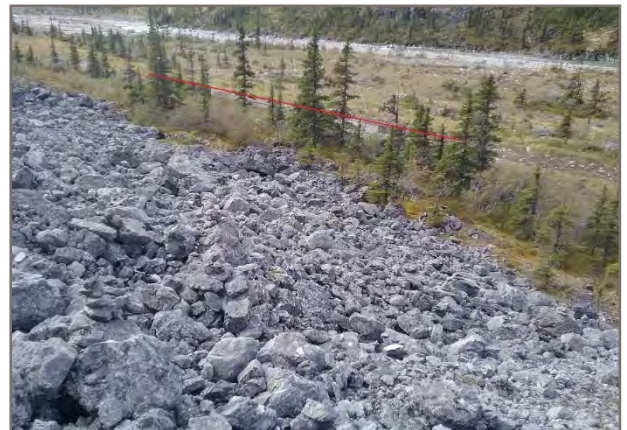
**Photo 5:** Looking downslope across CZN-32-PK-4 towards the meadow to Sundog Creek and the existing 1980s winter road (red line; approx. 12 m from edge of talus in this photo. See Photo 1 showing the existing road as close as 2.7 m to eastern edge of this talus site).

Construction of the PWR avoids direct loss to talus sites (0 ha direct loss) and currently results in 0.021 ha of temporary loss to available meadow at CZN-32-PK-4 because the 1980s road, which the PWR follows, is regenerating and providing some meadow habitat for pika at this site. Construction of the PWR does not damage the regenerating grasses in the meadow but does delay the snowmelt and spring availability of this portion of meadow to pika. This is a temporary loss to approximately 25% of the total meadow available at CZN-32-PK-4. Refer to Section 3.3.1.1 for adaptive management action below.

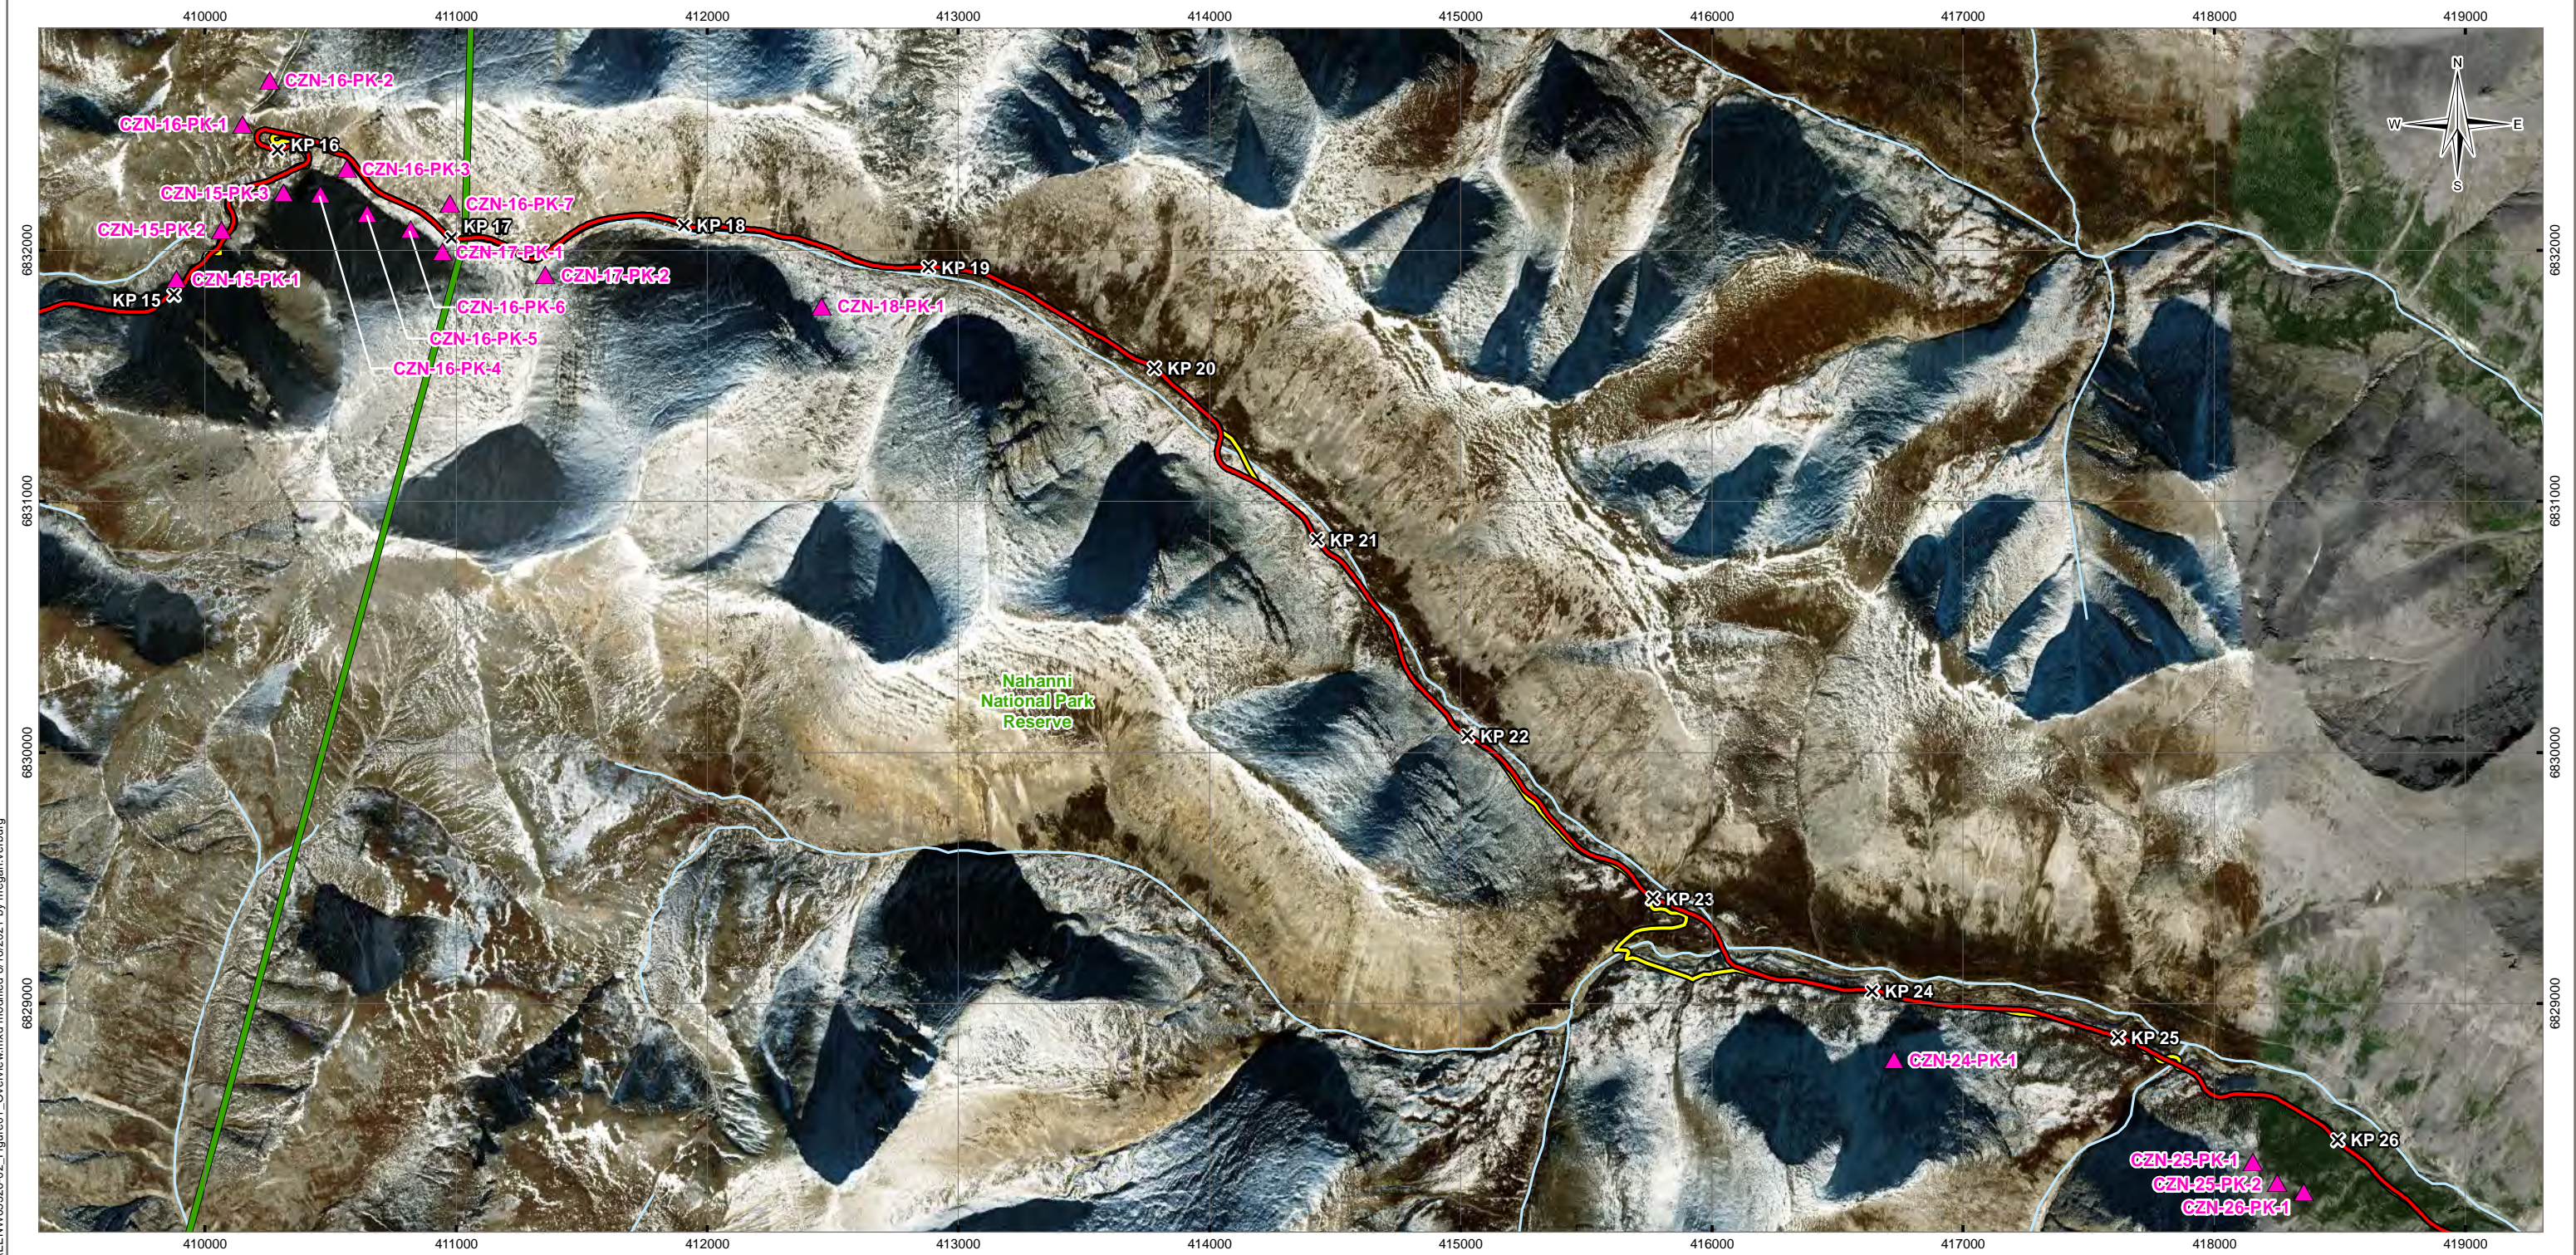
A talus site is defined as a distinct patch of talus (located at least 30 m from another talus site; Carroll 2016) that meets the criteria of pika habitat irrespective of whether pika or pika sign was detected. Those that are greater than 30 m apart and separated by habitat breaks (e.g., scree, meadow) are classified as distinct talus sites. Talus sites occur within 500 m on either side of the ASR between KP 15.0 and 38.1, with concentrations mainly near 1) KP 15-17, 2) KP 32-35, and 3) KP 37-38 (Table 1; Figure 1).

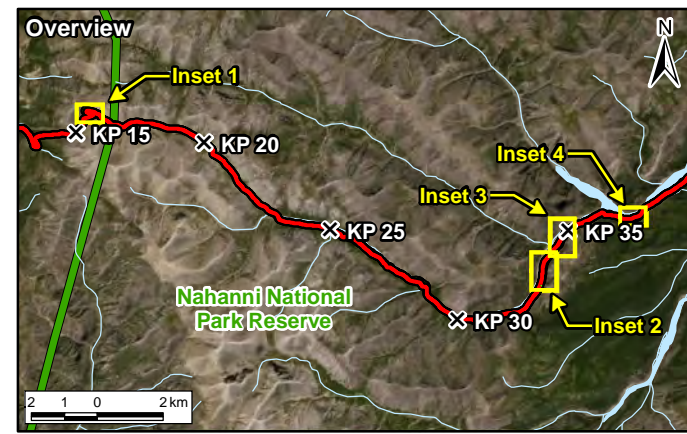
**Figure 3**

CZN is designing the ASR alignment to avoid talus sites and meadow to the extent possible. Since 2016, the ASR has undergone various re-alignments to avoid 15 talus sites and this work continues. Re-alignments to date are summarized below and shown on Figure 3:

**KP 16.1:** re-aligned the ASR by approximately 60 m to avoid CZN-16-PK-1 (Figure 3, Inset 1).

**KP 16.5:** re-aligned the ASR approximately 3 m upslope to further avoid CZN-16-PK-3 (Figure 3, Inset 1).

**KP 33.0 to 35.2 and KP 36.8 to 37.4:** re-aligned portions of the ASR along this segment to avoid 13 talus sites (Figure 3, Insets 2, 3, and 4). As first reported in the 2016 baseline report (Tetra Tech 2016), CZN directed Allnorth to move the proposed ASR alignment, to the extent possible, off the talus in the vicinity of lower Sundog Creek. As a result, the ASR alignment was moved onto the Sundog Creek floodplain and/or to the floodplain edge, to the extent possible.
