NWT Water Monitoring Bulletin

– May 16, 2022: 13:00

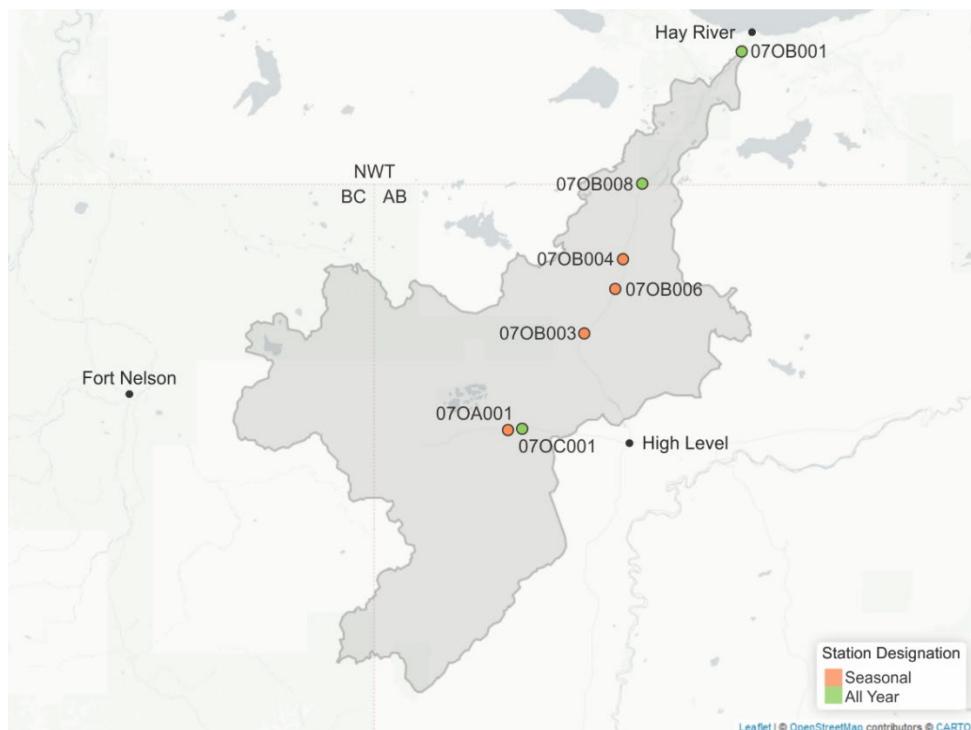
Above – Map of hydrometric stations in the Hay River basin. The station numbers are referenced in the water level plots below.

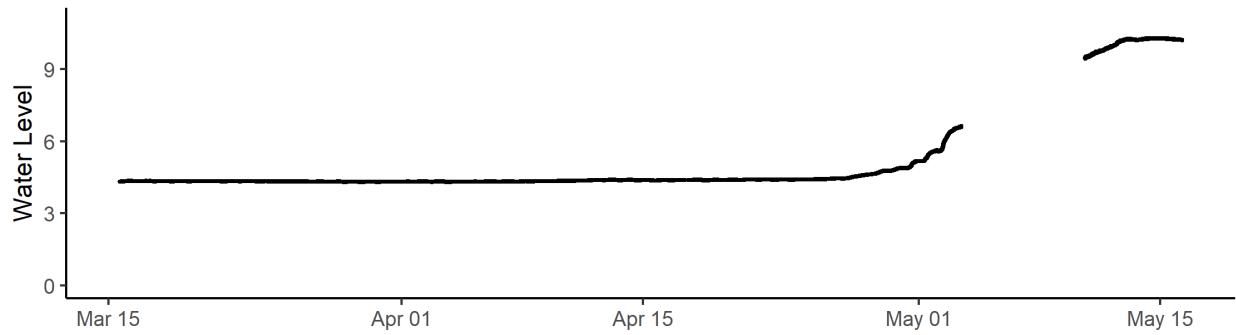
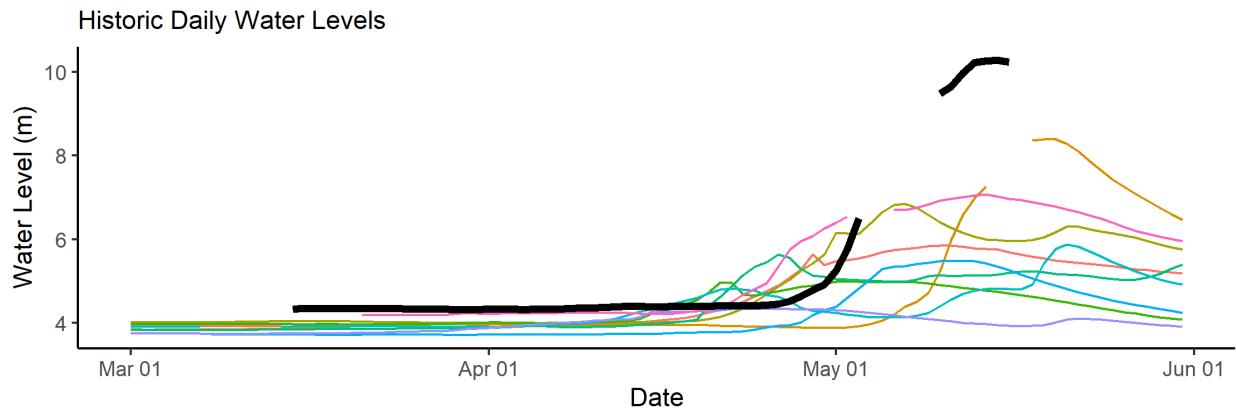
HAY RIVER NEAR MEANDER RIVER (07OB003)

Above – Water level data on the Hay River near Meander River, AB. It appears that water levels are reaching their peak in response to the precipitation event from last week.

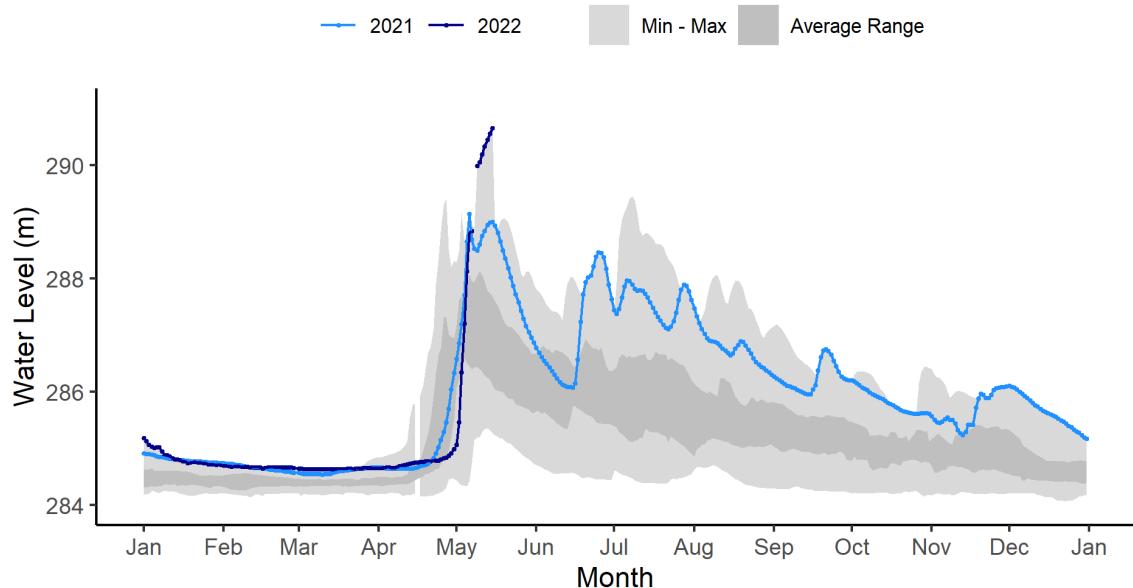
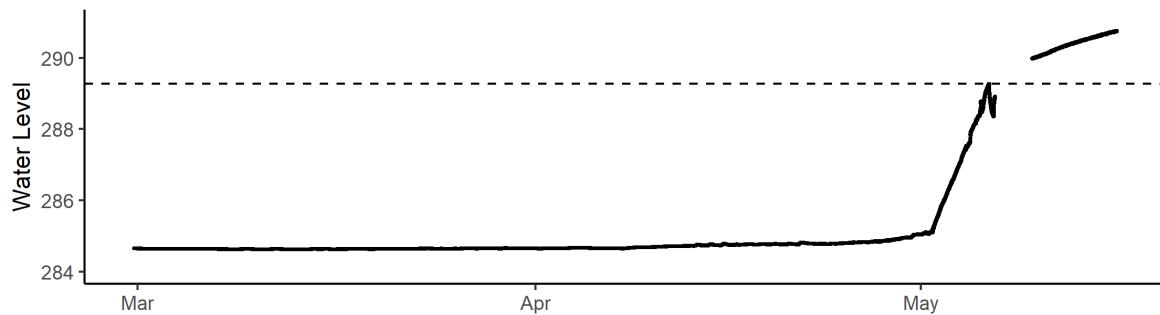
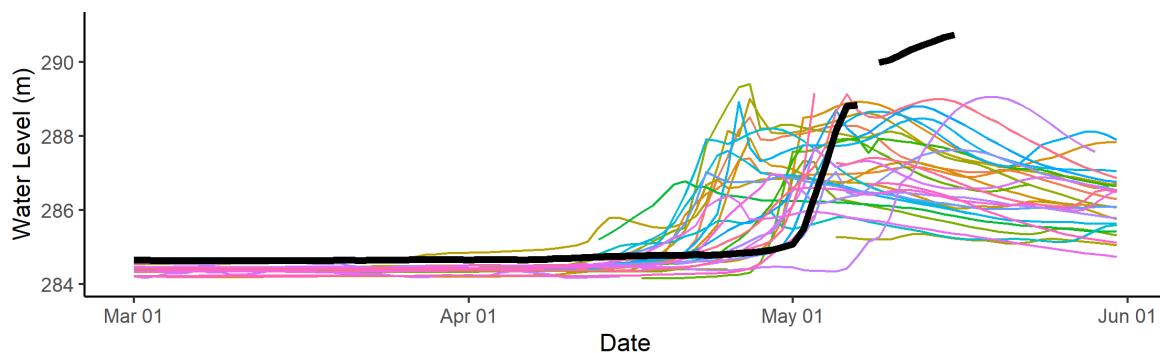
HAY RIVER NEAR ALTA/NWT BOUNDARY (070B008)

Above - The middle graph in this figure presents real time water level data at 5-minute resolution with the dashed line representing the peak water level from last year (2021). The lower graph shows daily average levels relative to the previous 20 years. Water levels continue to slowly rise as snowmelt water continues to move through the basin.

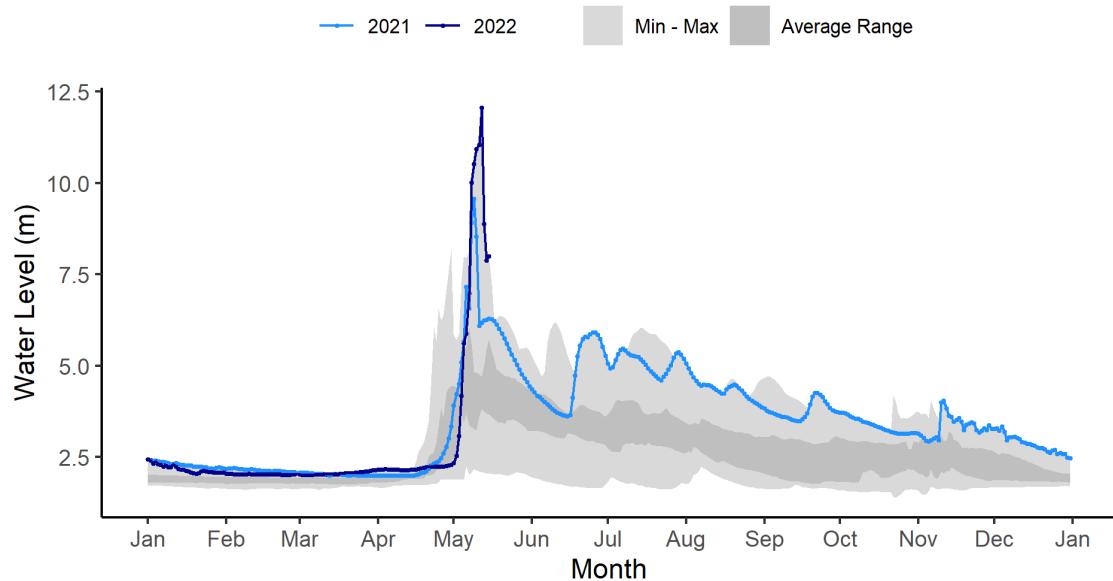
Hay River near Hay River [07OB001]:
HAY RIVER NEAR HAY RIVER (07OB001)

Above – hydrograph of daily average levels for the previous two years.

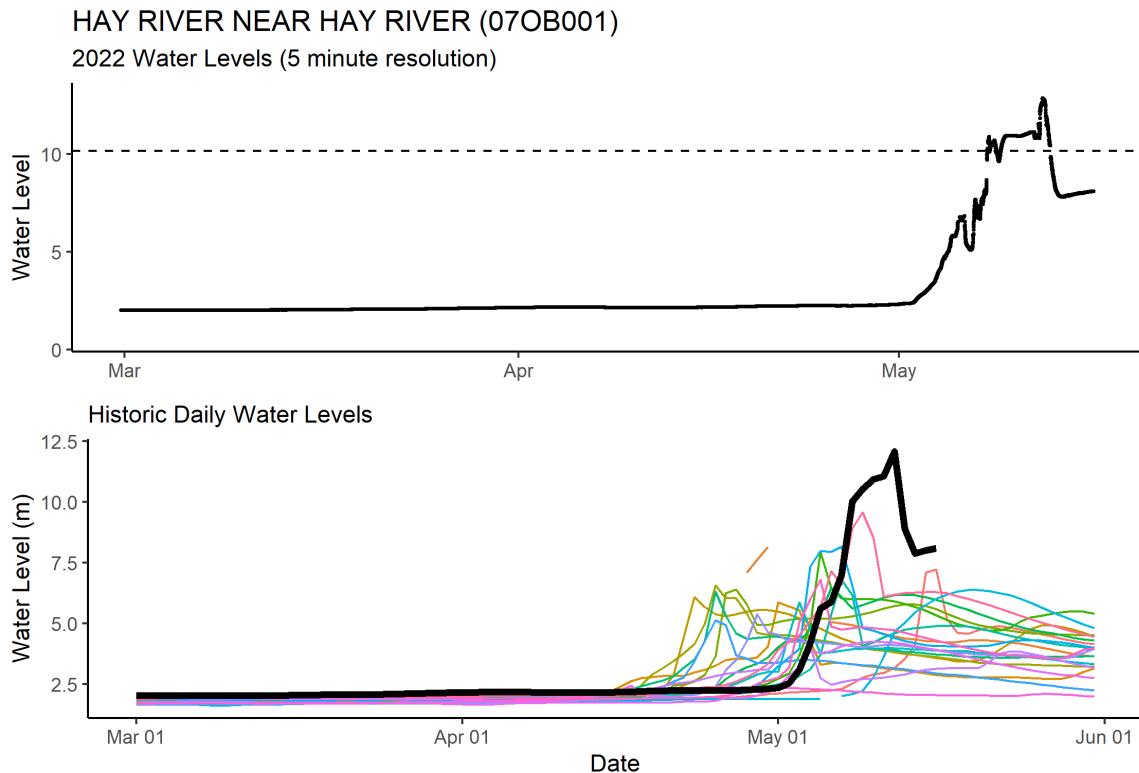
Above - The upper graph in this figure presents real time water level data at 5-minute resolution with the dashed line representing the peak water level from last year (2021). The lower graph shows daily average levels relative to the previous 20 years. The upper graph shows that provisional water levels have hit an open water equilibrium at ~8 m, which is the highest open water level on record.

- Provisional water levels at the Hay River near Hay River gauge (just upstream of town) dropped by 5 m since the peak on the morning of May 12;
 - The provisional water level reading as of 12:00 (8.12 m) is the highest open water level on record;
- While the gauge on the main stem of the Hay River at the border continues to slowly increase as residual snowmelt water moves through the basin and to the river, the gauge further south on the Hay River near Meander River has levelled off;
- Refer to the [Town of Hay River website](#) for the most up-to-date information, as well as webcam images of current conditions.

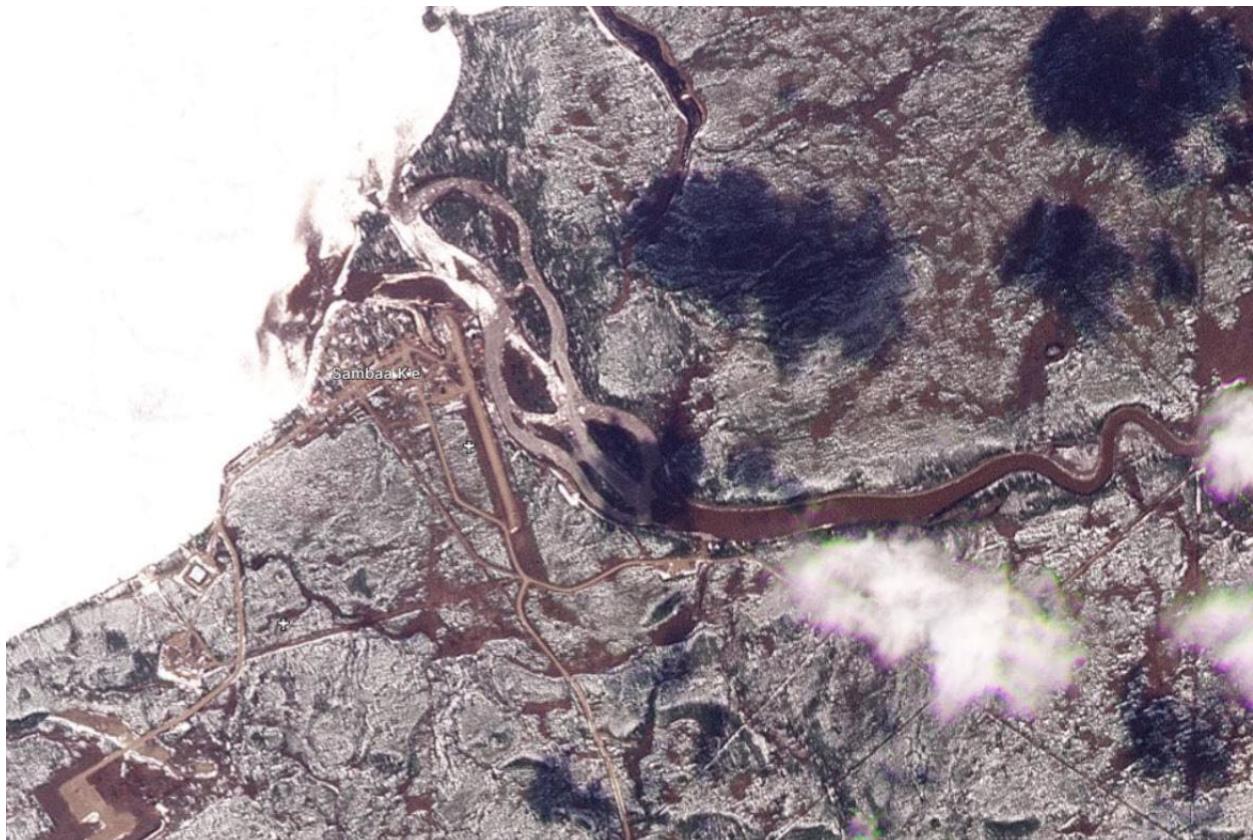
Above – Optical imagery taken at 13:01 MDT on May 15th over the community of Sambaa K'e. Obtained from Planet Explorer. The image shows open water (upstream) and ice (downstream) on the Island River.

- Some flooding was reported in Sambaa K'e yesterday afternoon;
 - Optical imagery indicates that ice on the Island River likely impeded river flow to the lake, backing water up into the community, but further verification required.

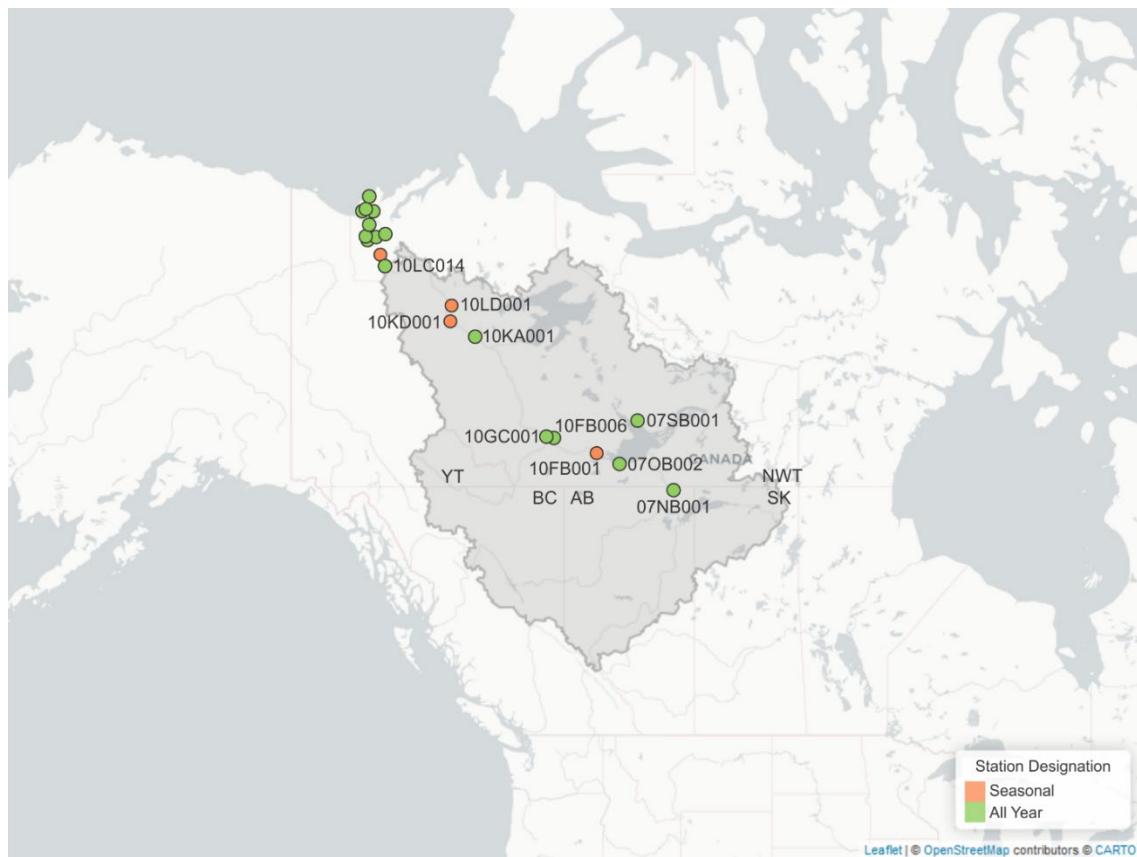
Above – Map of hydrometric stations in the Dehcho (Mackenzie River) basin. The station numbers are referenced in the water level plots below.

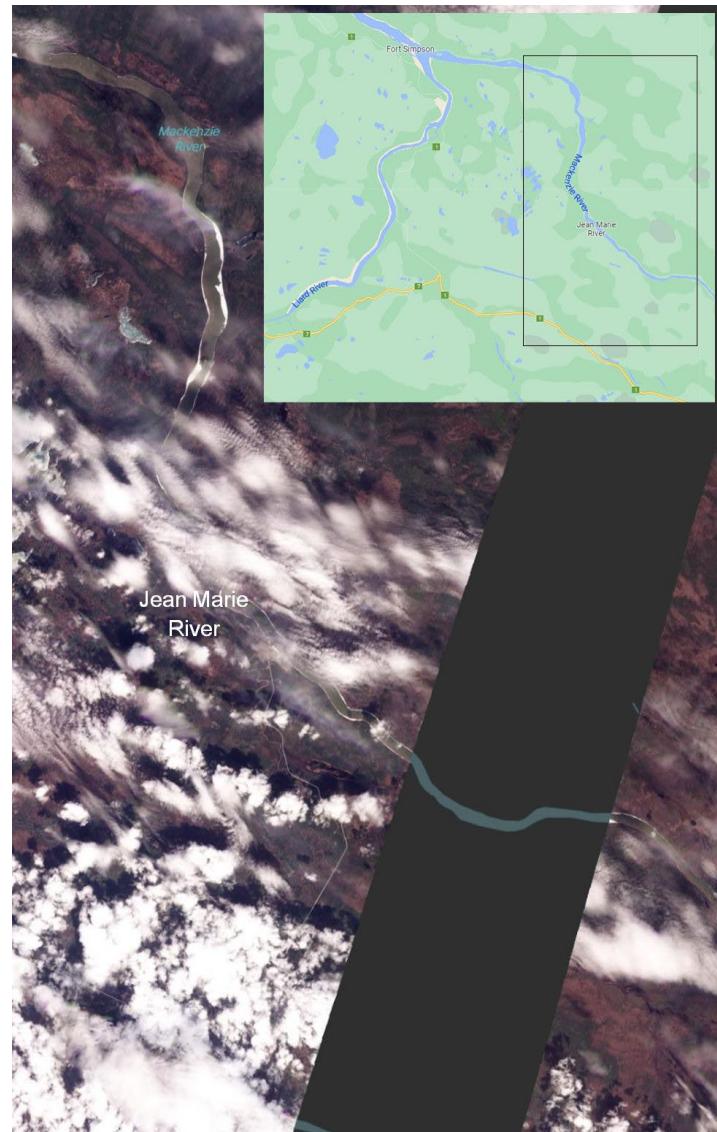
Above – Optical imagery taken between 13:01-13:06 MDT on May 15th of the Mackenzie River around Jean Marie River.

- According to optical imagery from yesterday at ~13:00, the Mackenzie River near Jean Marie River was relatively clear of ice, with some ice moving downstream in the area;

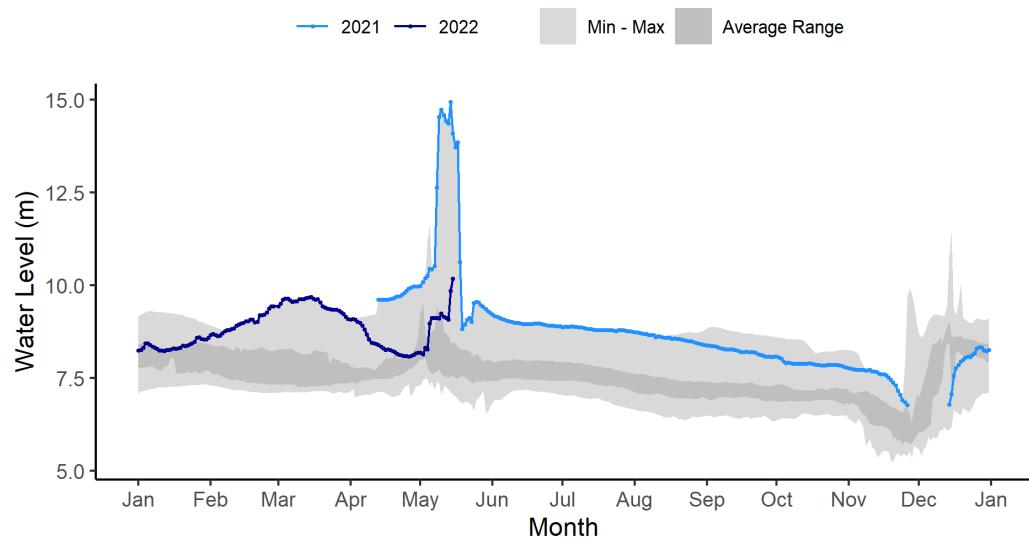
MACKENZIE RIVER AT STRONG POINT (10FB006)

Above – hydrograph of daily average levels for the previous two years.

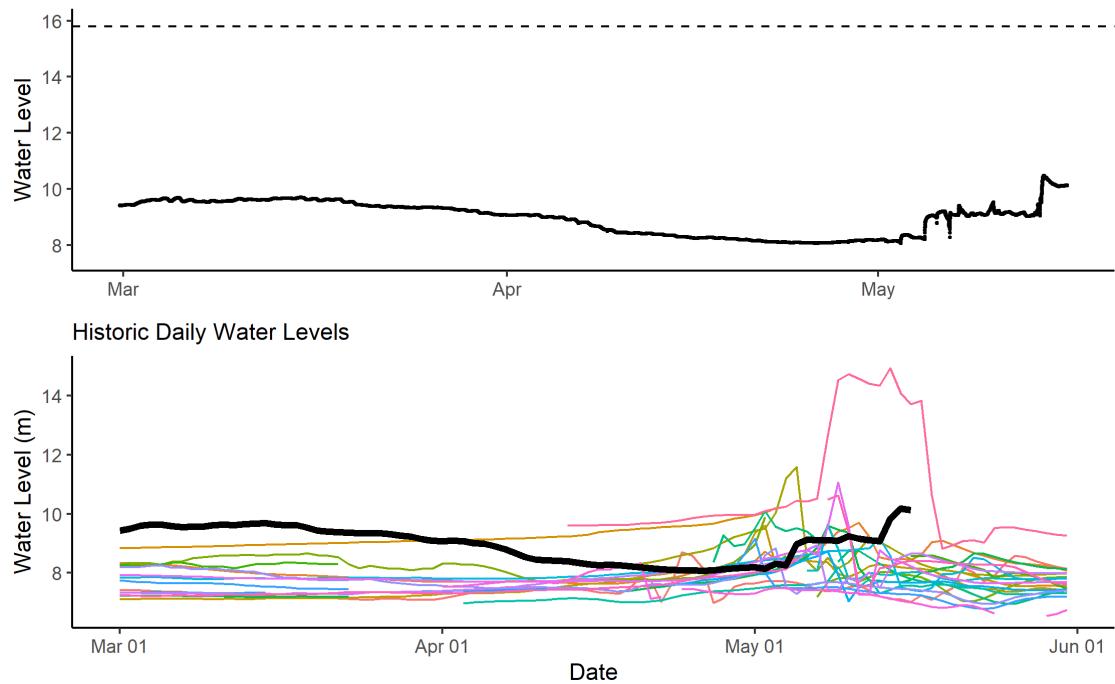
MACKENZIE RIVER AT STRONG POINT (10FB006)

Above - The upper graph in the figure presents real time water level data at 5-minute resolution with the dashed line representing the peak water level from last year (2021). The lower graph shows daily average levels relative to the previous 20 years.

- Provisional water levels on the Mackenzie River at Strong Point (~30 km downstream of Jean Marie River) have remained steady since yesterday;
 - This peak was more than 5 m lower than the peak from the 2021 (last year) flooding event at Jean Marie River;

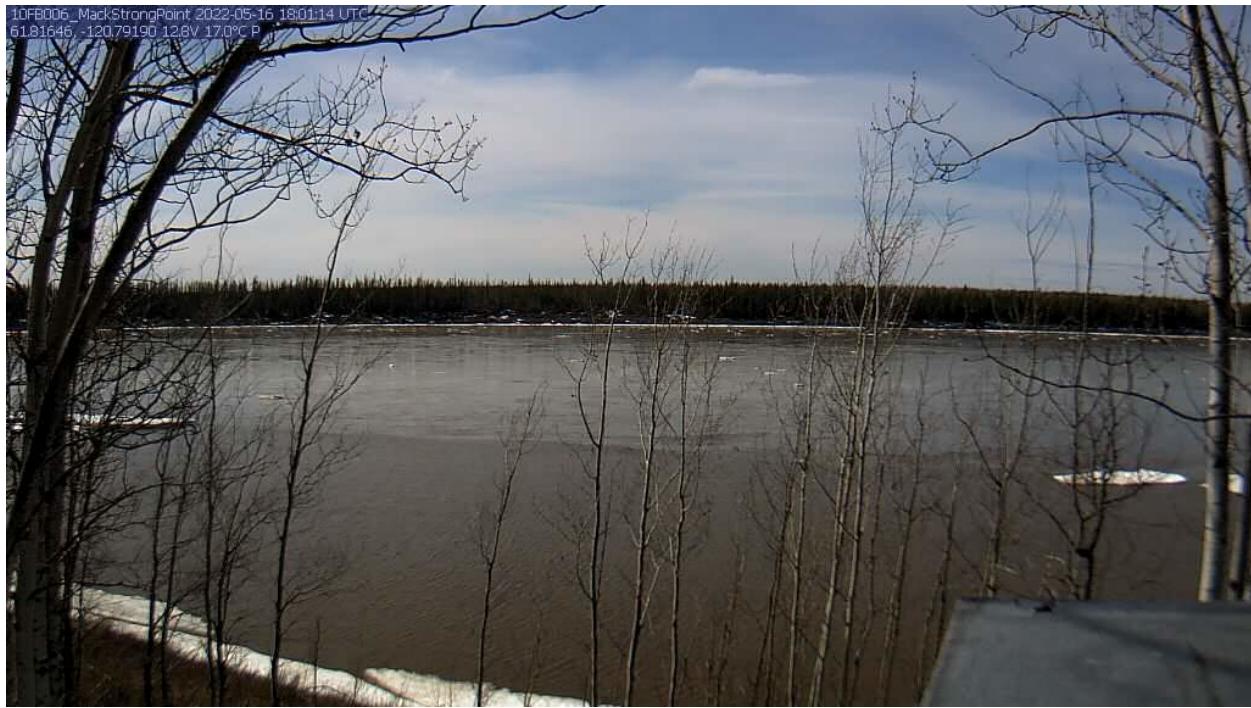
Above – Dehcho (Mackenzie River) at Strong Point hydrometric gauge photo from May 16 at 12:00. Photo courtesy of Water Survey of Canada and GNWT.

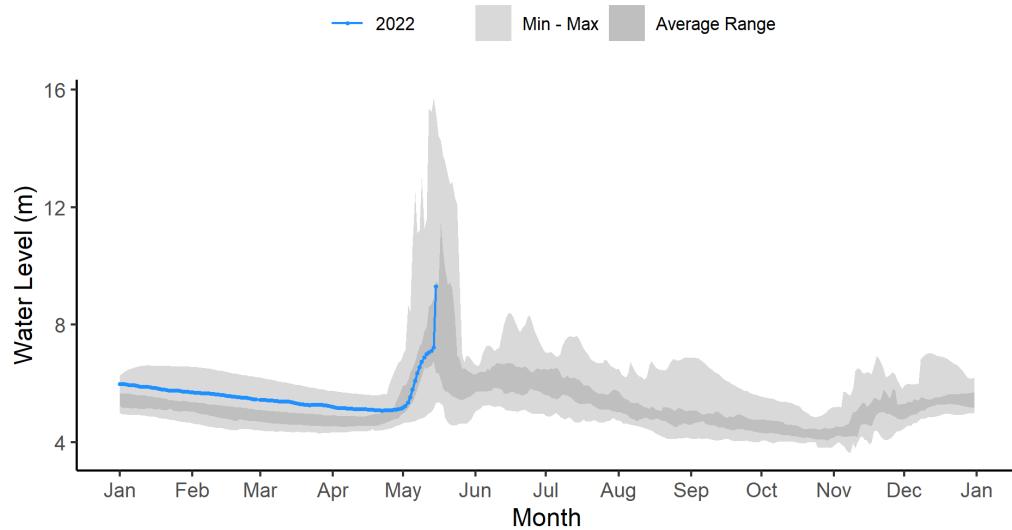
Mackenzie River at Norman Wells [10KA001]:
MACKENZIE RIVER AT NORMAN WELLS (10KA001)

Above – hydrograph of daily average levels for the previous two years. Note: the most recent data point is the average daily value from yesterday (May 15).

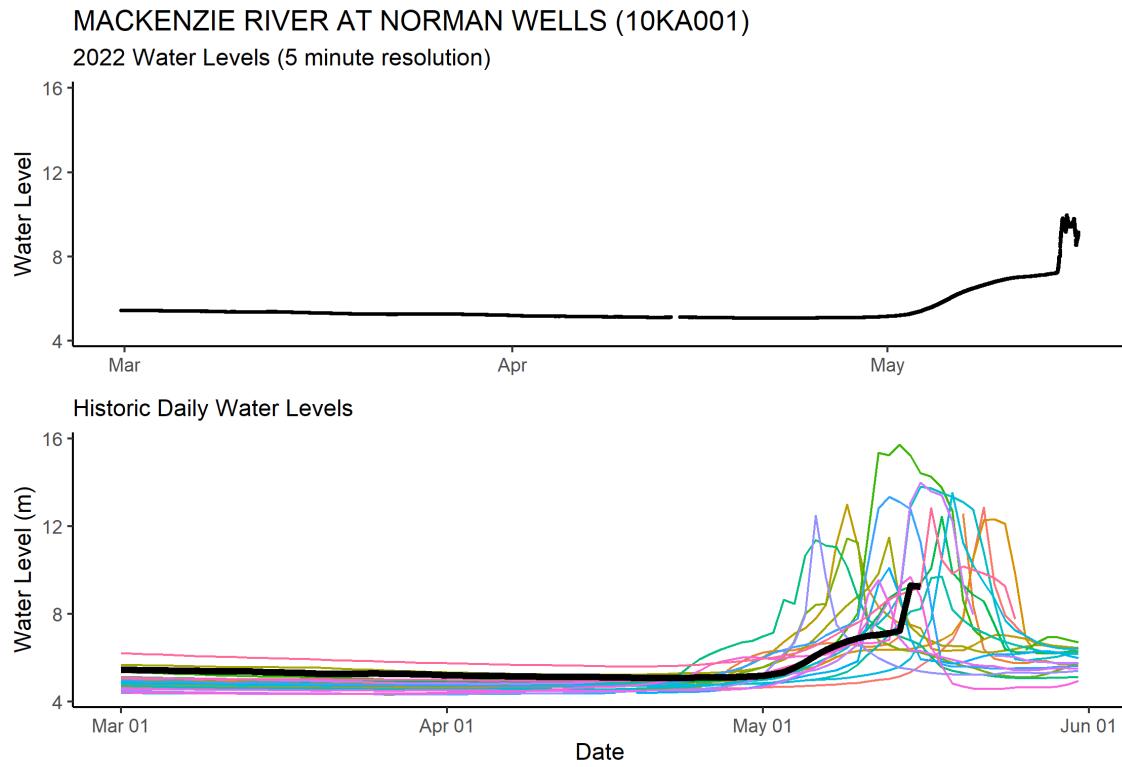
Above – The middle graph in the figure presents real time water level data at 5-minute resolution while the lower graph shows daily average levels relative to the previous 20 years. Unsteady water levels are an indication of ice movement. Water levels remain within typical levels for break up.

- Unsteady water levels on the Mackenzie River at Norman Wells are an indication of local ice movement on the river;
 - Currently water levels (12:00) are rising slowly, but remain near average;

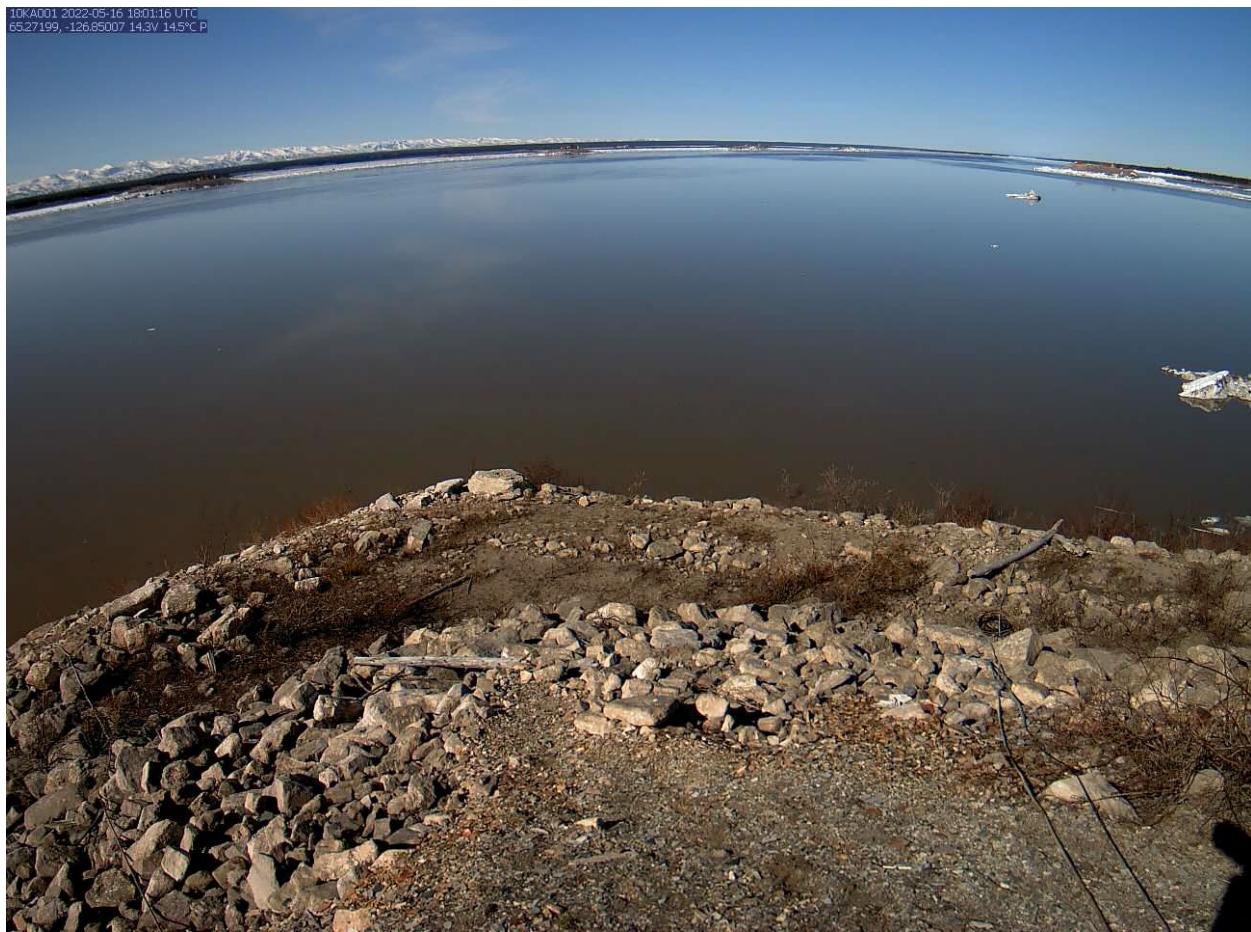
Above – Mackenzie River at Norman Wells hydrometric gauge photo from May 16 at 12:00. Photo courtesy of Water Survey of Canada and GNWT.

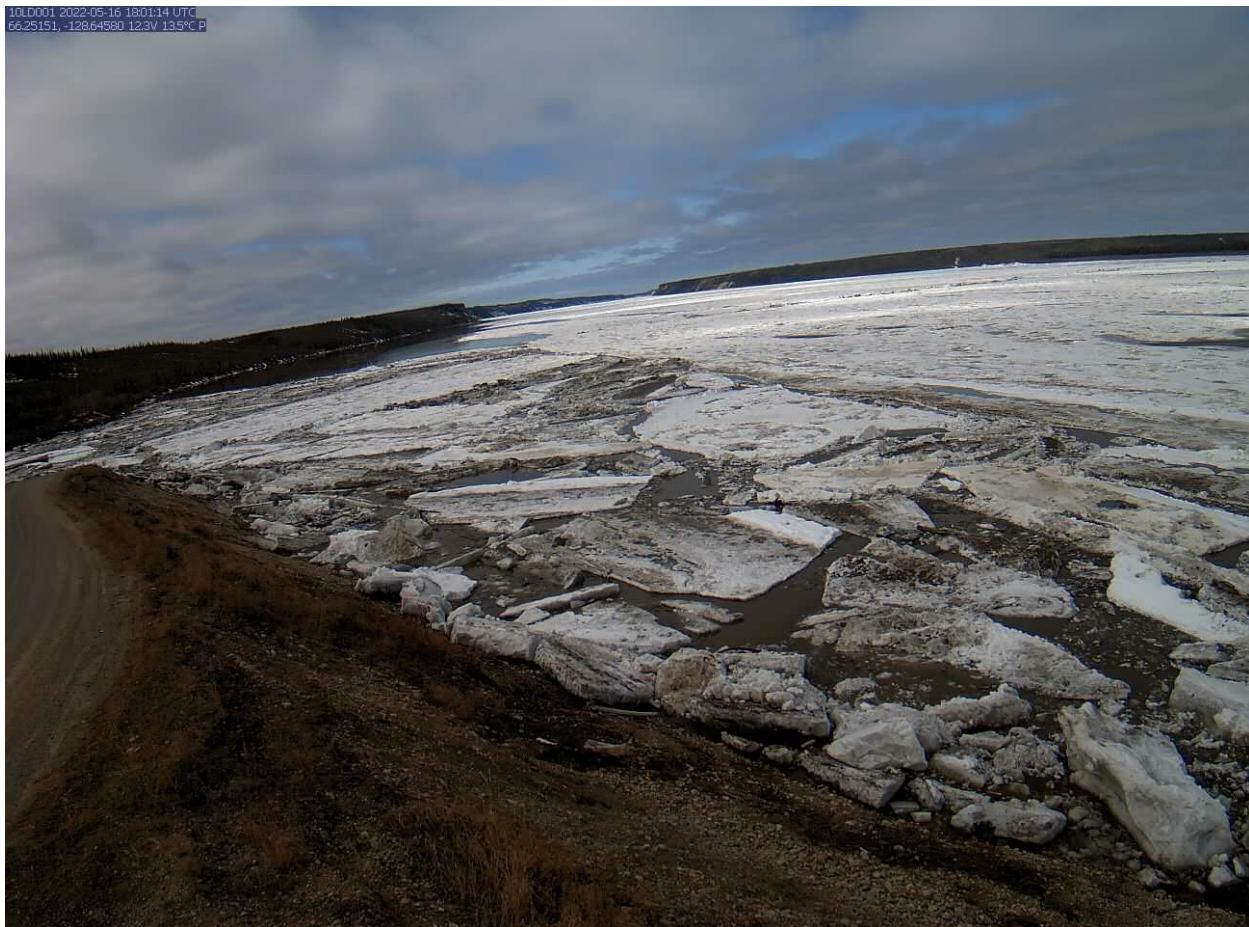
Mackenzie River at Fort Good Hope [10LD001]:

Above – Mackenzie River at Fort Good Hope hydrometric gauge photo from May 16 at 12:00. Photo courtesy of Water Survey of Canada and GNWT.

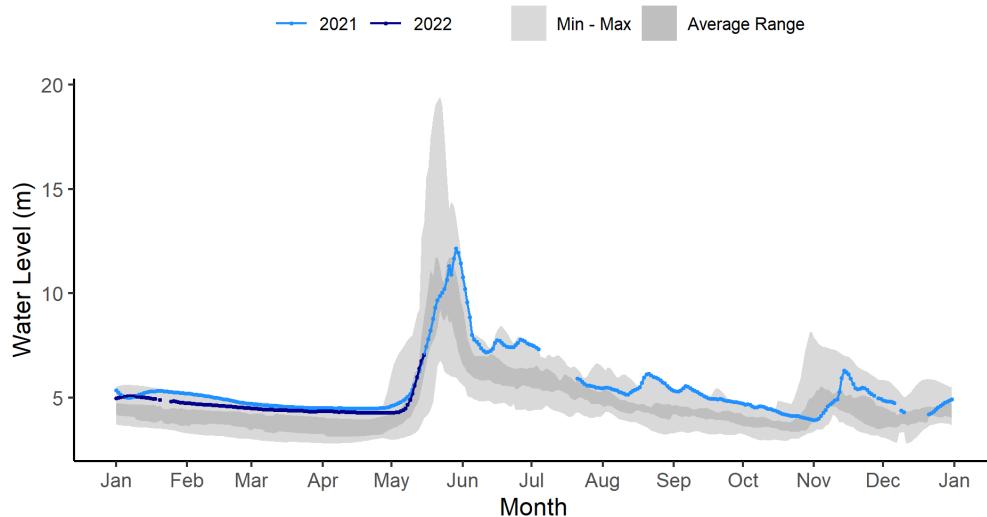
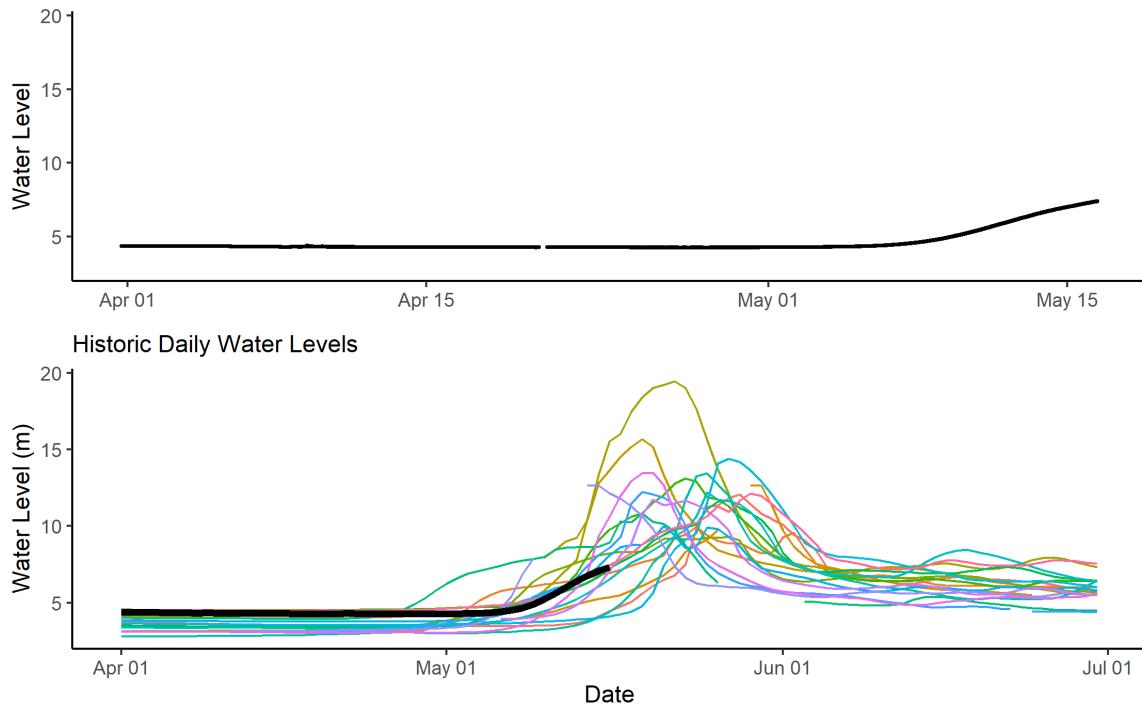
MACKENZIE RIVER AT ARCTIC RED RIVER (10LC014)
2022 Water Levels (5 minute resolution)

Above – The middle graph in the figure presents real time water level data at 5-minute resolution while the lower graph shows daily average levels relative to the previous 20 years. Water levels on the Mackenzie River at Arctic Red River have slowly begun to rise, with the timing being approximately average to previous years.

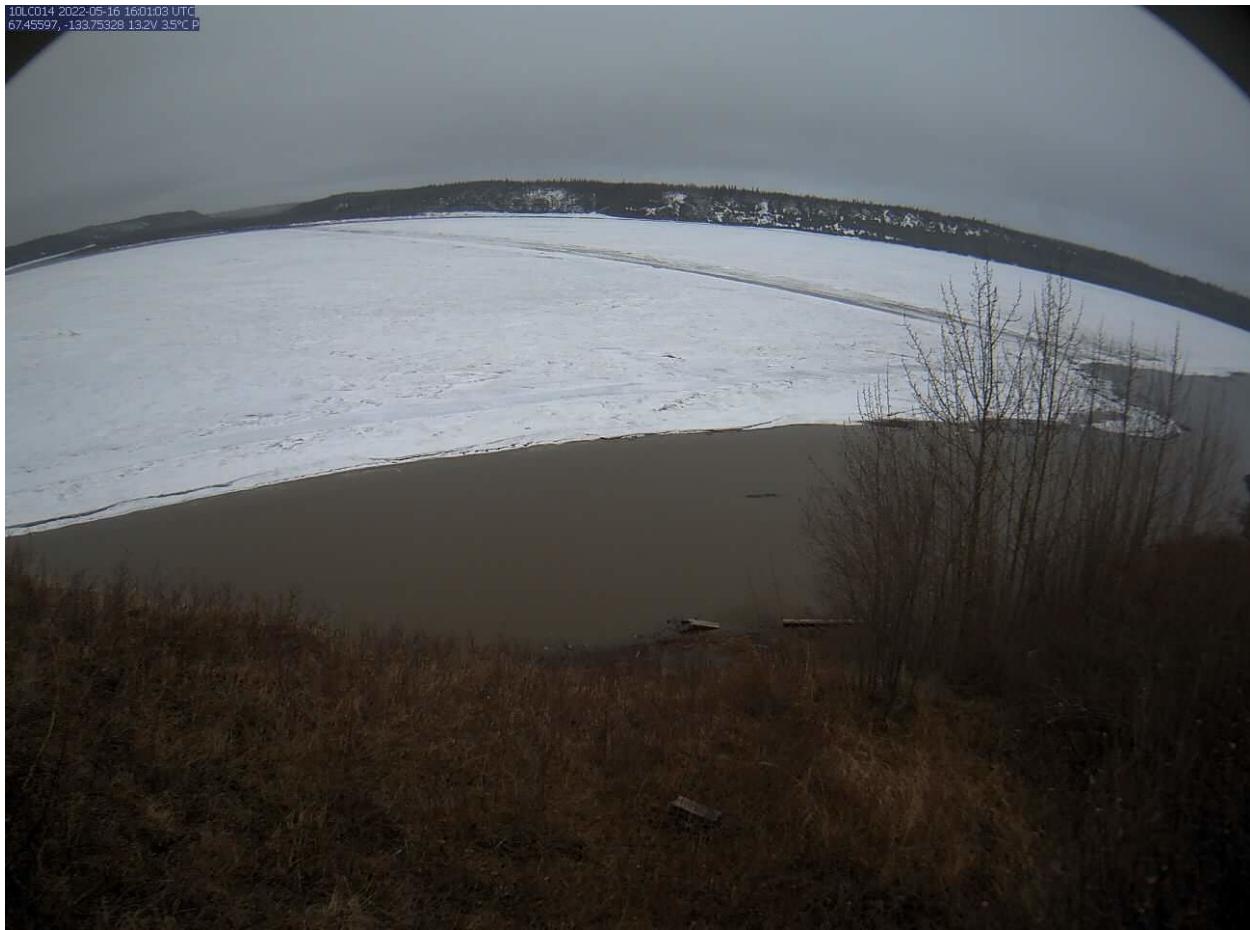
Above – Mackenzie River at Arctic Red River hydrometric gauge photo from May 16 at 10:00. Photo courtesy of Water Survey of Canada and GNWT.

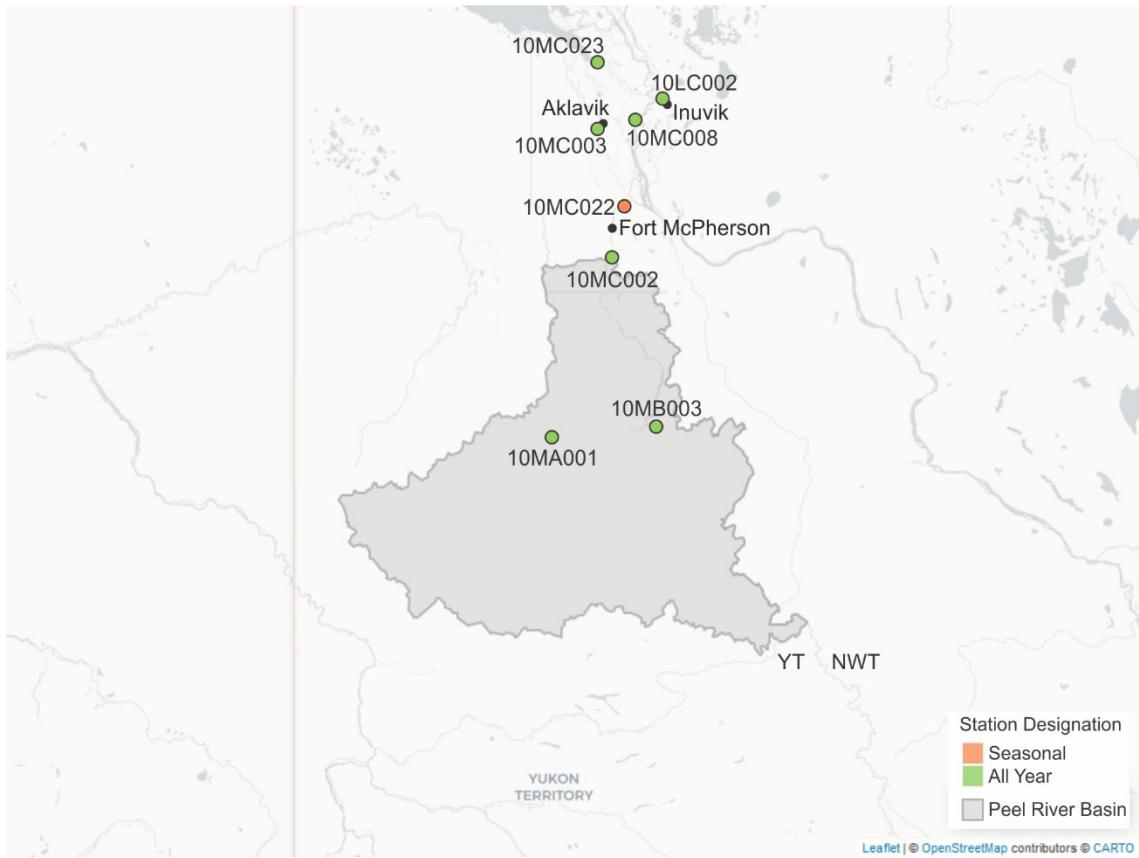
Above – Map of select hydrometric stations in the Peel River basin and the Beaufort Delta. The station numbers are referenced in the water level plots below.

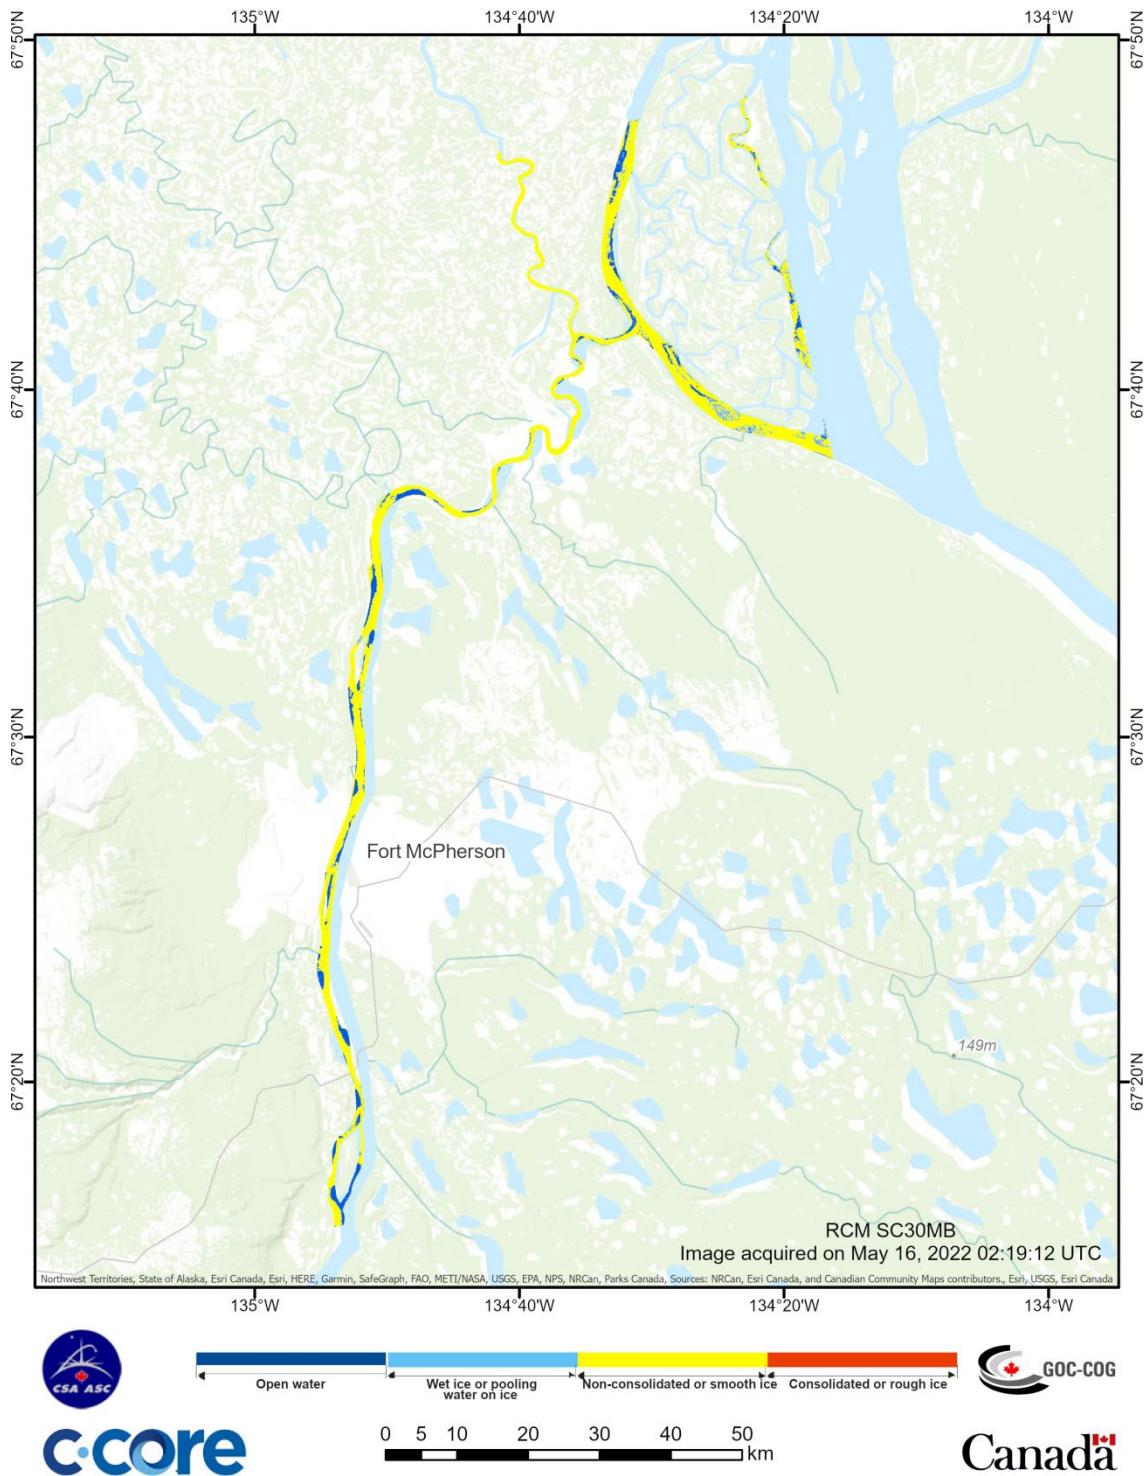
Peel River Ice Classification

Above – Ice classification map based on radar imagery of a stretch of the Peel River, around Fort McPherson and downstream to the Peel Channel and Mackenzie River. Taken on 15th May at 20:19 MDT.

- Water levels are beginning to increase on the Peel River, as is usual for this time of year;
- Water levels in the Mackenzie Delta continue to rise;
 - Water levels were much higher than average over winter, but lower than last year.
- Radar imagery of the Peel River indicates predominantly intact ice with some areas of open water forming.

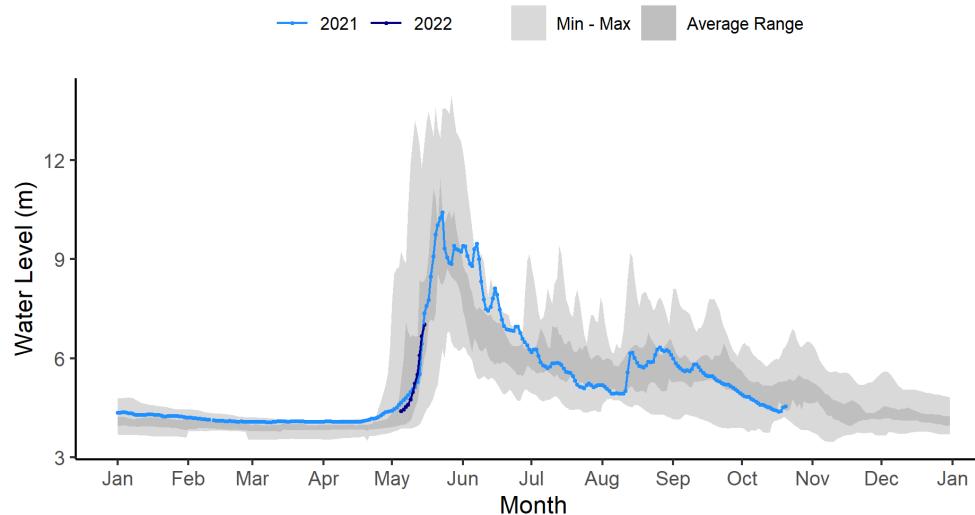
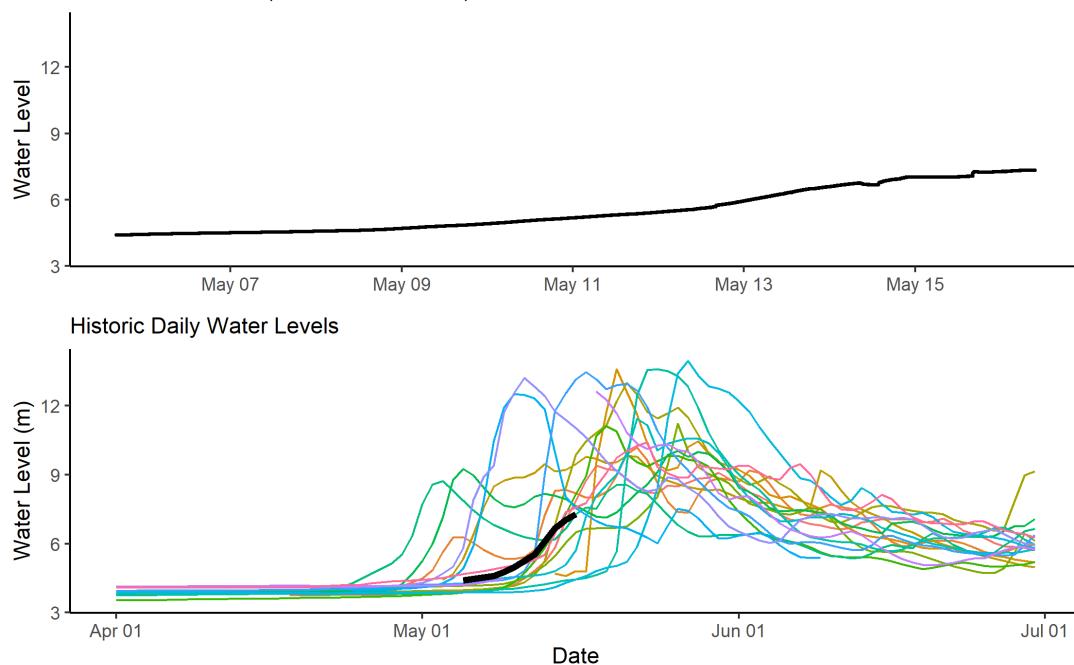
PEEL RIVER ABOVE FORT MCPHERSON (10MC002)
2022 Water Levels (5 minute resolution)

Above – The middle graph in the figure presents real time water level data at 5-minute resolution while the lower graph shows daily average levels relative to the previous 20 years. Water levels on the Peel River at Fort McPherson have slowly begun to rise, with the timing being approximately average to previous years. There were reports of ice movement on the Peel River near Fort McPherson as of this morning.

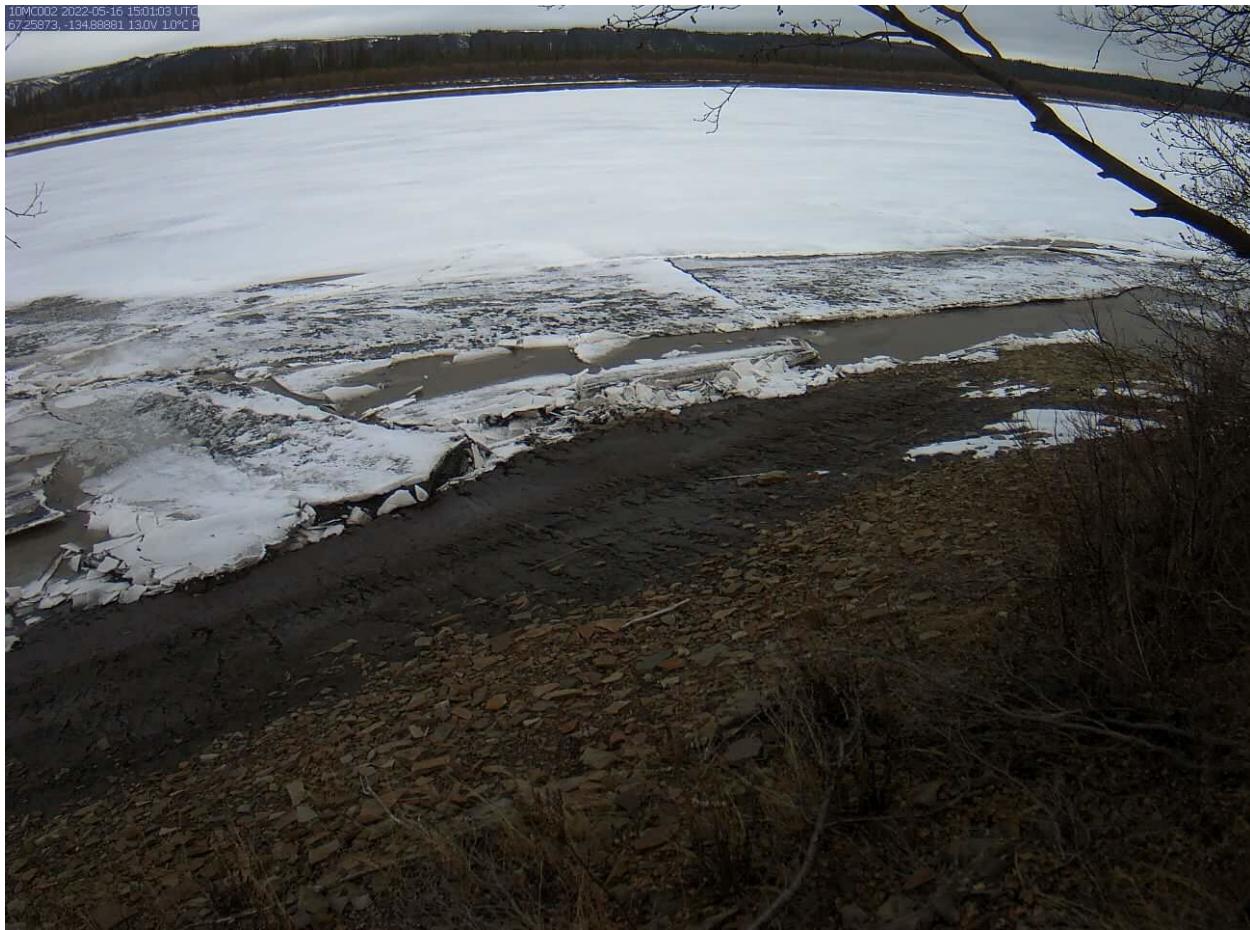
Above – Peel River at Fort McPherson hydrometric gauge photo from May 16 at 09:00. Photo courtesy of Water Survey of Canada and GNWT.
