NWT Water Monitoring Bulletin

– May 16, 2022: 13:00

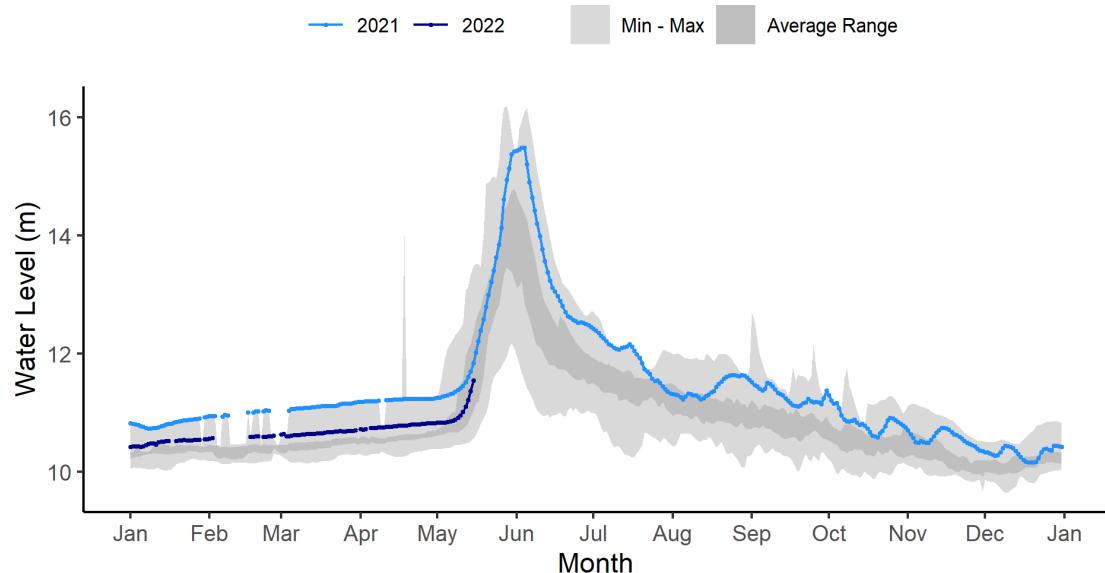
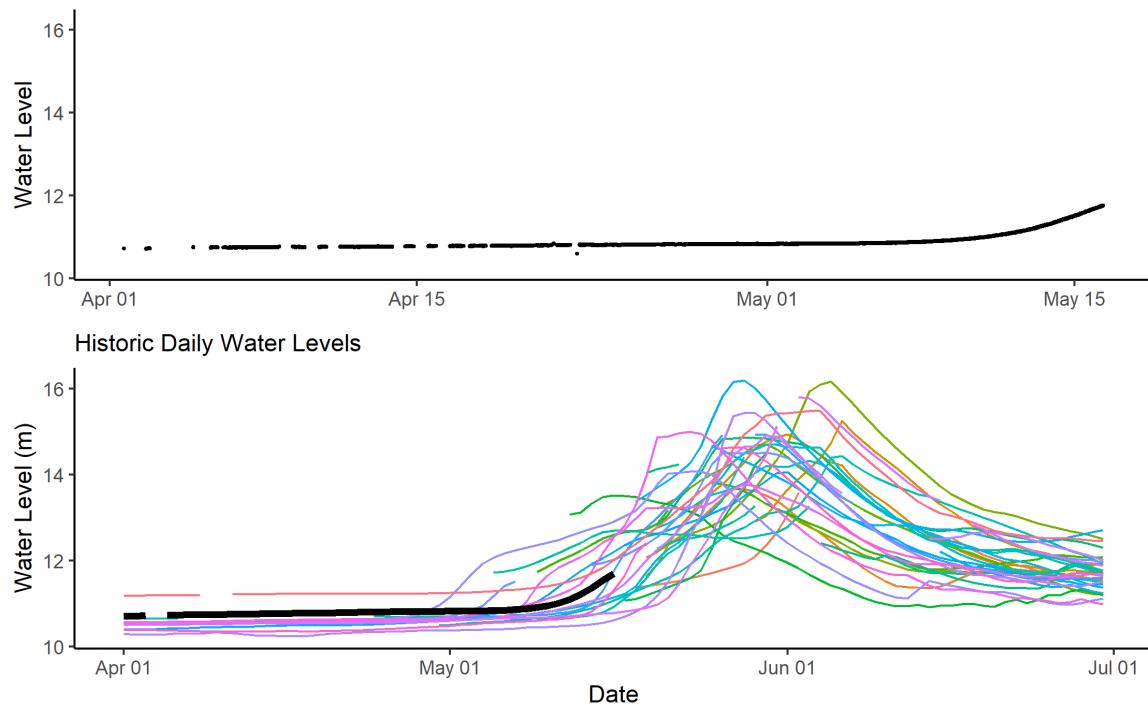
MACKENZIE RIVER (PEEL CHANNEL) ABOVE AKLAVIK (10MC003)
2022 Water Levels (5 minute resolution)

Above – The middle graph in the figure presents real time water level data at 5-minute resolution while the lower graph shows daily average levels relative to the previous 20 years. Water levels in the Mackenzie Delta are slowly beginning to rise. Water levels are lower than last year but have been higher than average throughout the winter.

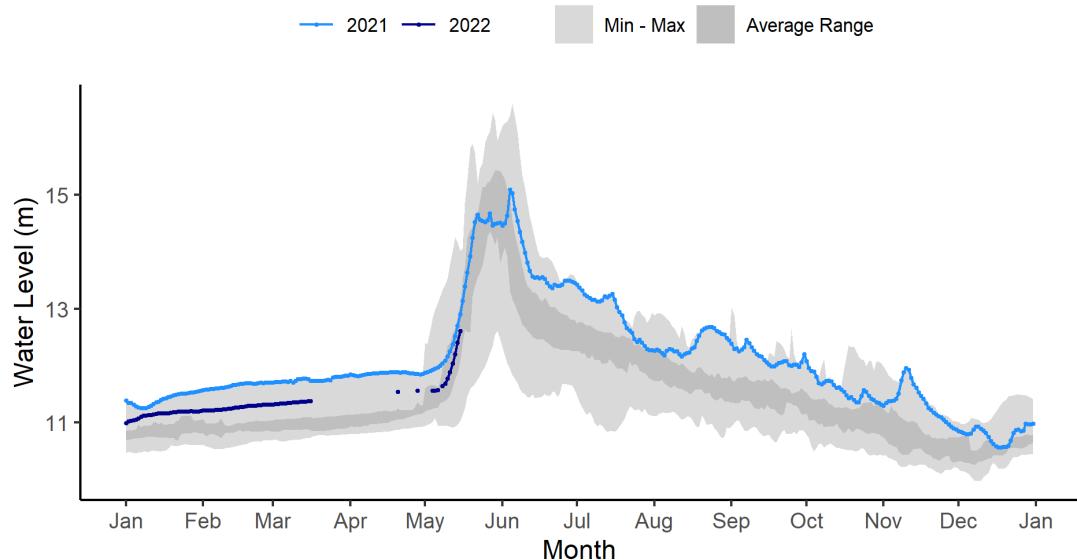
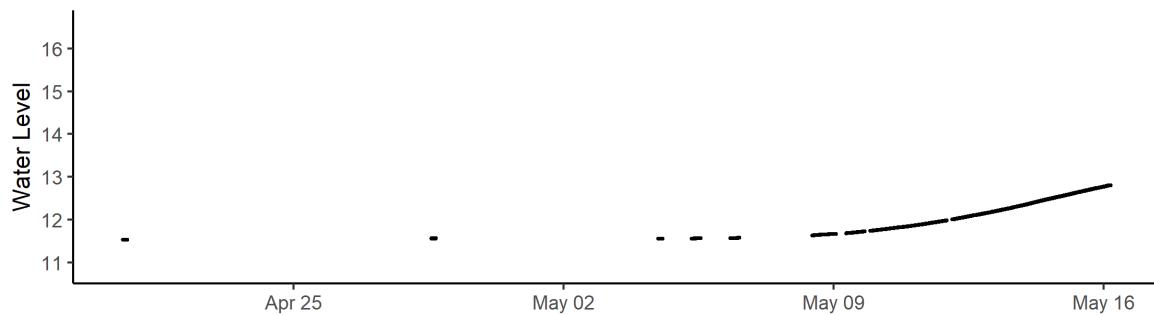
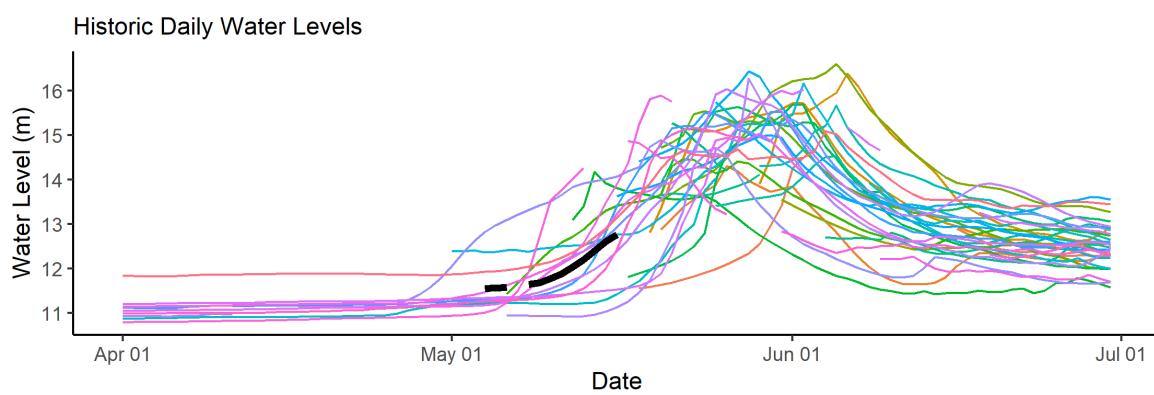
MACKENZIE RIVER (MIDDLE CHANNEL) BELOW RAYMOND CHANNEL (10MC008)
2022 Water Levels (5 minute resolution)

Above – The middle graph in the figure presents real time water level data at 5-minute resolution while the lower graph shows daily average levels relative to the previous 20 years. Water levels in the Mackenzie Delta are continuing to rise. Water levels are lower than last year but have been higher than average throughout the winter.

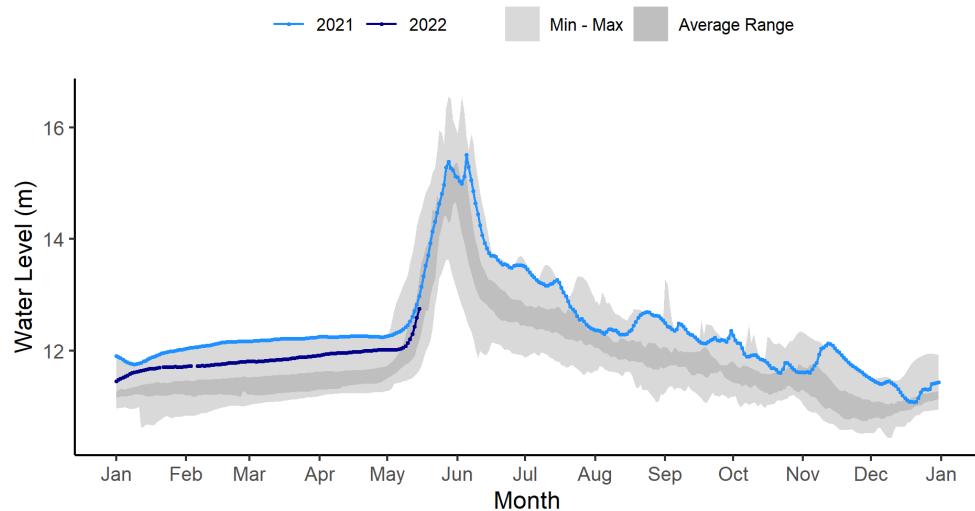
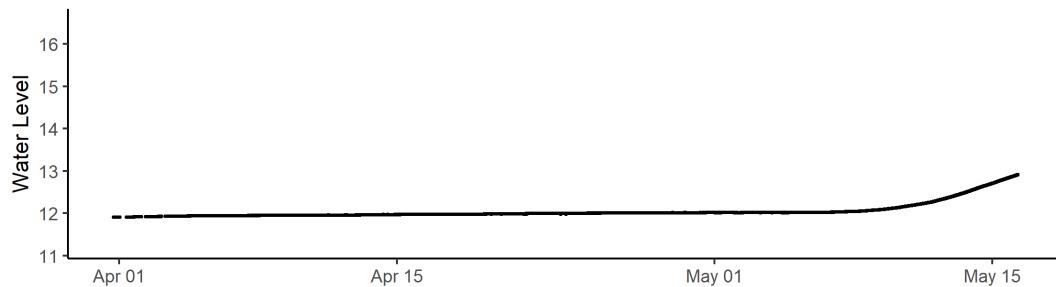
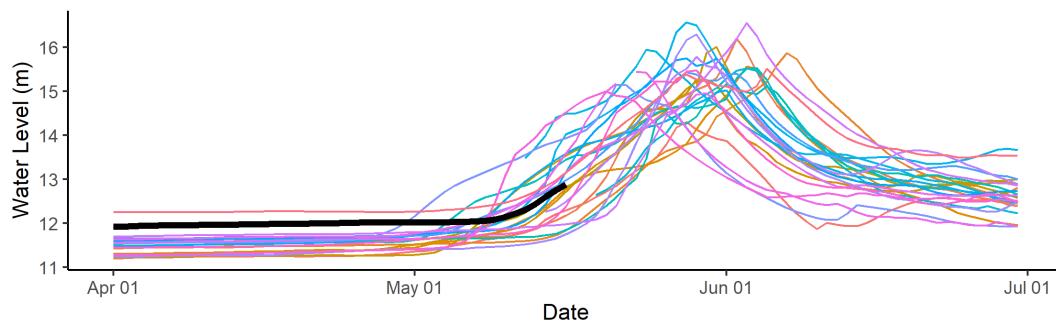
MACKENZIE RIVER (EAST CHANNEL) AT INUVIK (10LC002)
2022 Water Levels (5 minute resolution)

Above – The middle graph in the figure presents real time water level data at 5-minute resolution while the lower graph shows daily average levels relative to the previous 20 years. Water levels in the Mackenzie Delta are continuing to rise. Water levels are lower than last year but have been higher than average throughout the winter.

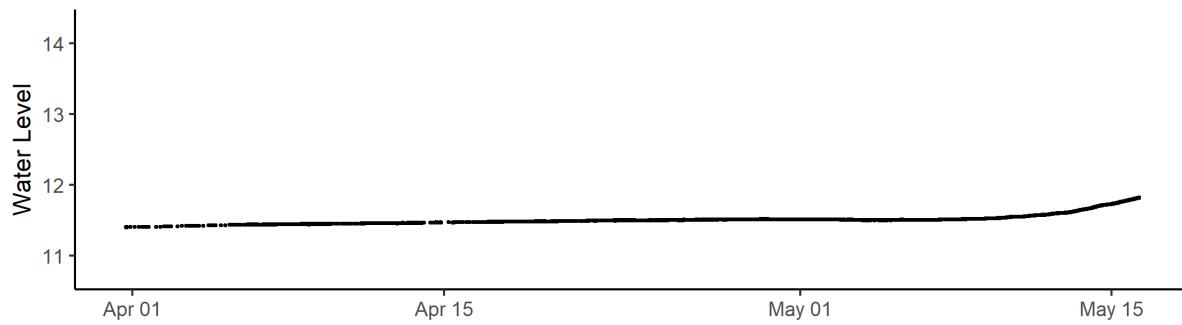
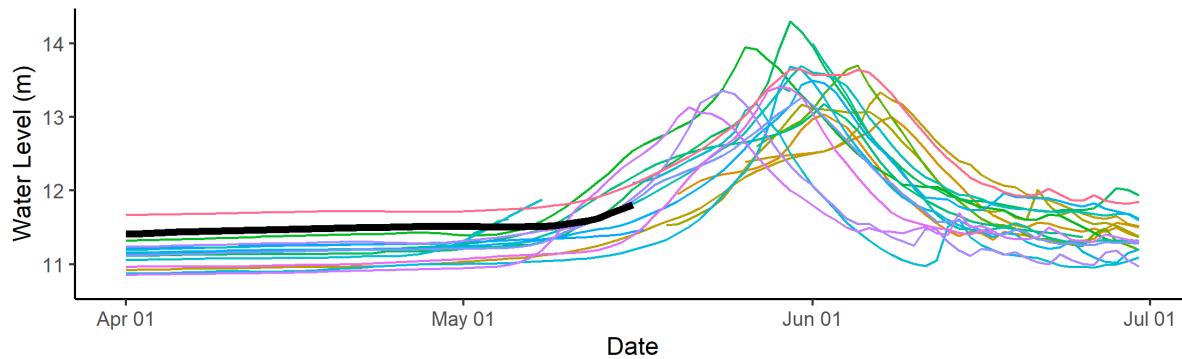
MACKENZIE RIVER (NAPOIAK CHANNEL) ABOVE SHALLOW BAY (10MC023)

Above – The top graph in the figure presents real time water level data at 5-minute resolution while the lower graph shows daily average levels relative to the previous 20 years. Water levels in the Mackenzie Delta are continuing to rise. Water levels are lower than last year but have been higher than average throughout the winter.
