# Canol Trail Miles 0-8 Project

Norman Wells and Tulita  
2025

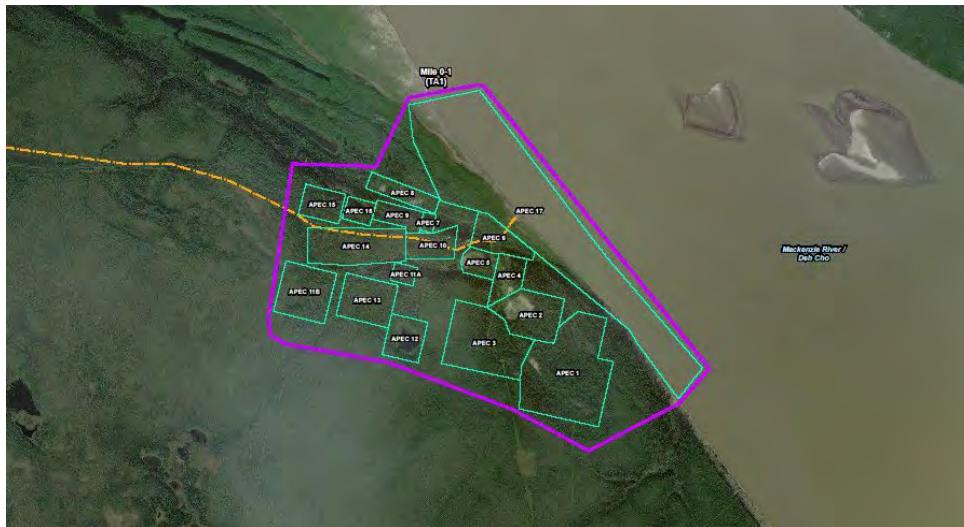
Location of APECs at Mile 0-1

- The Phase I ESA identified 17 APECs at Mile 0-1 and 6 APECs at Mile 8.

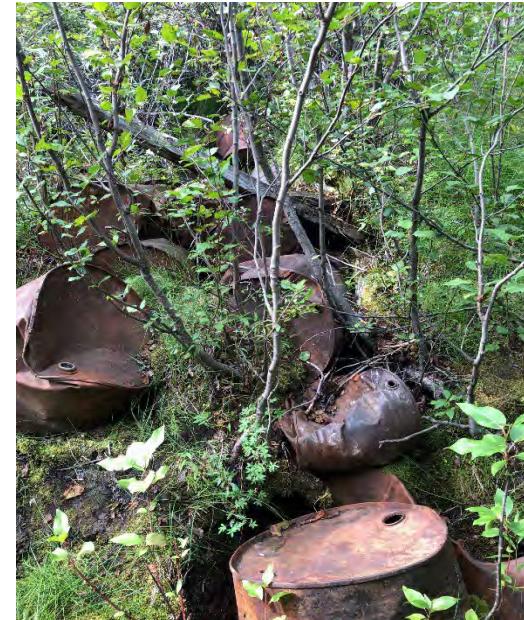
Barrels

- The following contaminants were confirmed at several locations:
  - Fuel/oil;
  - Metals;
  - Asbestos and lead paint found in some building materials; and
  - Surface debris including drums, abandoned vehicles, scrap metal, and abandoned buildings.

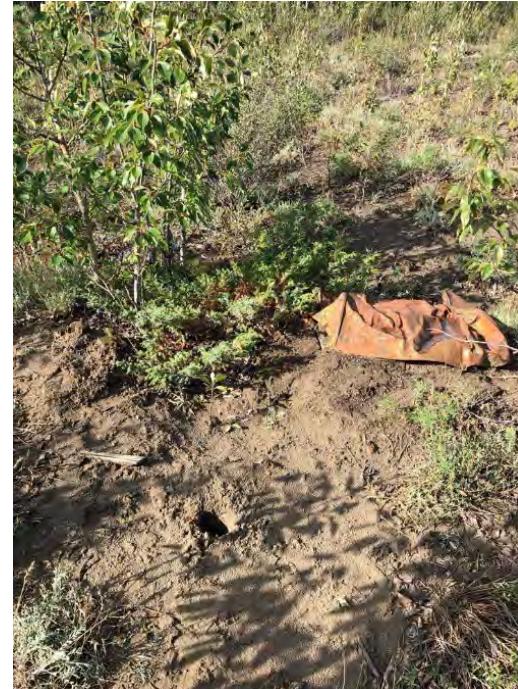
Soil sampling near barrel

- Most areas of concern have not been delineated, but data gathered from the ESAs is sufficient to determine the risk to people and the environment.
- There is good plant health at most Areas of (Potential) Environmental Concern (AECs).
- Site waterbodies do not naturally support aquatic life, therefore there are no aquatic life-related risks.
- A drone program identified:
  - Magnetic areas that match locations of where buildings and surficial debris were observed;
  - Three areas at Mile 0-1 and two areas at Mile 8 showed magnetic responses but could not be attributed to existing buildings or surface debris; and
  - No areas of buried debris were noted at Canol Lake.

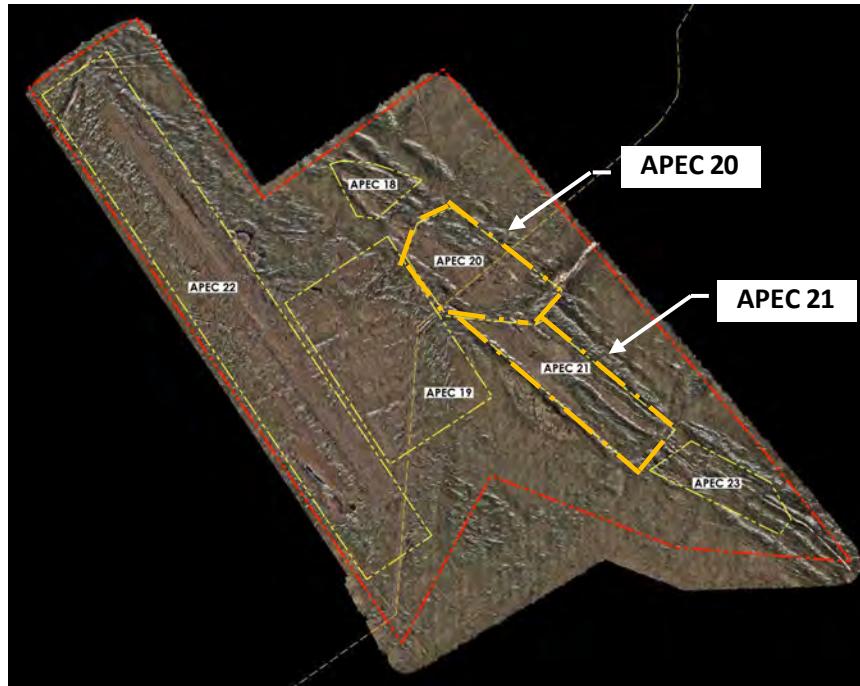
Areas of lead contaminated soil in at Mile 8 in APEC 20 (camp area 1) and APEC 21 (camp area 2)

- Human health risks from contaminants were low, with the exception of four areas of lead contaminated soil at Mile 8.
- Areas of lead contaminated soil pose a risk to the health of trail users that come in contact with the soil. These areas should be remediated or managed.

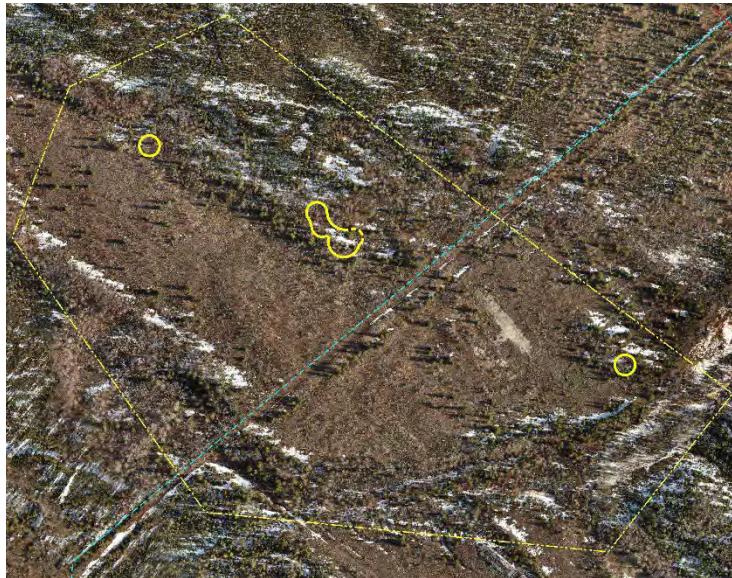
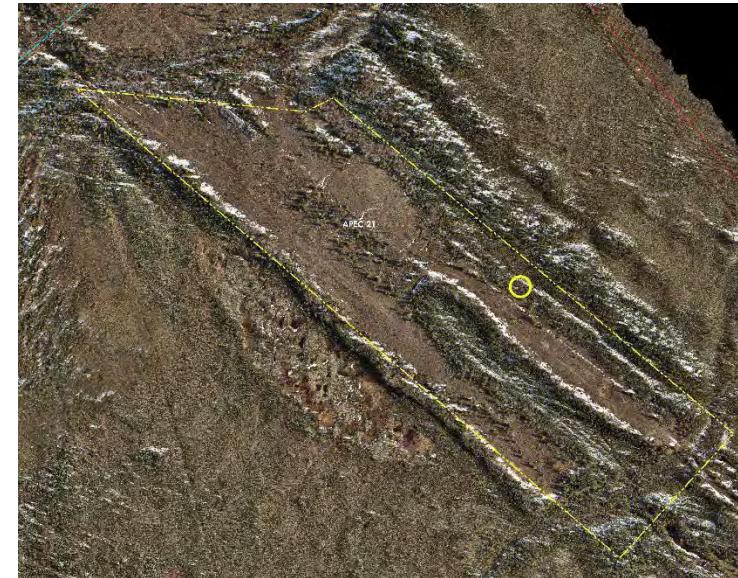
Areas of lead contaminated soil in APEC 20 (camp area 1) and APEC 21 (camp area 2)
