APPENDIX A

Community Engagement Summary

APPENDIX B

Selected Photos from the River Bathymetry Survey

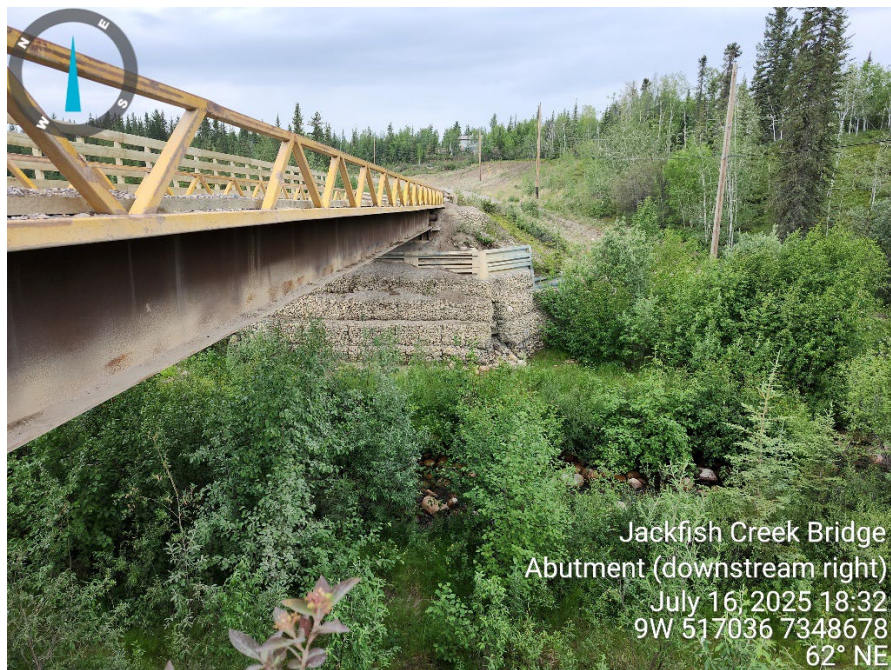
Figure 1: Jackfish Creek Bridge Opening Facing Northeast

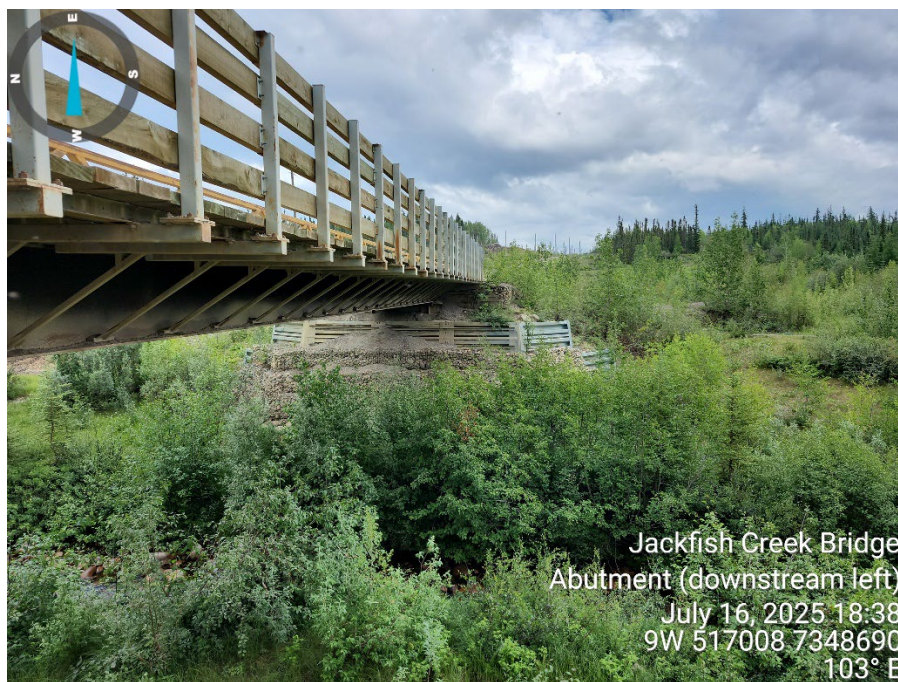
Figure 2: Jackfish Creek Bridge Facing East

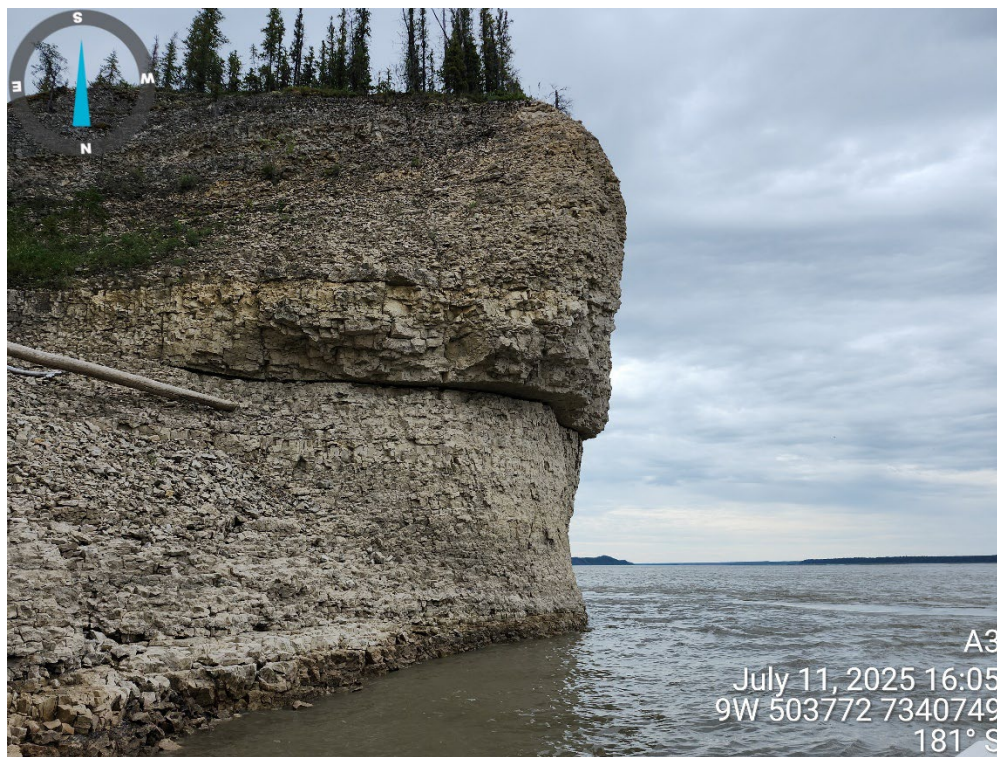
Figure 3: Mackenzie River at the Ramparts Right Downstream Bank at A3 Facing Upstream (South)

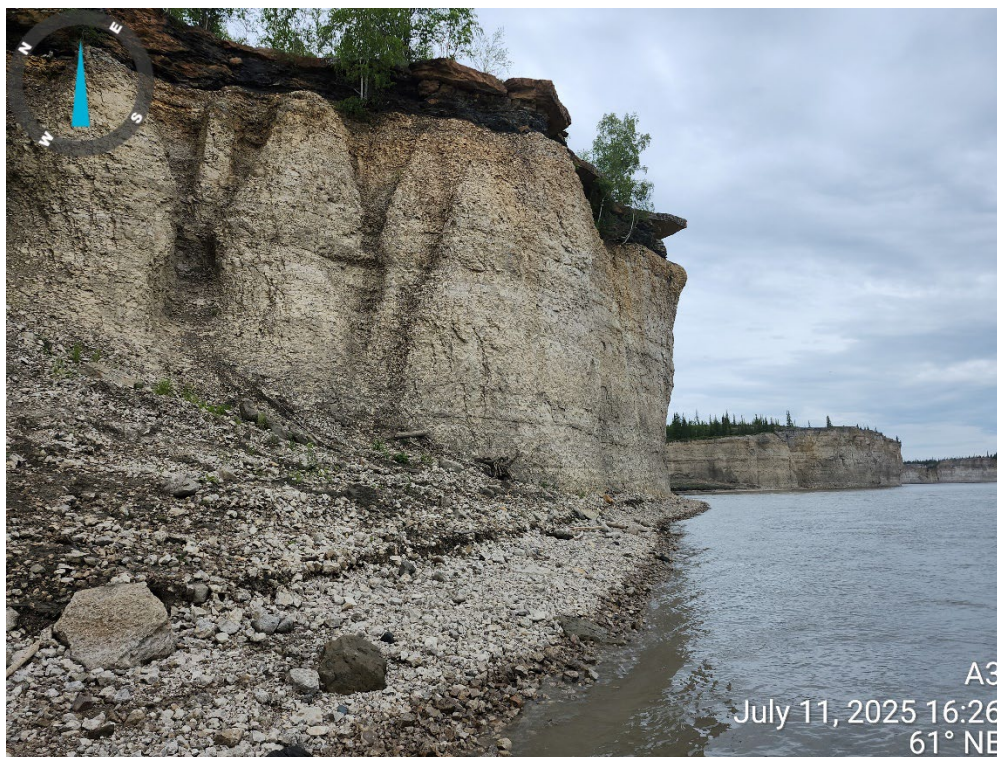
Figure 4: Mackenzie River at the Ramparts Left Downstream Bank at A3 Facing Downstream (Northeast)

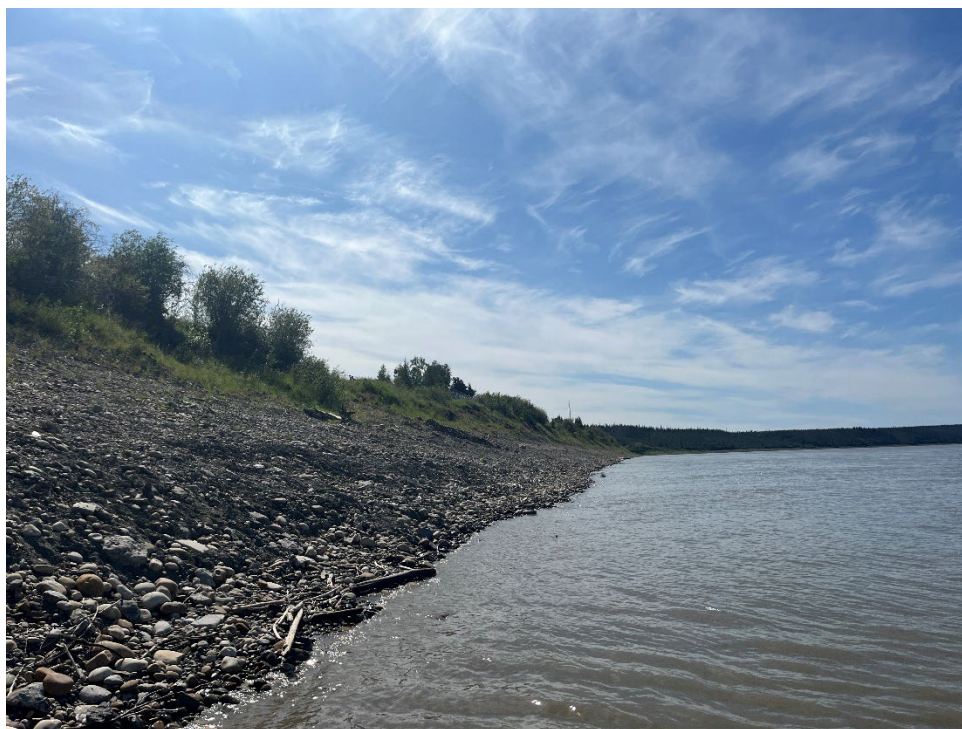
**Figure 5: Mackenzie River at Fort Good Hope Right Downstream Bank at B4 Facing Upstream (South)
July 5, 2025**

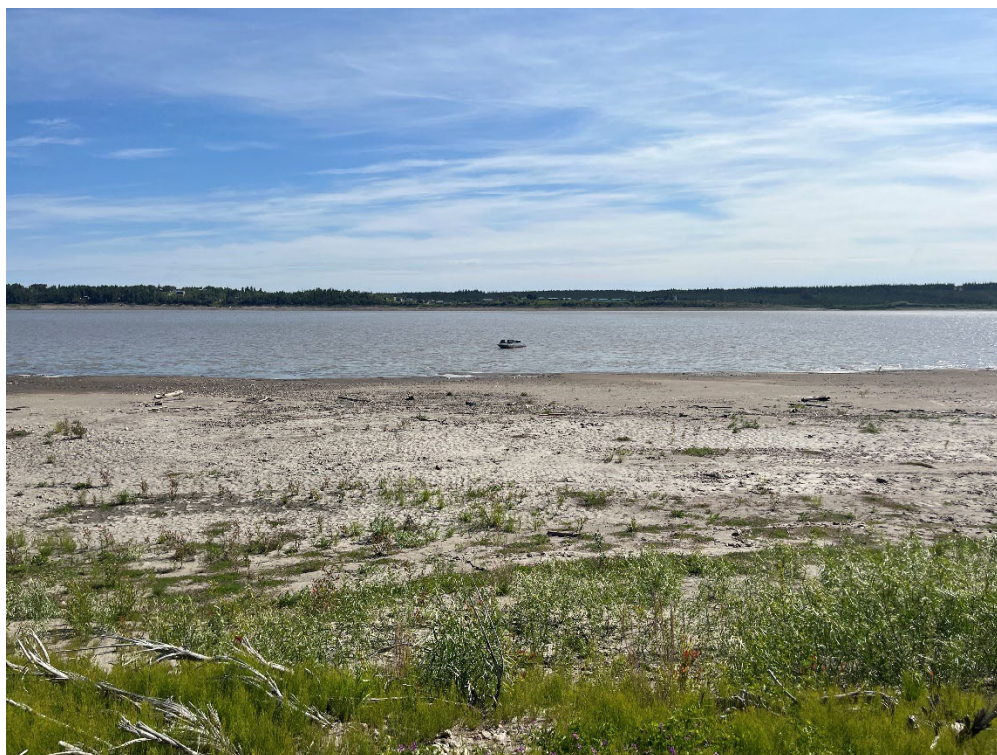
**Figure 6: Mackenzie River at Fort Good Hope Left Downstream Bank on Manitou Island at B4 Facing East
July 5, 2025**

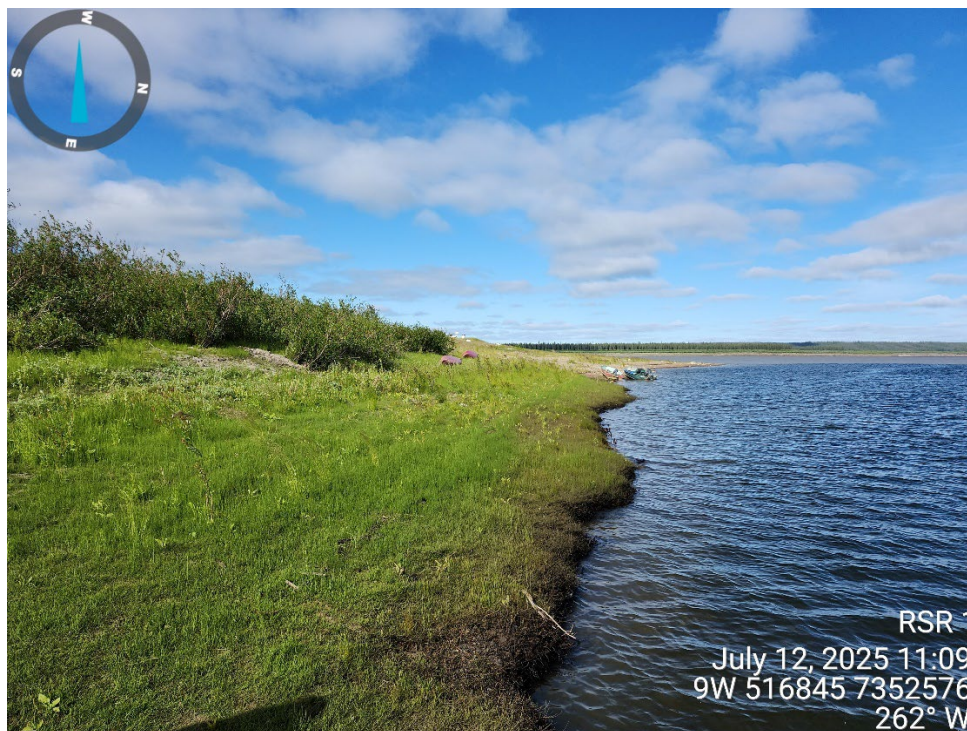
Figure 7: Mouth of Rabbit Skin River facing West

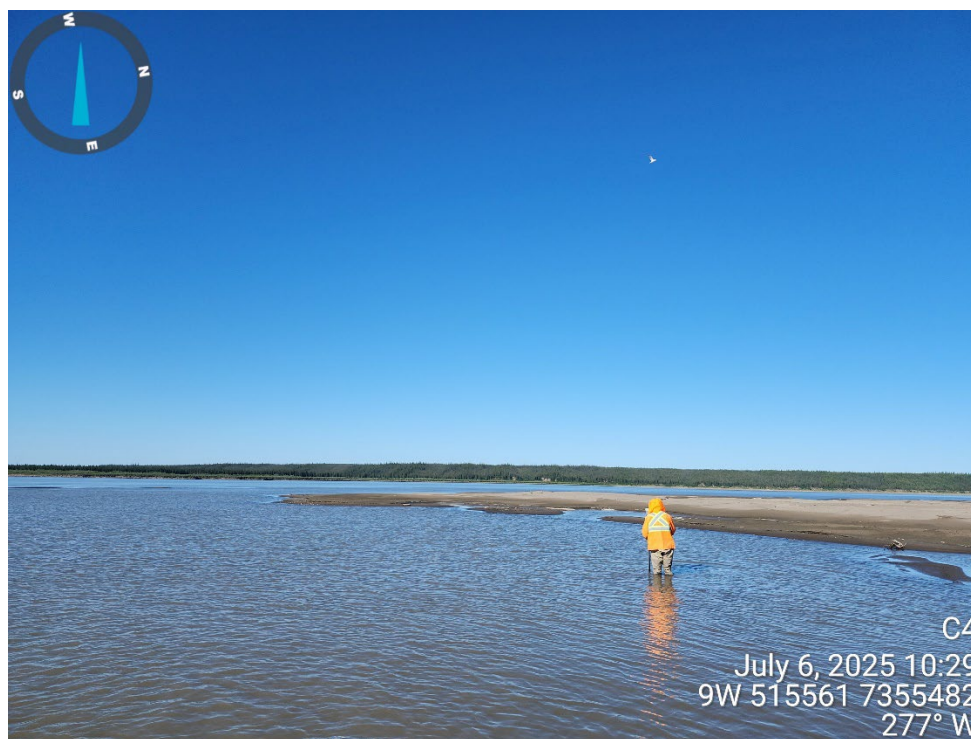
Figure 8: Mackenzie River downstream of Rabbit Skin River at Mid-channel Island at C4 (An Ice-Jam Head Location)

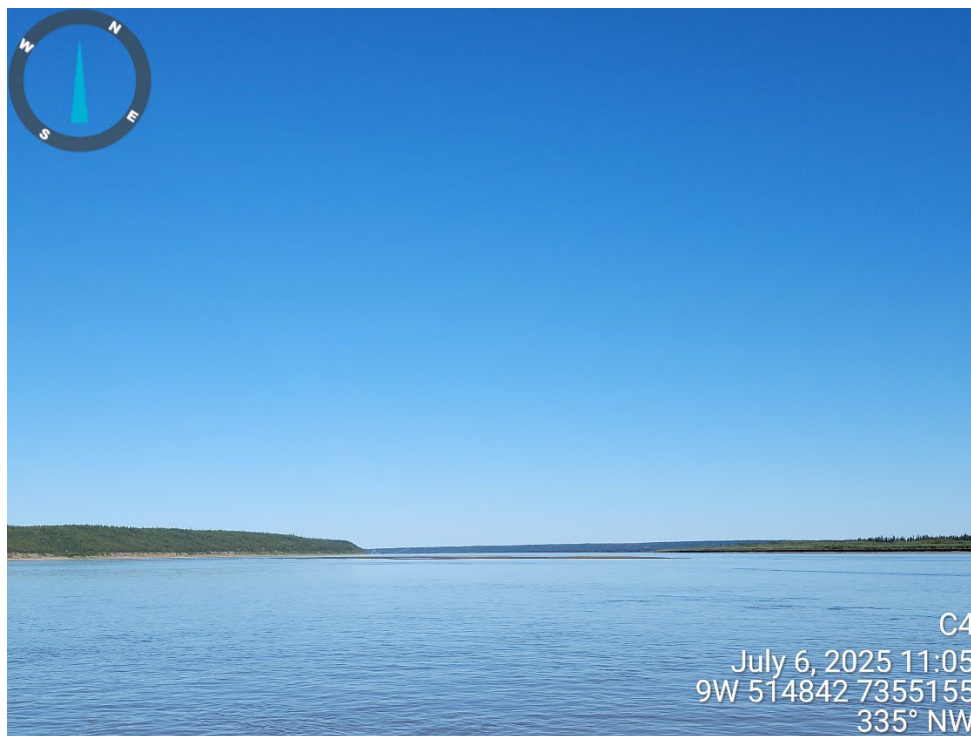
Figure 9: Mackenzie River downstream of Rabbit Skin River facing downstream at C4 – Shallow Bar

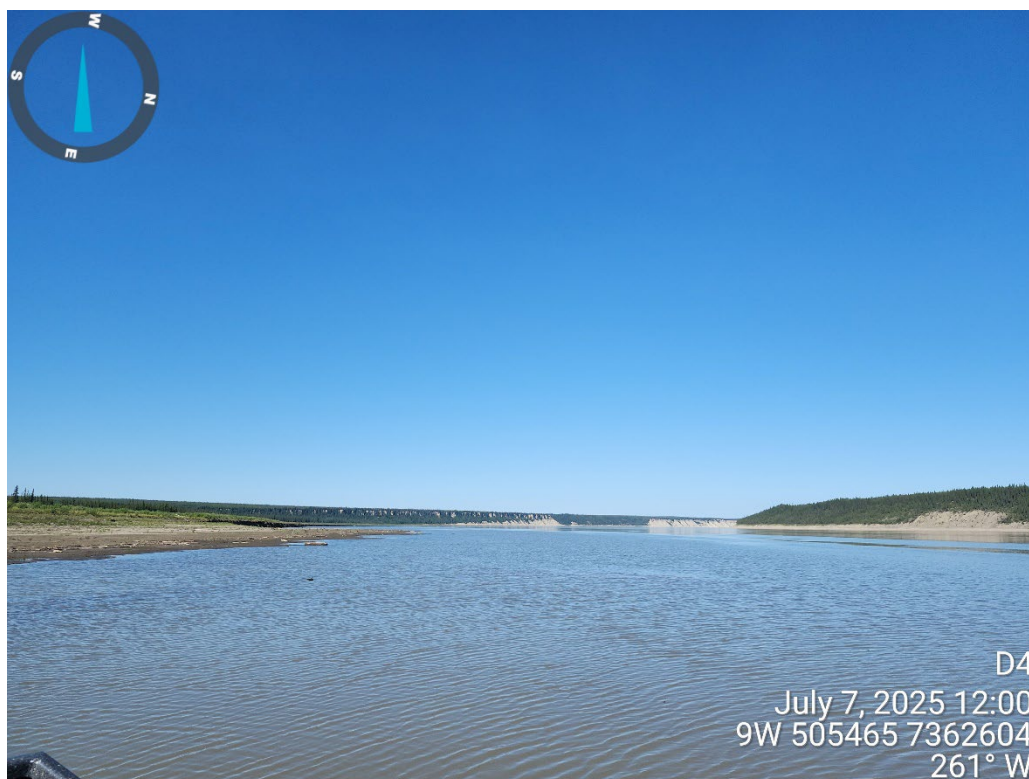
Figure 10: Mackenzie River facing downstream at D4 (An Ice-Jam Toe Location)

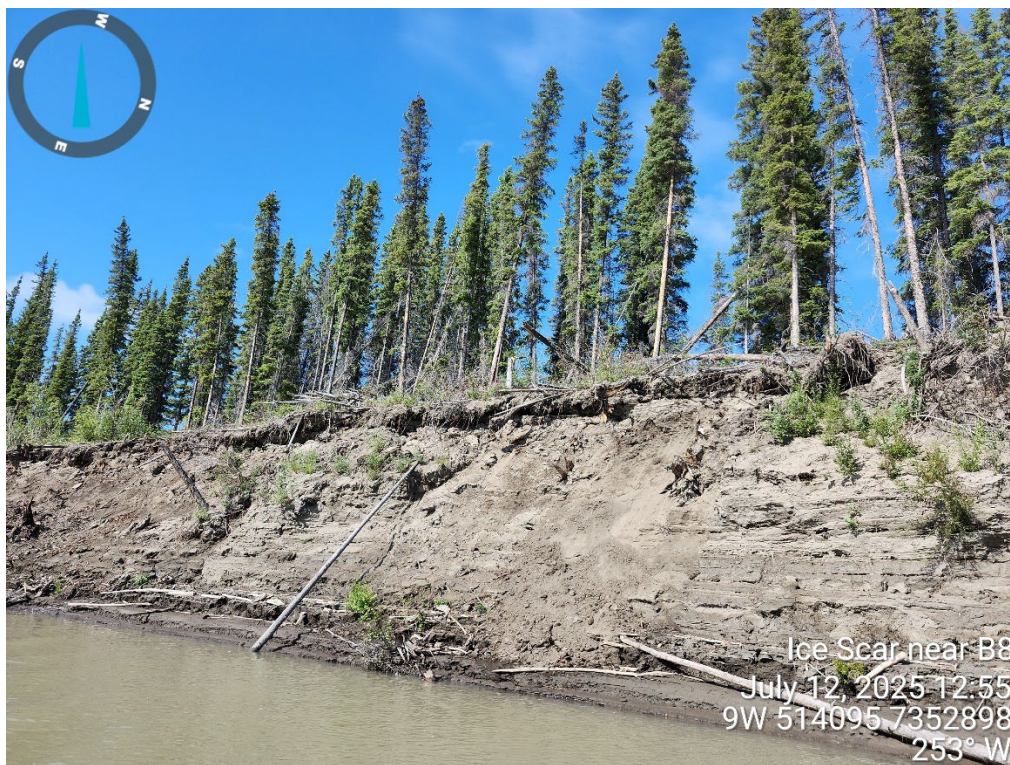
Figure 11: Mackenzie River Ice Scars on Trees near B8

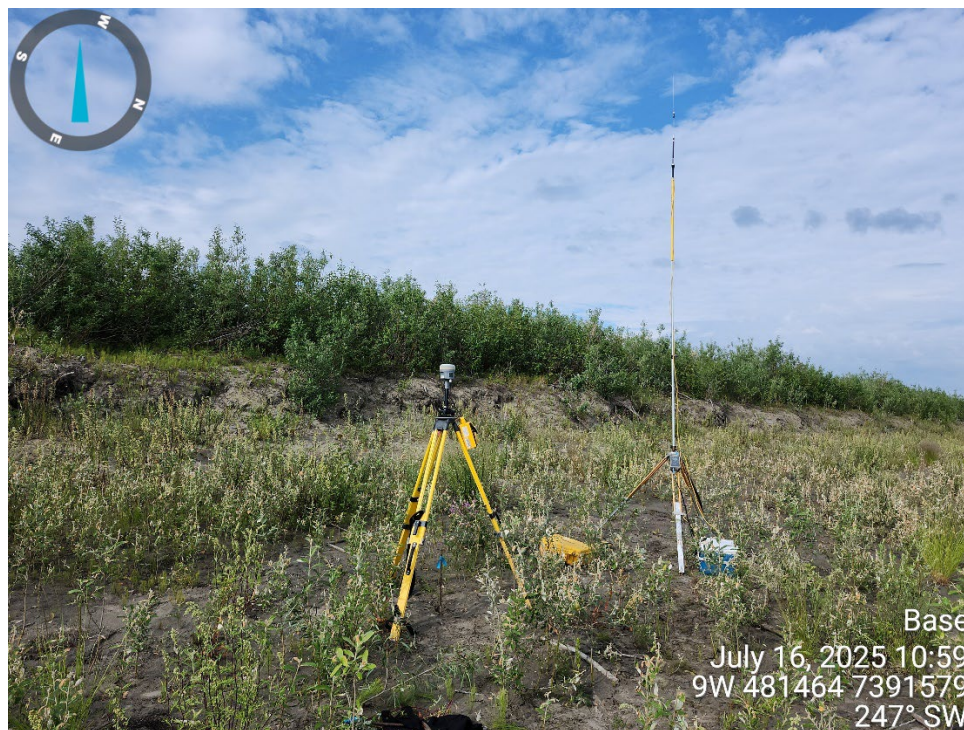
Figure 12: Base Station and Antenna

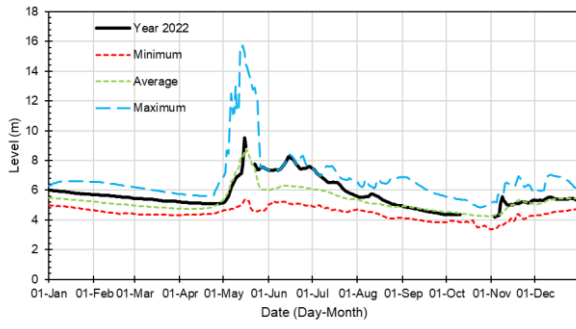
2022

Norman Wells Ice Break-up Water Level Analysis
