Re: Submission of the Point Lake Project 2023 Stage Two Dewatering Pipeline Wildlife Effects Monitoring Report

EKATI DIAMOND MINE

**Point Lake Project 2023 Stage Two Dewatering Pipeline
Wildlife Effects Monitoring**

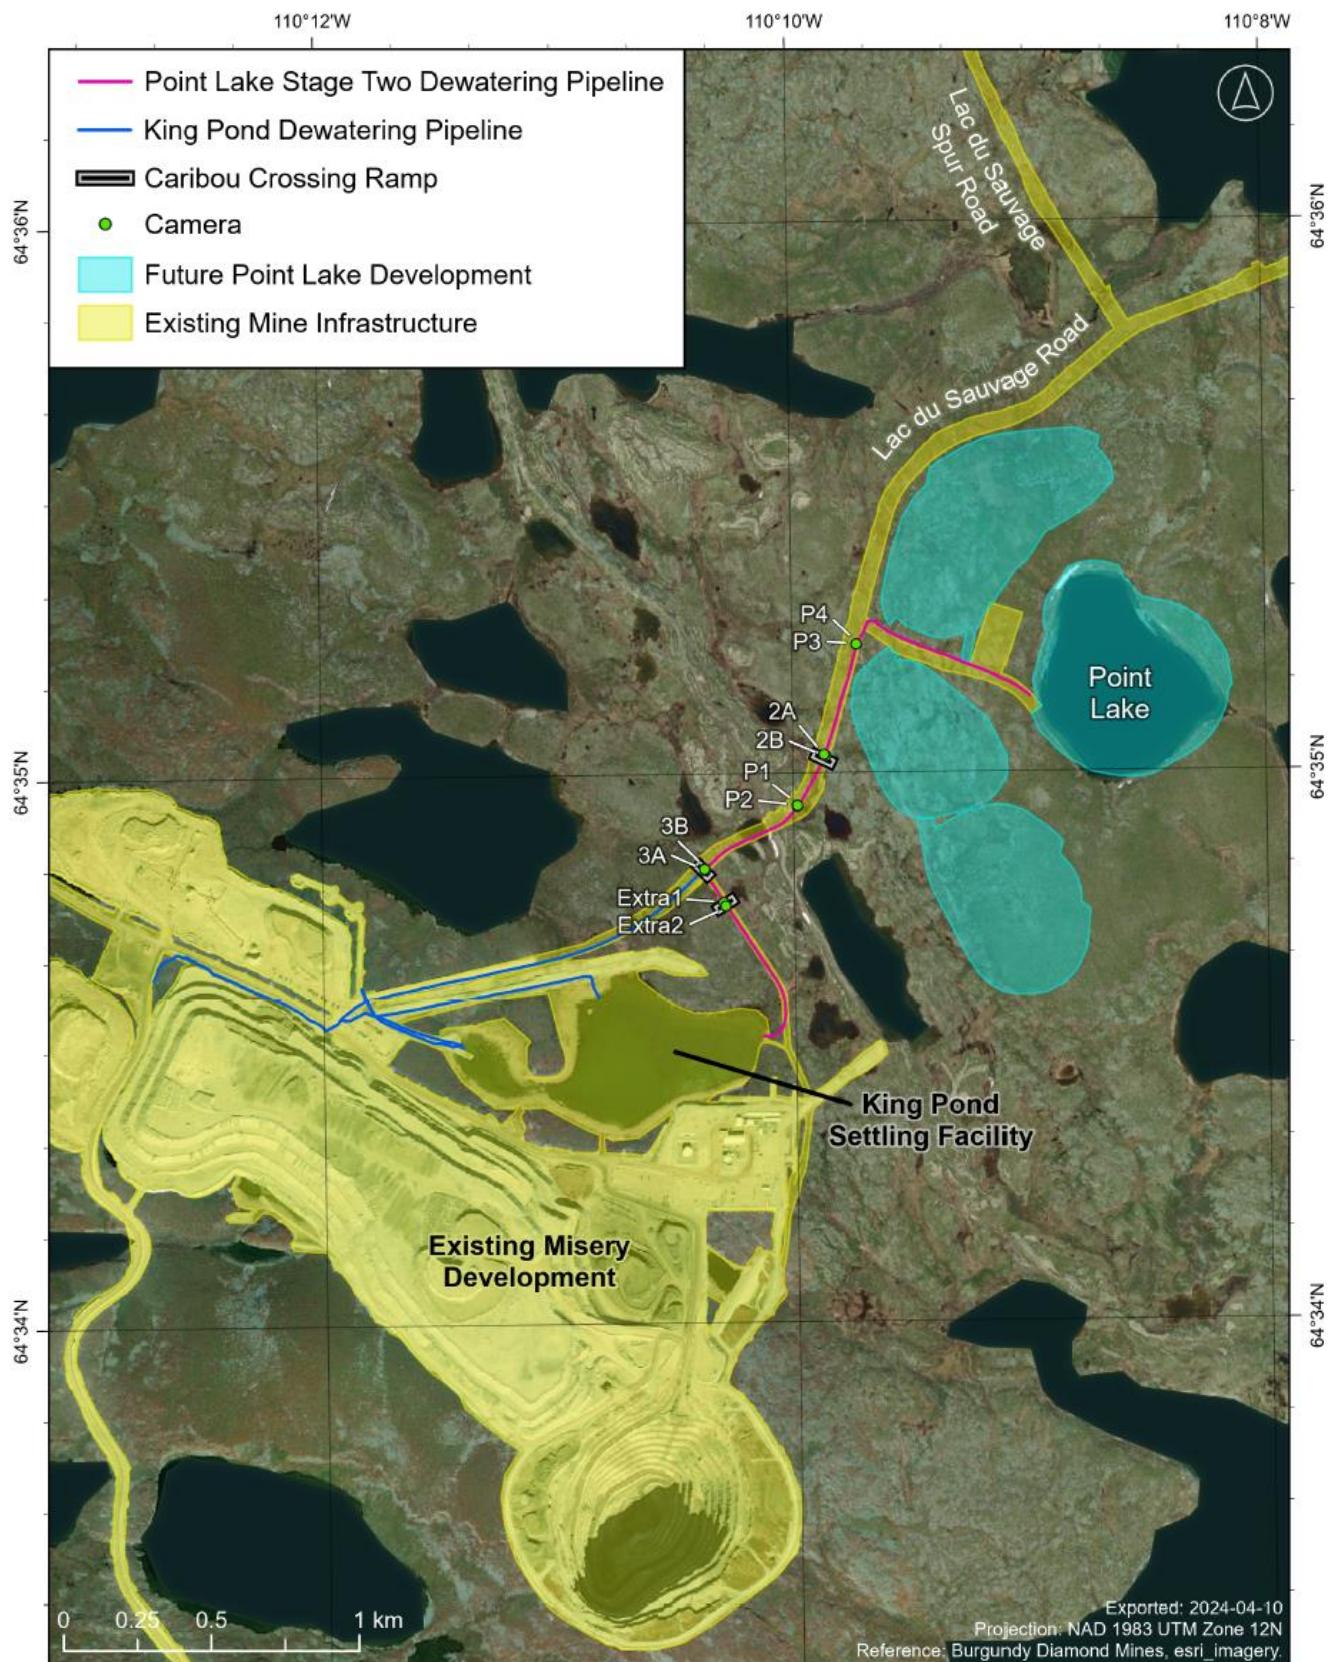
Figure 3: Locations of Point Lake Stage Two Dewatering Pipeline, Caribou Crossing Ramps, and Wildlife Cameras

The 76 cm Point Lake stage two dewatering pipeline was installed between May 26 and 28, 2023. Figure 3 shows the pipeline route: beginning at Point Lake, on top of the east edge of the Point Lake Access Road; then under the Point Lake Access Road at the junction with the Lac du Sauvage Road (Figure 3); continuing on top of the south/east side of the Lac du Sauvage Road to the Pipeline Road; there it turned south and continued on top the western side of the road before emptying into King Pond Settling Facility. Pumping occurred from July 10 to October 7, 2023 (90 days total) and the dewatering pipeline was removed between October 7 and 10, 2023.

Caribou crossing ramps (Figure 4) were constructed between May 26 and May 28, 2023 at three locations along the pipeline (Figure 3). The 10 m wide ramps were constructed from stacked pallets and 15 cm (6") minus crushed rock with a slope of 1:3. The ramps were in place until October 7 to 10, 2023 (maximum duration of 138 days) when the dewatering pipeline was cut into sections and removed.

The monitoring program began with the placement of wildlife cameras at each of the three crossing ramps between June 11 and June 24, 2023 (Figure 3). At each ramp, two cameras were established, one positioned next to the ramp on either side of the pipeline (Figure 4).

The study area for Program 1 monitoring was defined by the location of the dewatering pipeline as described in Section 1.5 and presented in Figure 3 above. All Program 1 monitoring was along the existing Lac du Sauvage Road between the Point Lake Access Road and the Pipeline Road, and along the Pipeline Road to the point where the stage two dewatering pipeline left the road to its outlet in King Pond Settling Facility (Figure 3).

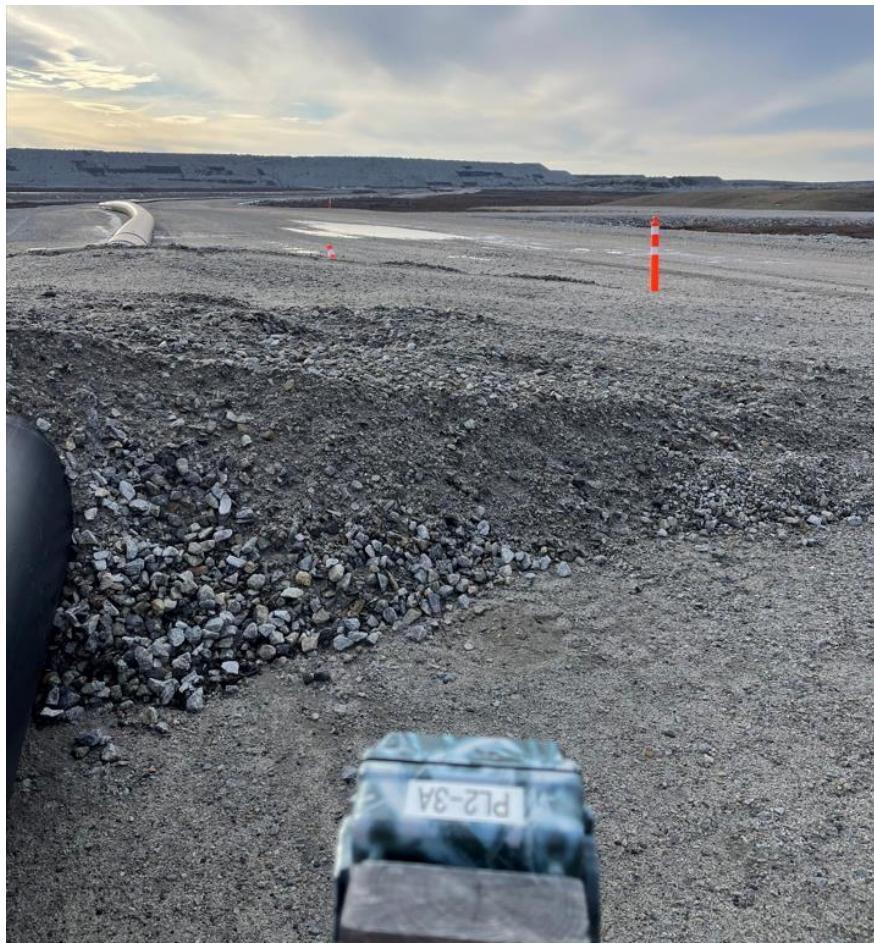
Figure 4: Caribou crossing ramp over the Point Lake Stage Two Dewatering Pipeline on the Lac du Sauvage Road at the Ekati Diamond Mine, June 2023. Note wildlife monitoring camera 3A mounted on a wooden post in the foreground. Misery Waste Rock Storage in the background.

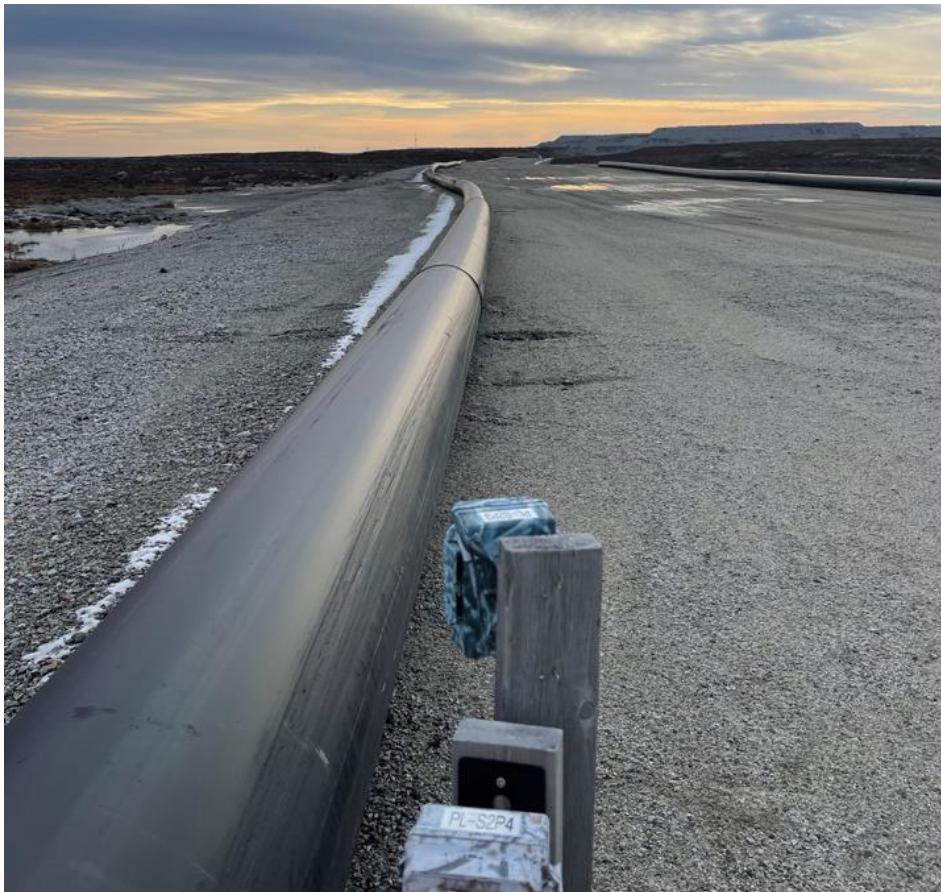
Figure 5: Pair of wildlife monitoring cameras (Cameras P3 and P4) on the west side of the Point Lake Dewatering Pipeline on the Lac du Sauvage Road at the Ekati Diamond Mine, June 2022.

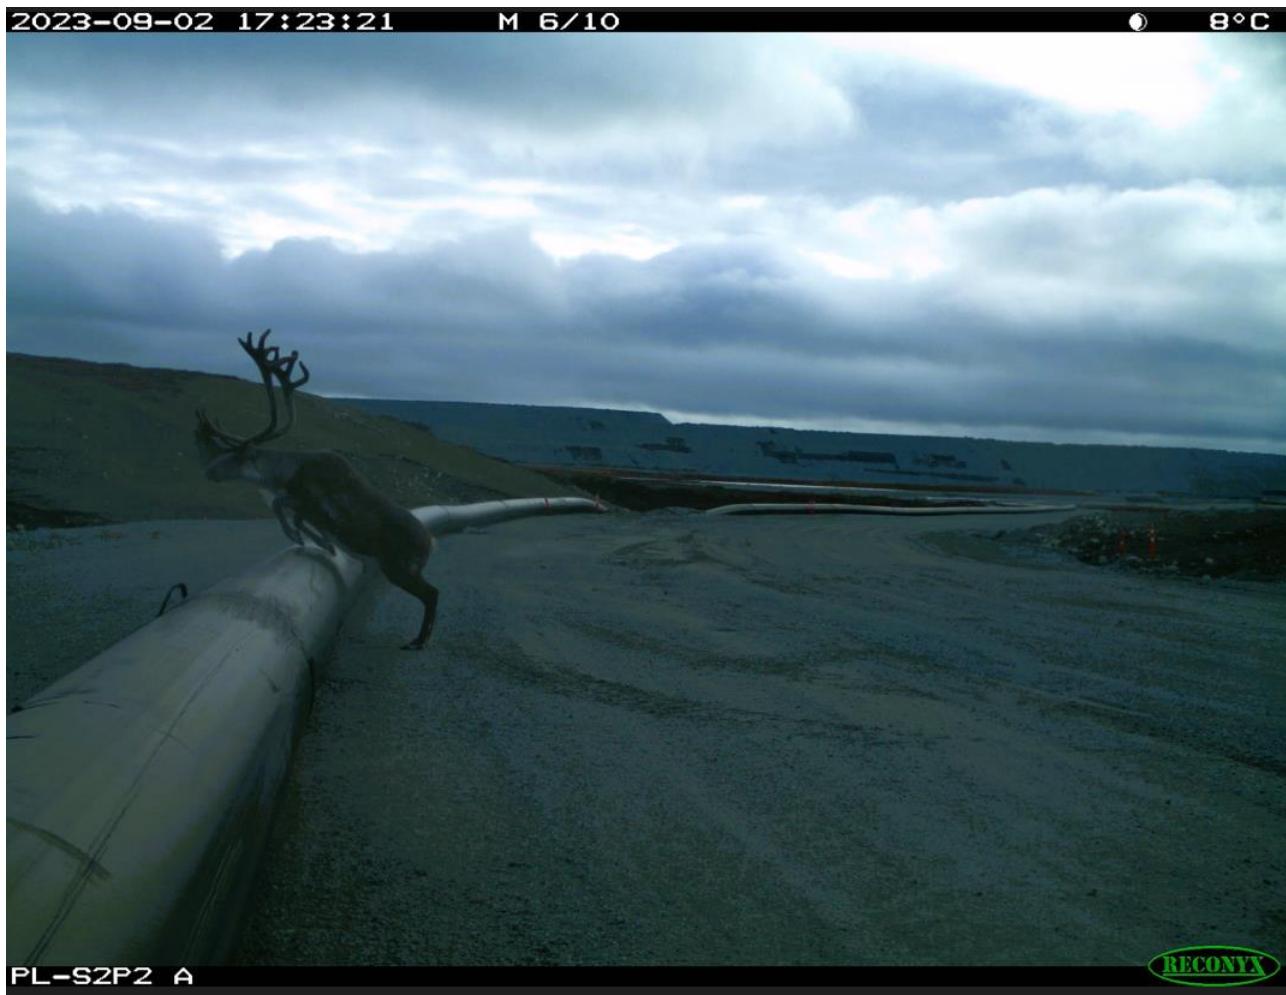
The four cameras positioned to monitor movements of caribou along the Lac du Sauvage Road adjacent to the pipeline between the ramps yielded 10 observations of caribou moving along the road adjacent to the dewatering pipeline. In 6 of the 10 observations caribou were observed jumping over the pipeline (Figure 6).

Figure 6: A caribou jumping over the Point Lake Project stage two dewatering pipeline on the Lac du Sauvage Road north of Thinner Lake on September 2, 2023.

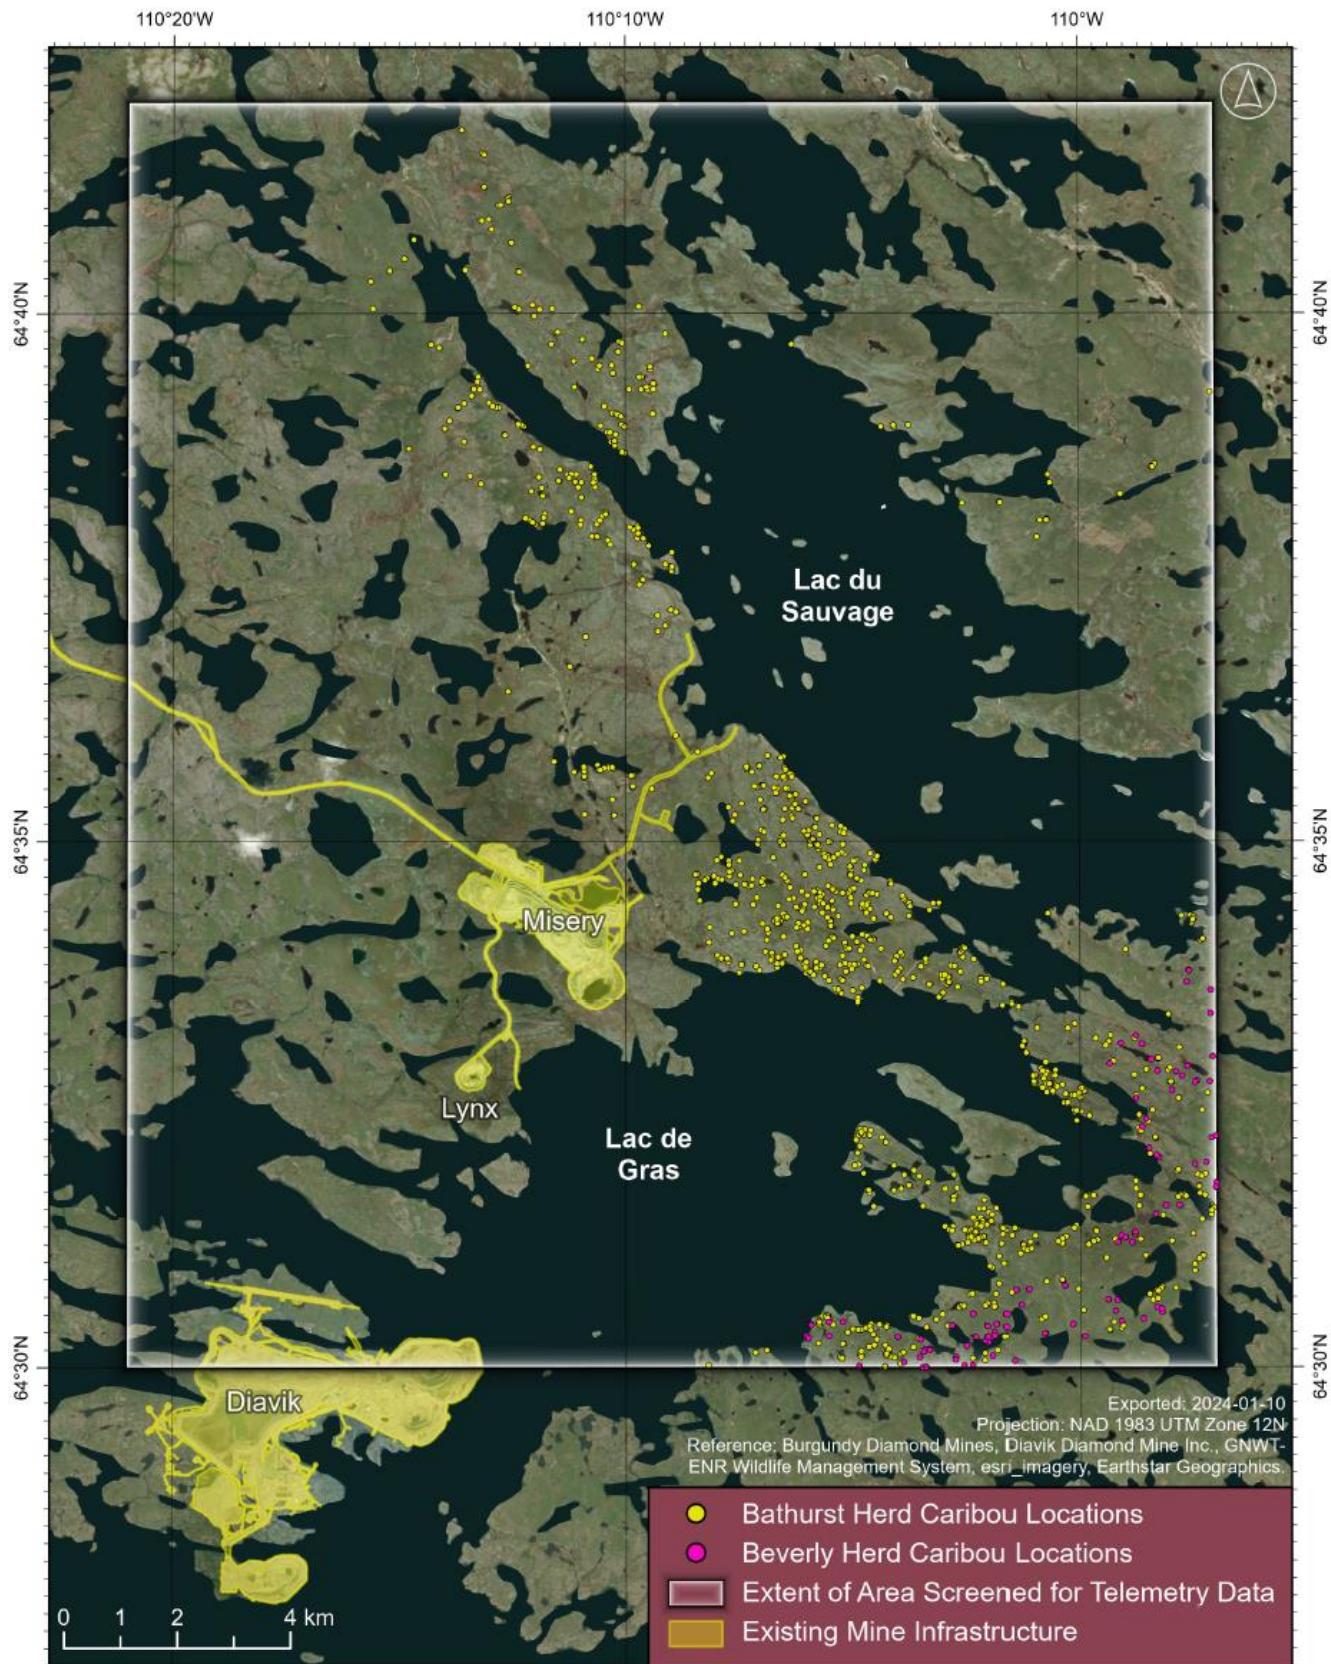
There were 1,391 locations in the area (Figure 7), 104 locations from two radio-collared individuals (8 locations from a female and 96 locations from a male) in the Beverly herd and 1,287 locations from a single female caribou in the Bathurst herd. The Bathurst herd caribou was the only radio-collared animal on the west side of Lac du Sauvage during the study period (Figure 7). The two radio-collared Beverly herd animals observed in the area during dewatering were south of Lac de Gras and Lac du Sauvage in the southeast corner of the broad geographic area used for screening the data, well away from the dewatering pipeline (Figure 7).

Figure 7: Telemetry Locations of Bathurst and Beverly Herd Caribou from June 1, 2023 to October 10, 2023

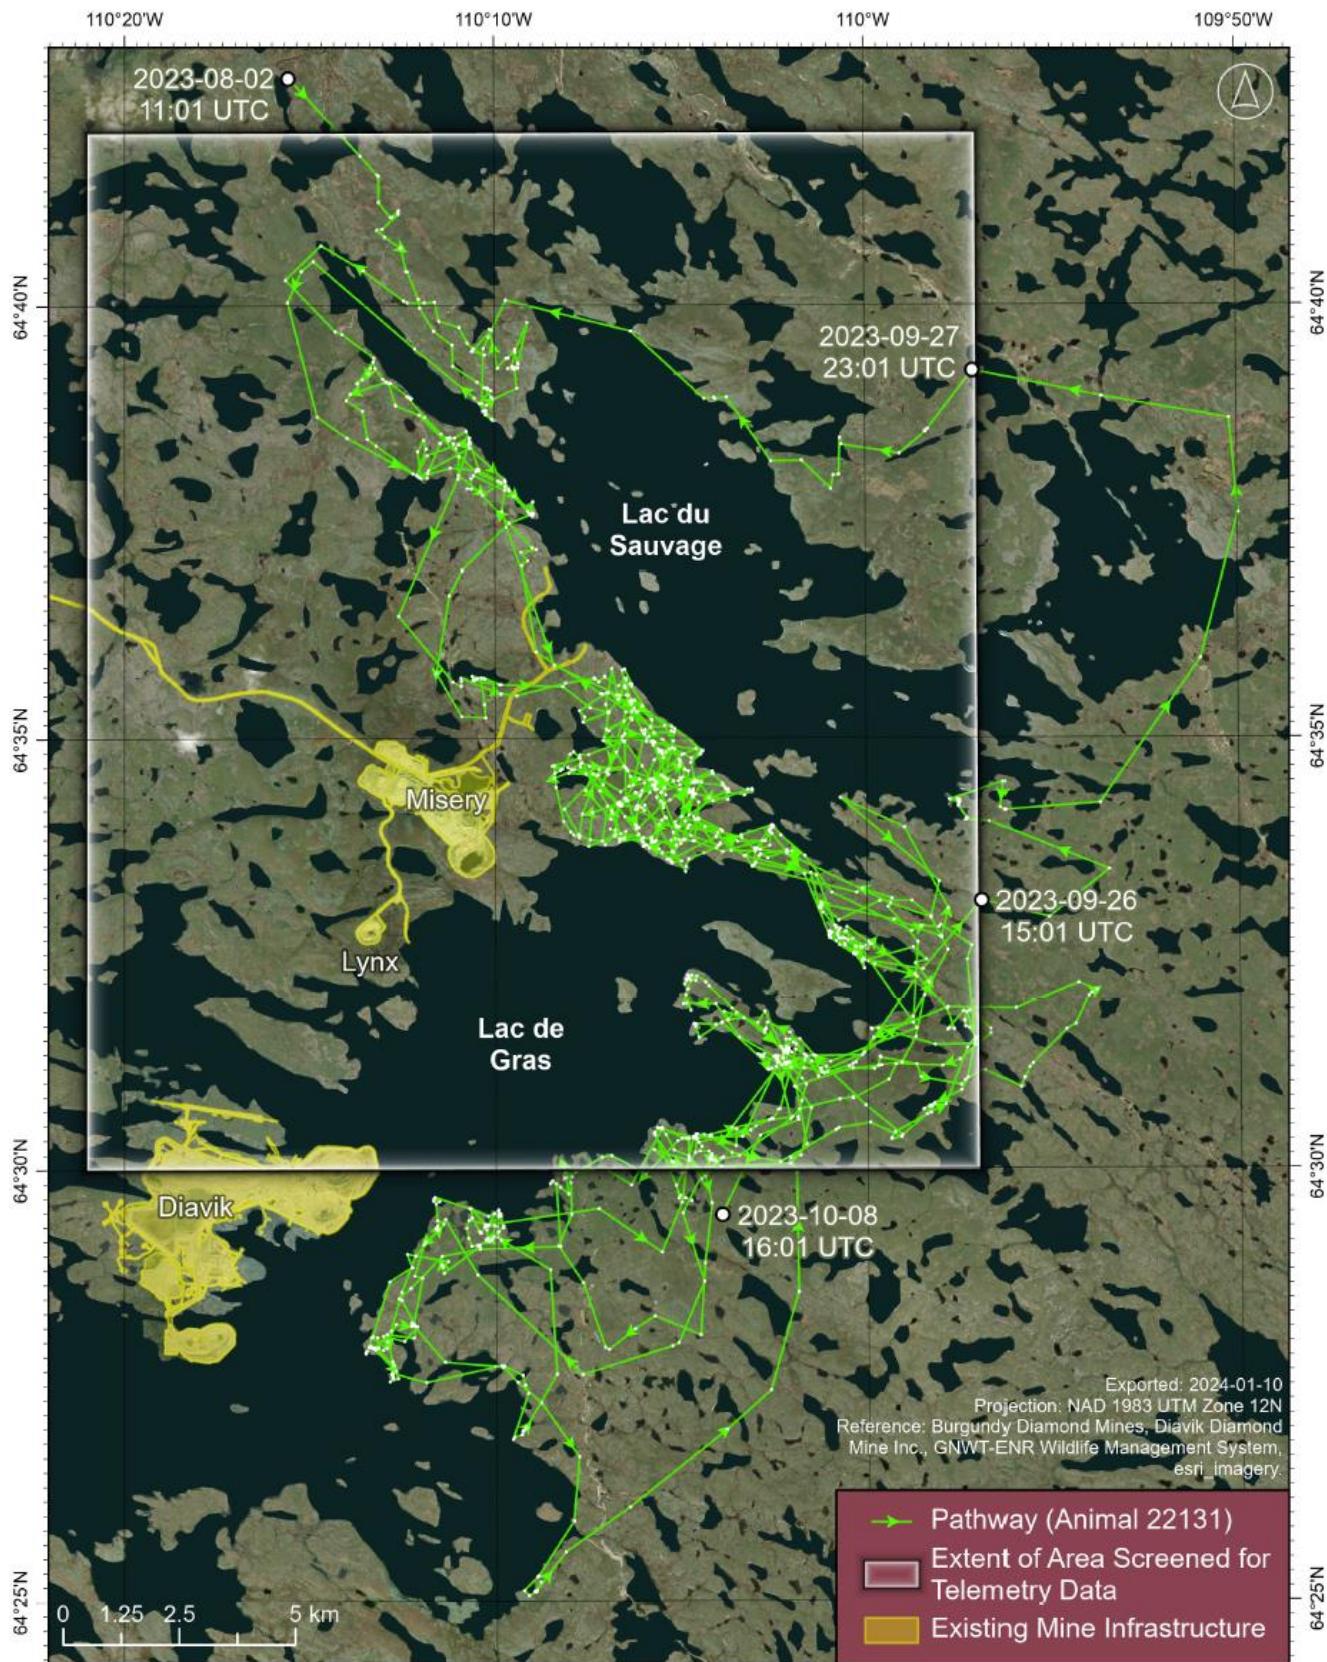
The path of the single radio-collared Bathurst caribou in Figure 8 shows:

- entry into the screening area on August 2, 2023;
- travel south on the west side of Lac du Sauvage;
- a period spent south of the screening area in September;
- travel north into the screening area again;
- a counterclockwise path around Lac du Sauvage between September 26 and 27;
- a second trip southward on the west side of Lac du Sauvage; and
- exiting the screening area on October 8, 2023.

Figure 8: Movement Pathway of Bathurst Caribou 22131 August 2 to October 8, 2023

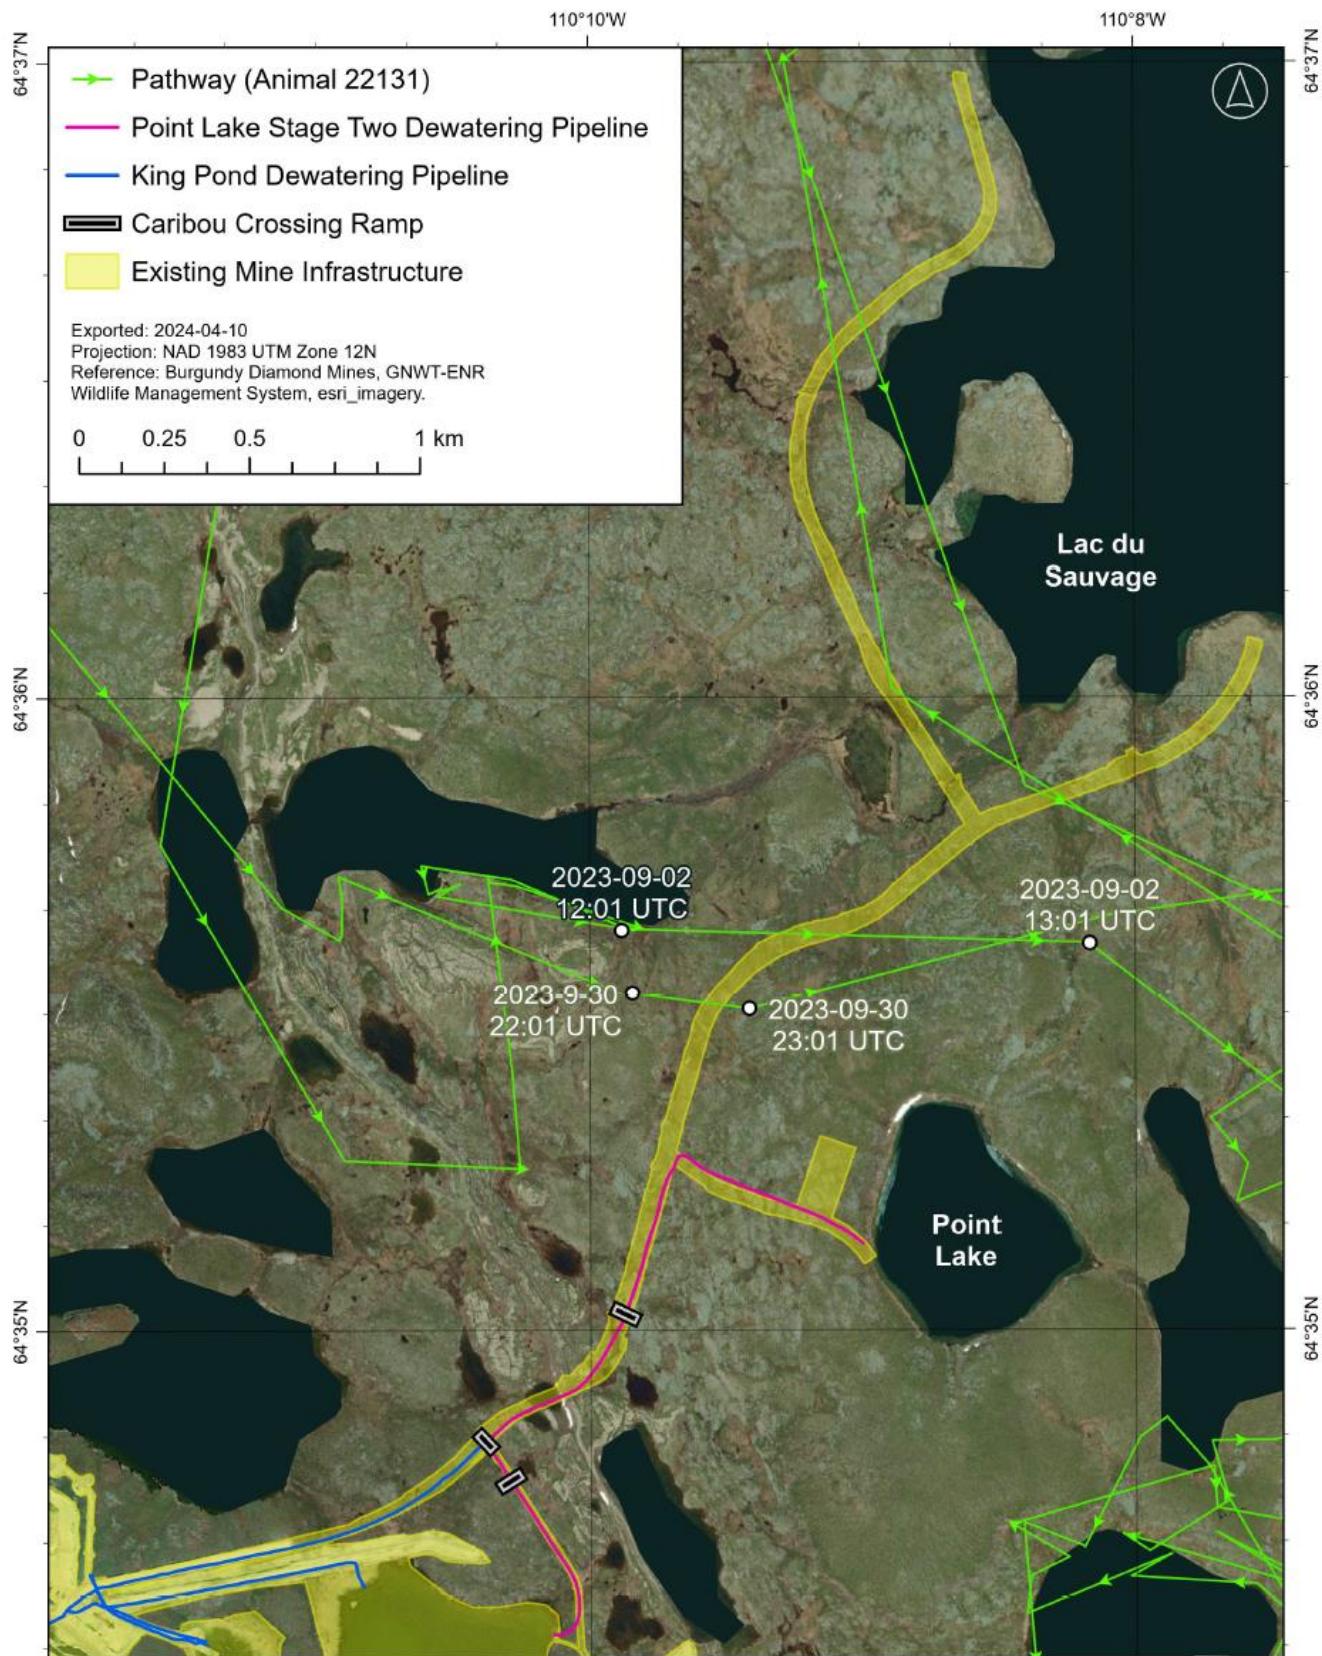
Figure 9: Movement Pathway of Radio-collared Bathurst Caribou 22131 Near Point Lake From August 7, 2023 to October 1, 2023

From first entry to last exit from the screened area was a period of 67 days. During that period the Bathurst caribou crossed the Lac du Sauvage Road on four occasions, all of them east of the Point Lake Access Road, and therefore not across the dewatering pipeline (Figure 9). The same animal was photographed on the Lac du Sauvage Road by camera 2A at the foot of, but not crossing, the ramp north of Thinner Lake (Figure 10). The same Bathurst caribou spent 43 days in the same area in August and September 2022; the only radio-collared caribou observed west of Lac du Sauvage and north of the Lac du Sauvage narrows during dewatering in either year.

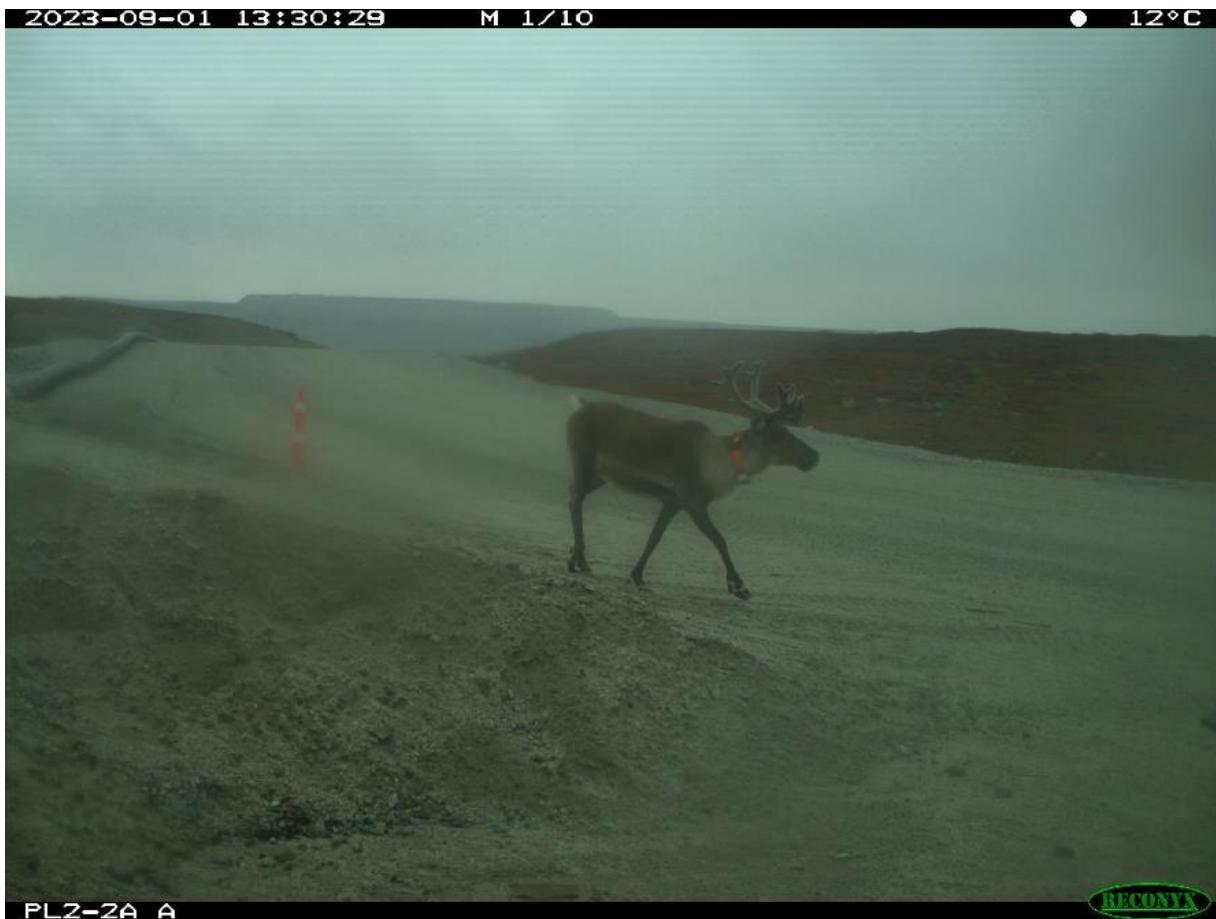
Figure 10: Radio-collared Bathurst caribou 22131 photographed walking on the edge of (but not crossing) the caribou crossing ramp over the dewatering pipeline north of Thinner Lake on September 1, 2023.
