**Snap Lake Mine 2022 Annual
Wildlife Management and
Monitoring Report**

Prepared for:
MetNuna Joint Venture

Prepared by:
Stantec Consulting Ltd. on behalf of
Metcor-Stantec Joint Venture

Project Number:
111473029

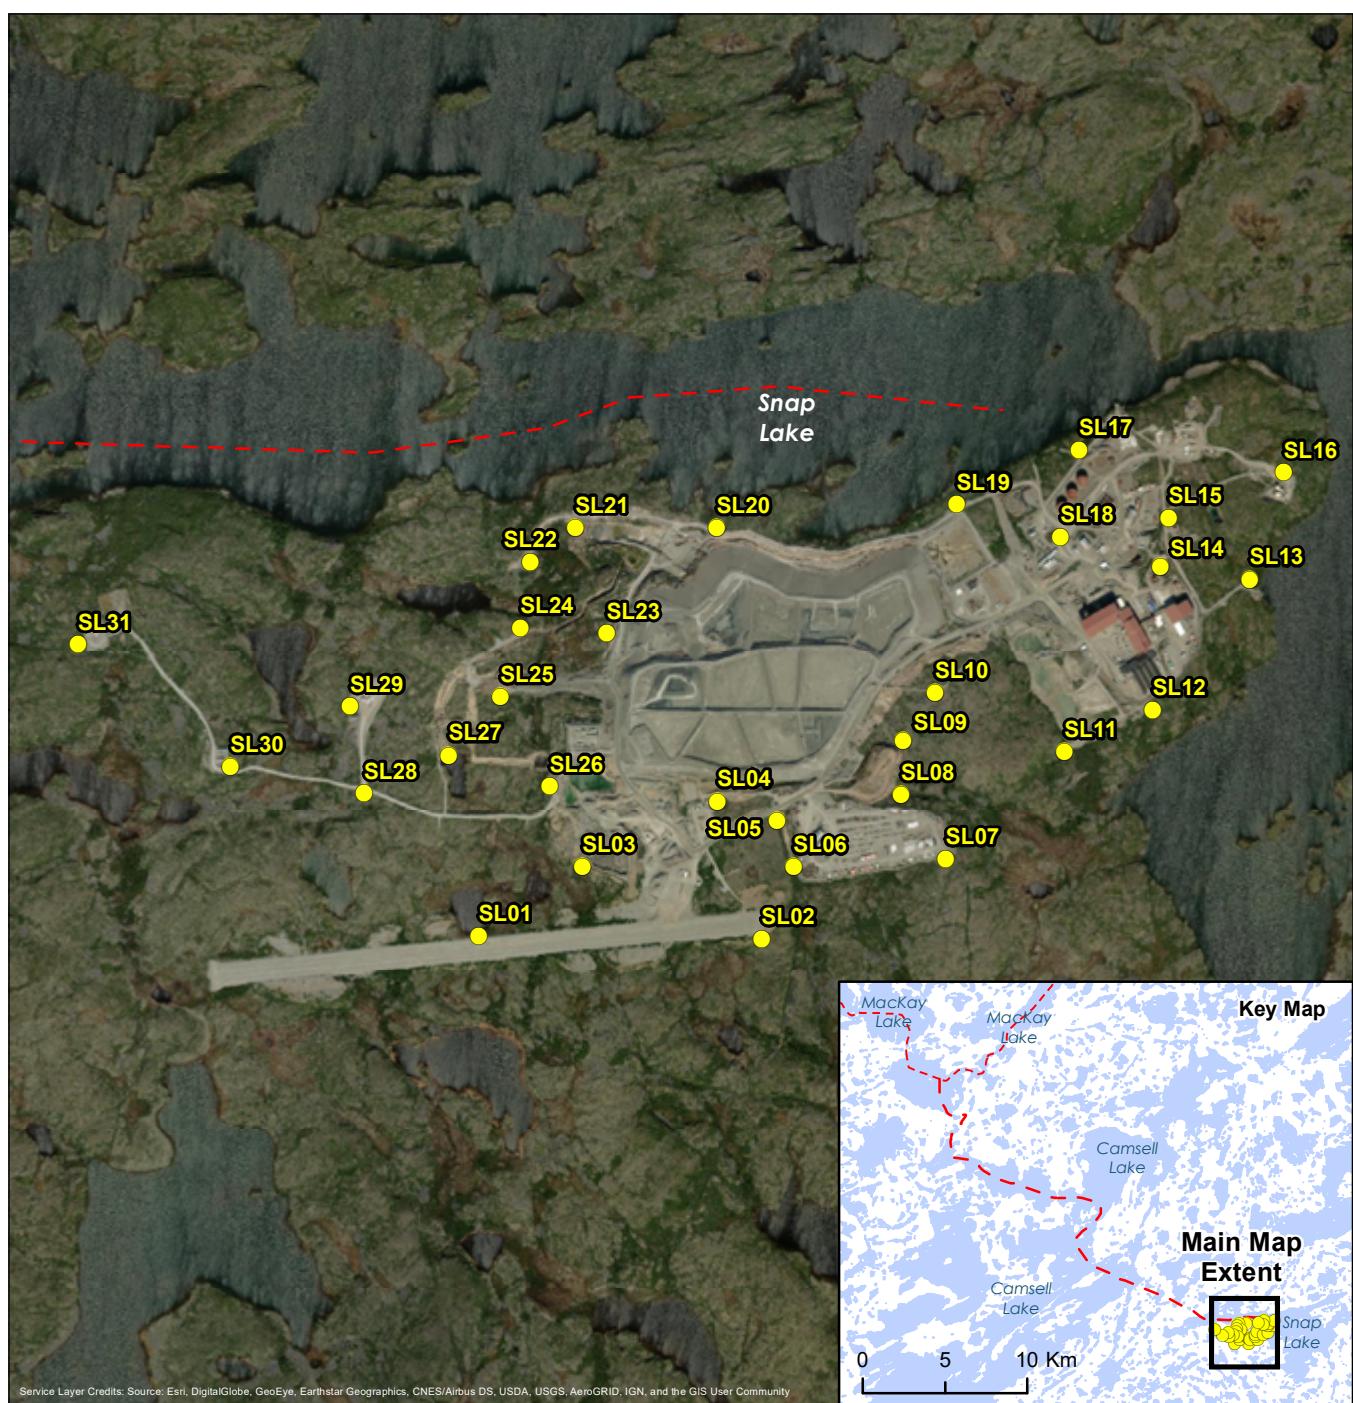
In addition to ZOI monitoring, remote camera monitoring is required to be implemented during periods of zero occupancy at the Mine site and during post-closure. In 2022, the remote camera station locations were selected and posts were installed for future camera placement (see Figure 3.1).

- Remote Camera Monitoring Stations
- - - Tibbit-to-Contwoyo Winter Road
- - Winter Access Road

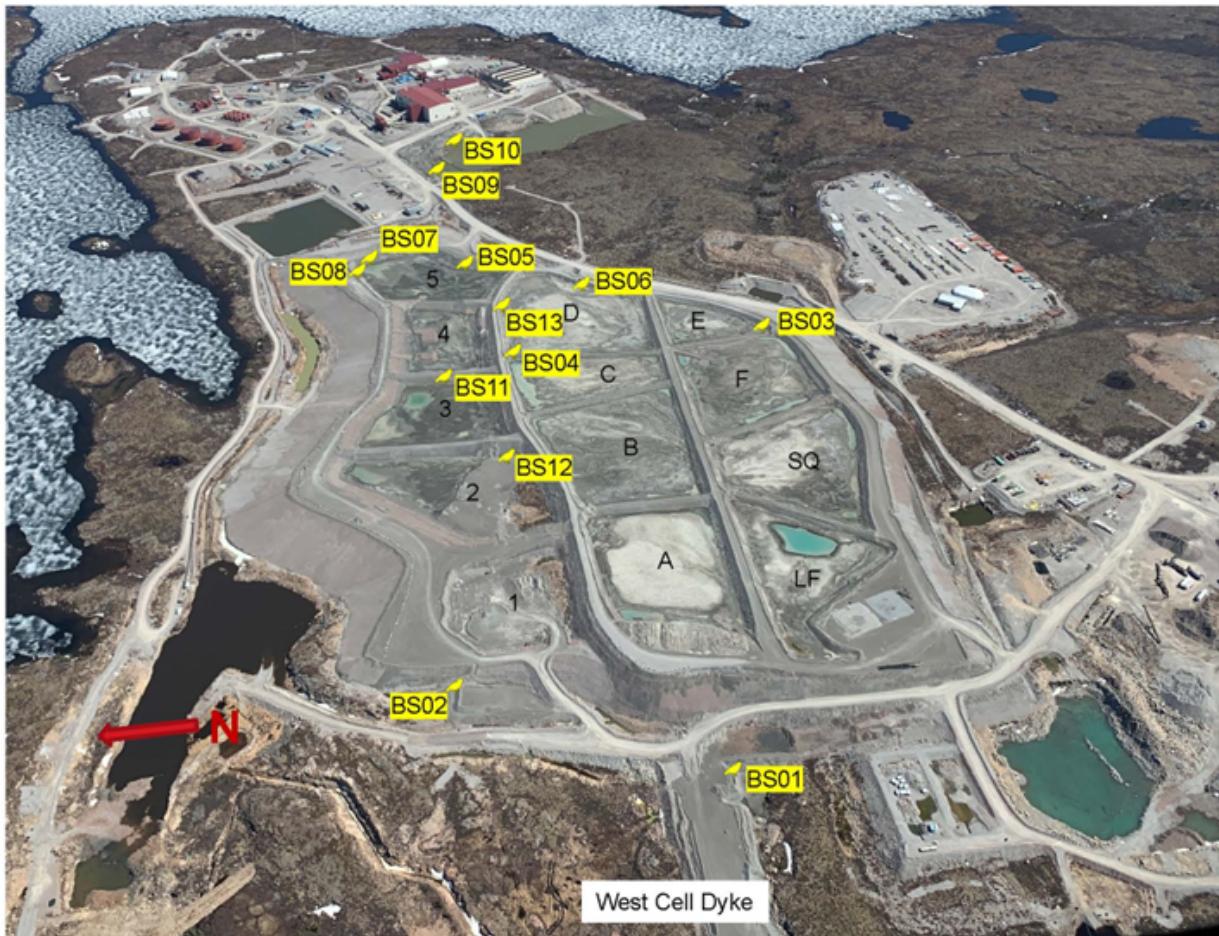
Figure 3.2 Bank Swallow Nest Sites

Thirteen bank swallow nesting cavity sites were monitored at the Mine site during 2022 (Figure 3.2). Each site was visited regularly (e.g., once per week) during the breeding season to determine nest status and number of birds present. Nesting sites were observed for approximately 30 minutes at each location. Monitoring occurred more frequently (e.g., once per day or two) to establish when nests were no longer active.

The results of the bank swallow monitoring indicated most of the nesting sites (cavities) were eventually depredated (46.1%) during the breeding season, 3 had collapsed (23.1%) due to slope erosion and 4 nesting sites (30.8%) were deemed inactive where bank swallows were observed but did not enter existing burrows (i.e., possible prospecting to evaluate potential nesting sites). A summary of bank swallow monitoring results is provided in Table 3.1.

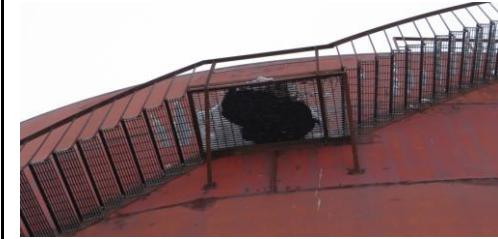
Date	Species	Location	Comment	Photo
23-Mar-22	Raven	TK-002	[March 23, 2022] Nest construction on landing of stairs. Removal required. [March 25, 2022] Nest removed. [March 26, 2022] Ravens observed carrying sticks to same location for nest reconstruction on landing of stairs. [April 1, 2022] Nest removed. [April 28, 2022] Gathered sticks observed. [May 1, 2022] Nests removed.

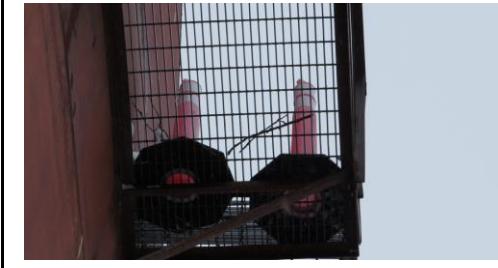
23-Mar-22	Raven	TK-003	[March 23, 2022] Nest construction on top landing of stairs. Removal required. [March 28, 2022] Nest removed. [March 31] Ravens observed carrying sticks for nest construction. Removal required. [April 1, 2022] Nest removed.

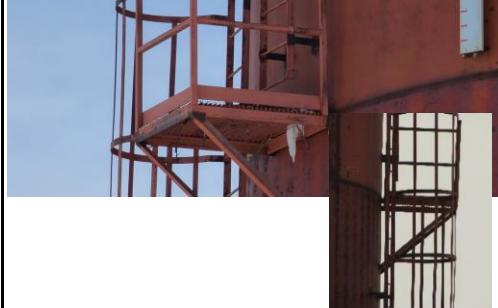
06-Apr-22	Raven	EC00030053	[April 6, 2022] Nest construction on first landing. Removal required. [April 27, 2022] Nest was previously removed. Confirmatory photos taken

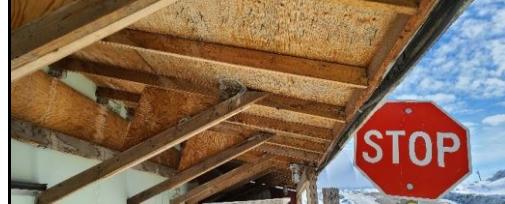
23-Mar-22	Cliff Swallow	Carpenter Shop	<p>[March 23, 2022] Nest at southwest corner of overhang 2-3.</p> <p>[April 8, 2022] Nests removed.</p>

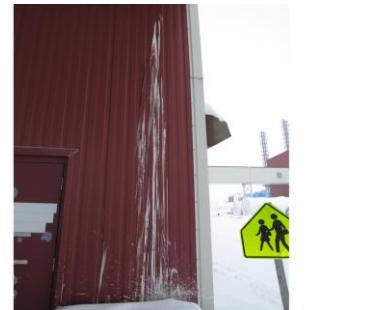
23-Mar-22	Cliff Swallow	Overhang at old mine ops.	<p>[March 23, 2022] No nest observed. Large amount of watery scat observed on the side of the building at southeast corner of ERT. Owl pellets found during C&M.</p>

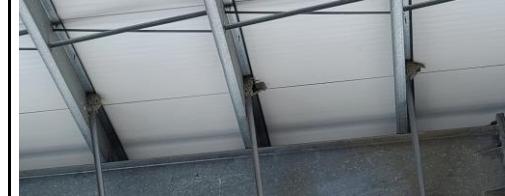
10-Apr-22	Cliff Swallow		<p>[April 10, 2022] Five nests observed above the ERT trailer.</p> <p>[April 25, 2022] Nuna confirmed that they intend to leave these nests in place in 2022.</p> <p>[August 12-14, 2022] Three days of monitoring concluded the nests were inactive.</p>

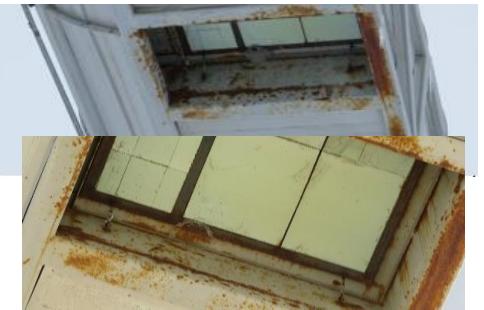
23-Mar-22	Cliff Swallow	Conveyor	<p>[March 23, 2022] Nest in opening on the bottom of the conveyor. One visible but there could be more. Removal required.</p> <p>[April 27, 2022] Nest was previously removed. Confirmatory photos taken</p>

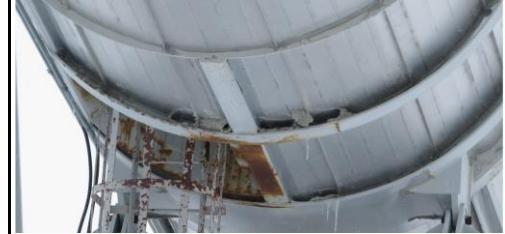
23-Mar-22	Cliff Swallow	Conveyor	<p>[March 23, 2022] Approximately 9 nests in ridges of conveyor. Removal required.</p> <p>[April 8] Nest removed.</p>

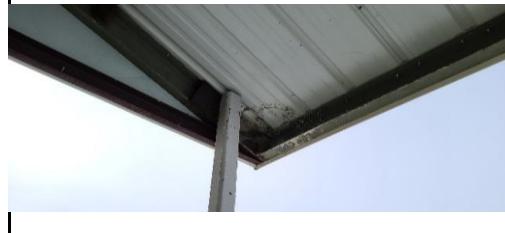
23-Mar-22	Cliff Swallow	Security Complex 71	<p>[March 23, 2022] Nest on north face of north east corner of building.</p> <p>[April 8, 2022] Nest removed.</p>

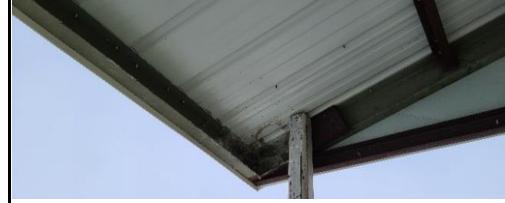
23-Mar-22	Cliff Swallow	Security Complex 71	<p>[March 23, 2022] Nest on north face of north east corner of building.</p> <p>[April 8] Nest removed.</p>

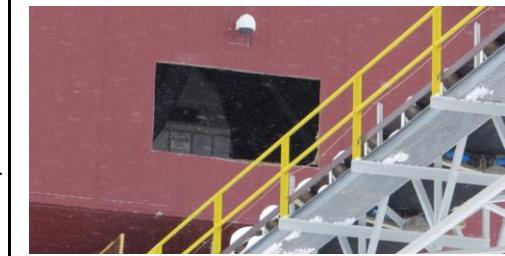
23-Mar-22	Raven	Conveyor	<p>[March 23, 2022] Nest reporting by site personnel in west entrance of transfer town. Confirmed by Ed.</p> <p>[March 26, 2022] Site services and Stantec unable to locate nest. Need location confirmation.</p> <p>[April 10, 2022] Ravens observed entering building by MetNuna.</p>

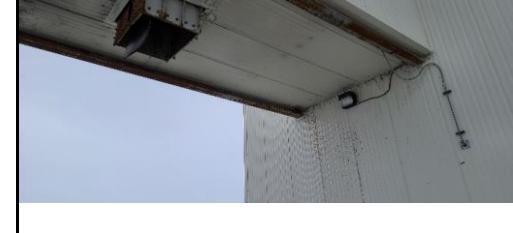
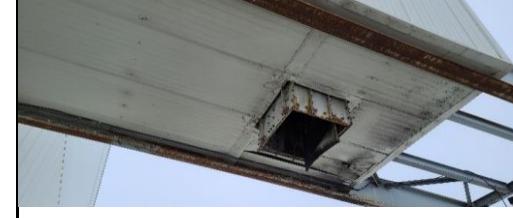
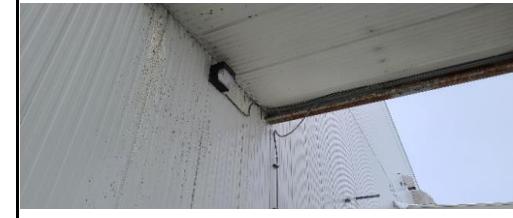
23-Mar-22	Cliff Swallow	Process plant drive through/ over hang	[March 23, 2022] Approximately 40 nests at process plant loading drive through. [April 8, 2022] Nests removed

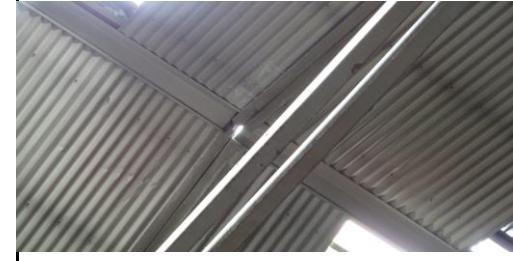
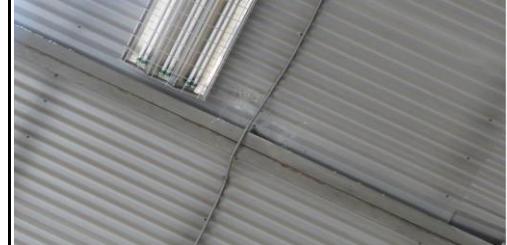
25-Mar-22	Cliff Swallow	Nuna Building	[March 25, 2022] Two nests on the ceiling inside the Nuna building. Birds come in through broken sky light. [April 8, 2022] Nest Removed.

25-Mar-22	Cliff Swallow	Nuna Building (cont.)	<p>[March 25, 2022] Two nests on the ceiling inside the Nuna building. Birds come in through broken sky light. [April 8, 2022] Nest Removed.</p>

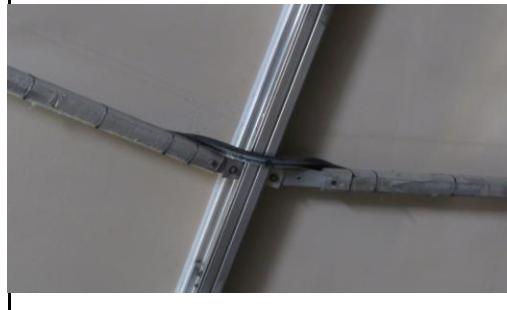
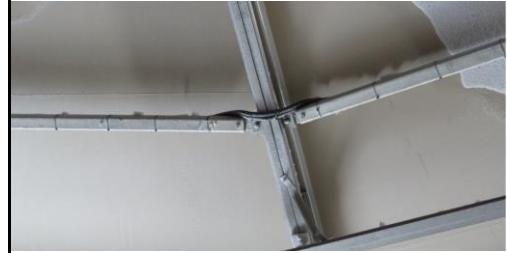
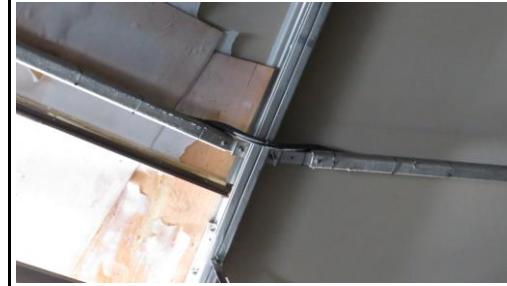
29-Mar-22	n/a	Igloo at Laydown 1	<p>[March 29, 2022] Three nests near bay door entrance inside Igloo. Unsure of species. [April 11, 2022] Nests removed.</p>

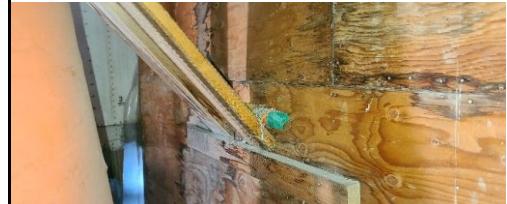
04-Mar-22	n/a	Cold Storage 1	[April 4, 2022] 1 Nest found in the back end of Cold Storage 1. Unsure of species. [April 9, 2022] Removal reported, confirmation required. [April 27, 2022] Removal confirmed

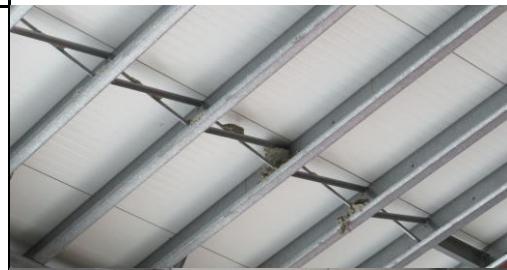
14-Apr-22	Cliff Swallow	Overhang at old mine ops.	[April 14, 2022] ~ 3 Nests under the overhang at the old mine ops. Previously documented above. [May 6] as per MNJV, no demo activities are planned at this location this year. To provide some habitat, these nests will not be disturbed in 2022. [June 1] Stantec observed no Swallows in this area or nesting here. [August 12-14, 2022] Three days of monitoring concluded the nests were inactive.

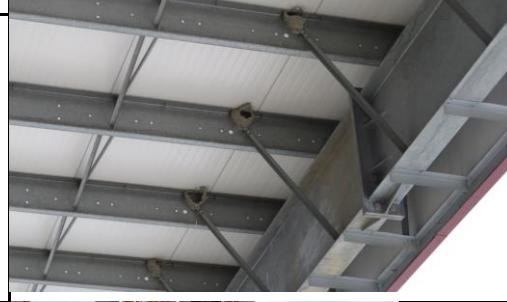
14-Apr-22	Cliff Swallow	Overhang at old mine ops.	[April 14, 2022] 4 Nests under the overhang at the old mine ops. Previously documented above. [May 6] as per MNJV, no demo activities are planned at this location this year. To provide some habitat, these nests will not be disturbed in 2022. [June 1] Stantec observed no Swallows in this area or nesting. [August 12-14, 2022] Three days of monitoring concluded the nests were inactive.

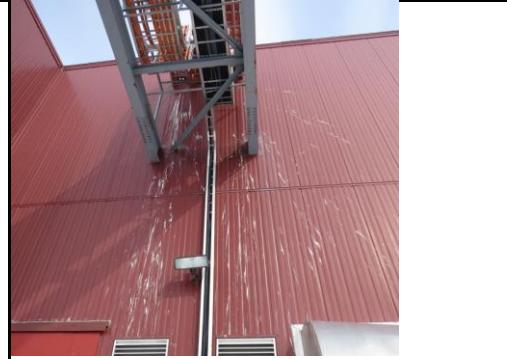
14-Apr-22	n/a	Utilities Building	No nest observed. Large amount of watery scat observed on the side of the building.

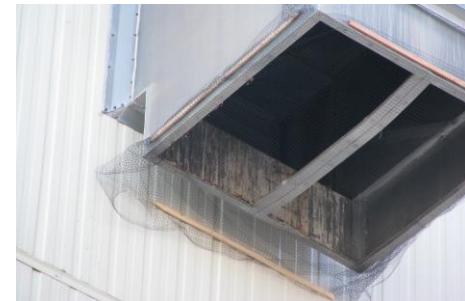
02-May-22	Unknown	Utilities Building	[May 2, 2022] Vent over door 107 [May 6, 2022] Removed, net installed and confirmed

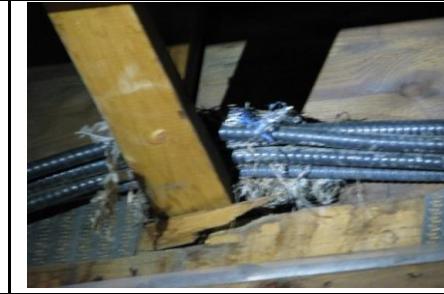
02-May-22	Unknown	Building 52 (cold storage 1)	[May 2, 2022] Rafters on far wall

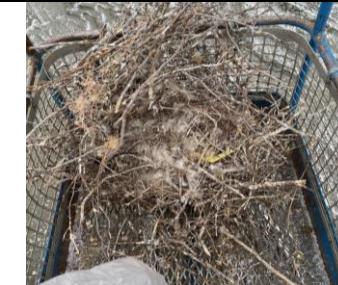
06-May-22	Raven	Process building	[May 6, 2022] West side in vent above man door 104(?)
