Prairie Creek Mine All-Season Road 2019 Den and Nest Pre-Clearing Survey

JULY 26, 2021
ISSUED FOR USE
FILE: ENW.EENW03326-02

PRAIRIE CREEK ALL-SEASON ROAD

2019 Den and Nest Pre-Clearing Monitoring Results

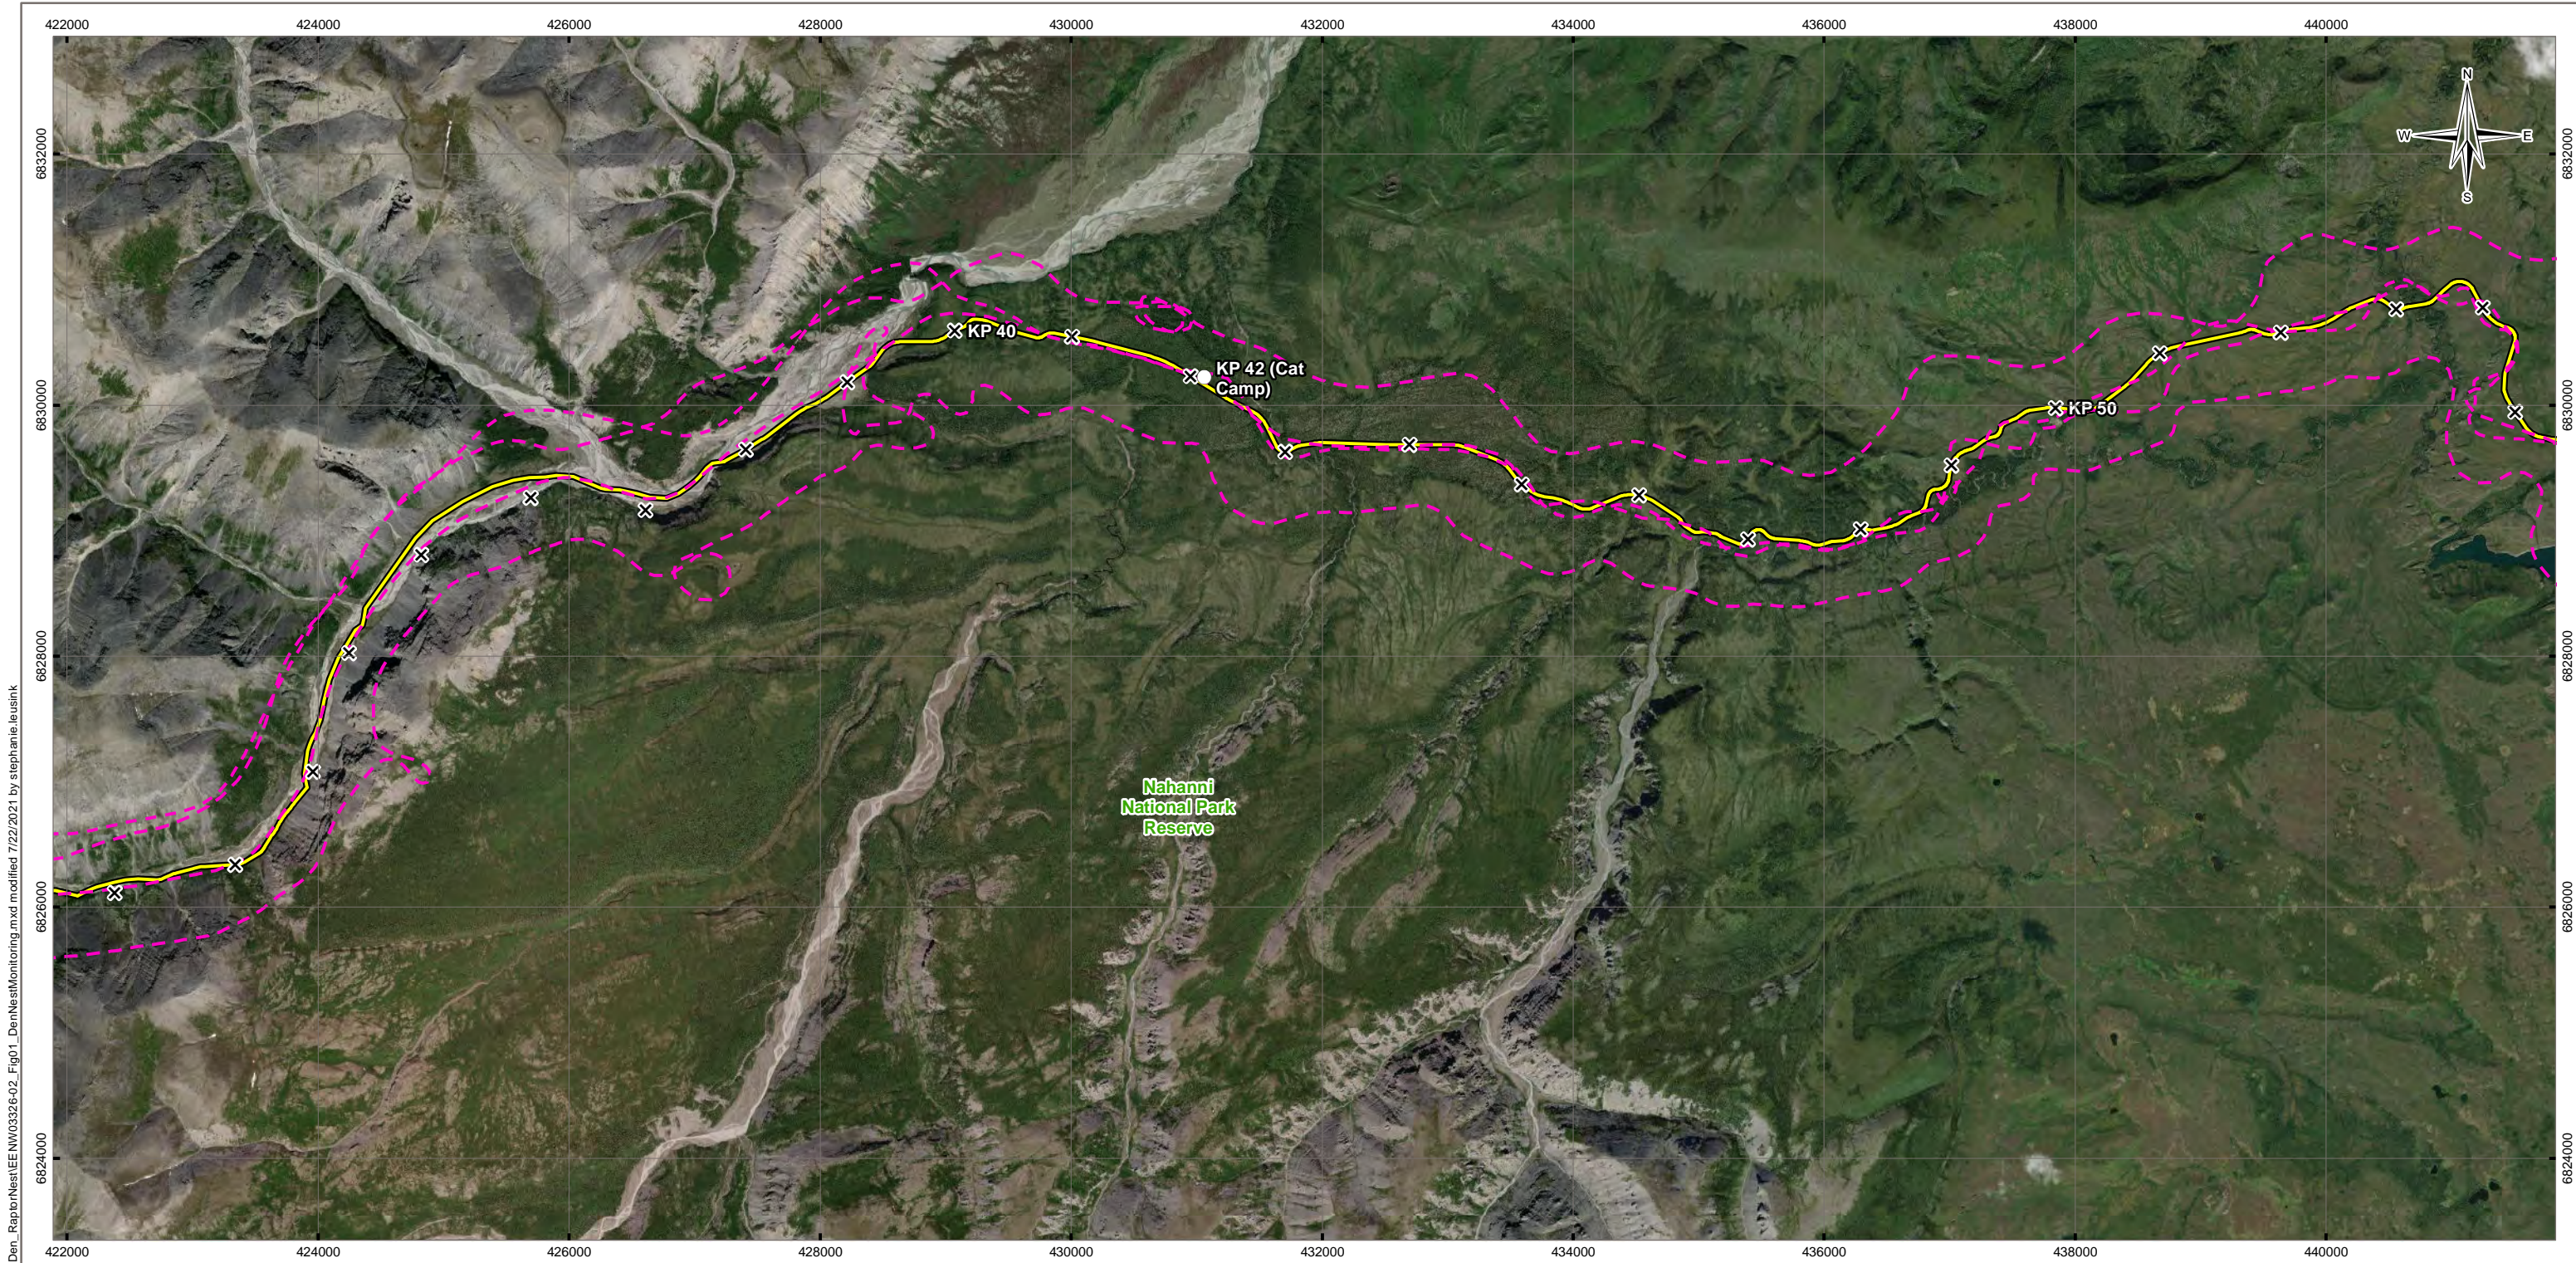
PROJECTION UTM Zone 10	DATUM NAD83	CLIENT CANADIAN ZINC CORPORATION
Scale: 1:50,000		
FILE NO. EENW03326-02_Fig01_DenNestMonitoring.mxd	CLIENT TETRA TECH	
OFFICE Tl-VANC	DWN SL	CKD MRV
DATE July 22, 2021	APVD JM	REV 0
PROJECT NO. ENW.EENW03326-02		Figure 1a

Ten beaver lodges and 25 beaver dams were observed immediately adjacent to the proposed road alignment (Figure 1). Other beaver sign, including old, harvested trees were also observed during previous fieldwork.

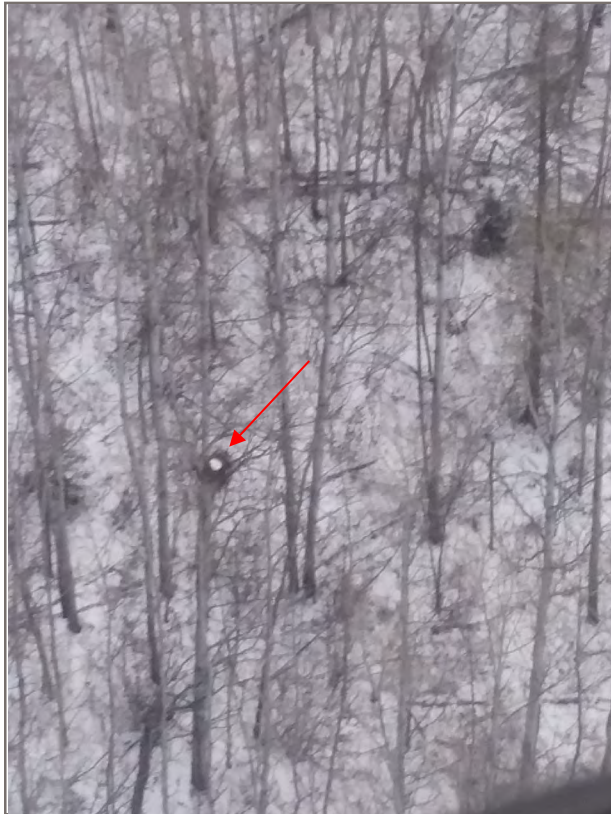
One unoccupied raptor nest was detected 130 m northeast of the proposed road at KP 97.5 and would not be destroyed by the planned PWR activities (Figure 1; Photo 1). The nest was located inside the Nahanni National Park Reserve (NNPR) at the eastern boundary. The nest was located in an aspen forest (land cover mapped as temperate or sub-polar broadleaf deciduous forest) on the western slope of the Silent Hills.

The stick nest was located in a mature aspen tree (live) and positioned in a low fork approximately half to two-thirds up the tree. The nest was roughly 50 cm in diameter (outside diameter), of approximate equal size depth and was made of short medium-coarse sticks. At the time of the survey, the cup of the nest was filled with snow, but the outer rim of the nest was clearly visible.

Photo 1: The raptor nest observed during the pre-clearing aerial survey in October 2019

No adaptive management was required for the raptor nest. Due to the distance between the proposed road and the nest the proposed road will not result in the destruction of the raptor nest or removal of surrounding vegetation.

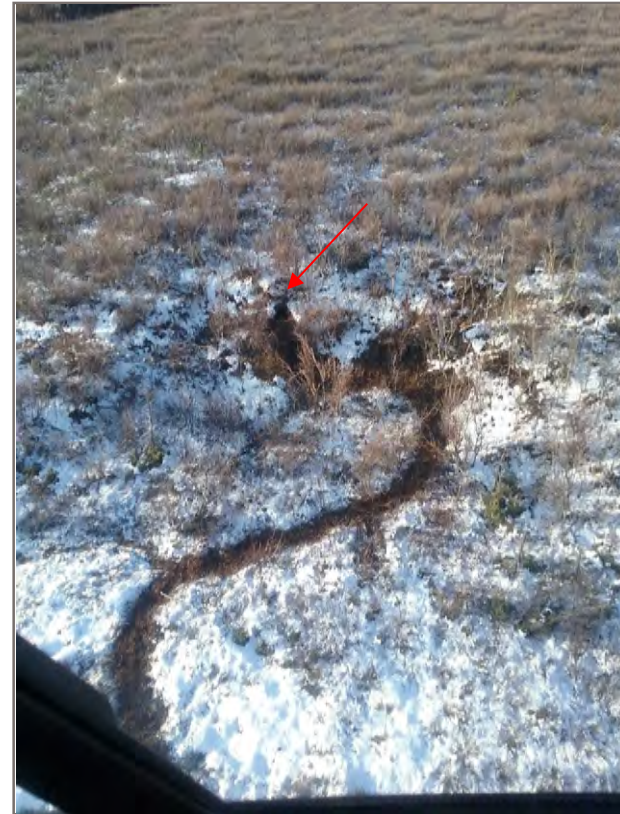
One active grizzly bear den was detected approximately 190 m east of the proposed road at KP 127 (Figure 1; Photo 2) and would not be destroyed by the planned PWR activities. Field personnel were able to confirm that the den was active due to the presence of a well-defined wildlife trail that led up to the den and the observation of an individual grizzly bear within approximately 75 m of the den site. Directly adjacent to the active den was a failed den attempt, likely abandoned in favor of the active den. The den site was not ground-truthed during the survey due to the presence of the bear.

The den was found on the eastern slopes of the Front Range Mountains, outside of the NNPR. The den was dug into the side of a short slope, approximately 5 m in height with a southeast aspect. Habitat surrounding the den site could be characterized as upland tall shrub habitat (land cover mapped as temperate or sub-polar shrubland), dominated by scrub birch. A small drainage channel, dominated by willows, was located just to the south of the den site.

Photo 2: The active bear den observed during the pre-clearing aerial survey in October 2019
A well-defined trail leads up to the entrance of the den (shown with a red arrow)

The PWR WMMP describes an 800 m setback distance to minimize disturbance to bear dens from clearing and construction and a 1.5 km setback from blasting. The grizzly bear den was detected within the 800 m setback to road clearing and construction and thus adaptive management action was taken.

- The proposed PWR was realigned to further avoid the bear den site to the extent possible. This section of road was shifted an additional 50 m to the west, away from the bear den. This was as far away from the den that the road could be realigned given that the slopes of the Front Range Mountains impede the realignment of the road any further west. With realignment, the PWR was located 225 m away from the den, and the 800 m setback was not able to be achieved.

- Clearing and construction within the den setback area was rescheduled to occur in January 2020 when the bear would be in the deepest period of hibernation and least disturbed by construction.

- Should clearing and construction have proceeded in 2019, a remote camera was to be installed at the bear den to monitor den activity before, during, and immediately after work inside the setback to determine if the work resulted in den disturbance/abandonment.
