Dominion Diamond Ekati Corporation – Approval of Wildlife Effects Monitoring Plan (WEMP), including Caribou Road Mitigation Plan (CRMP)

Subject: Ekati Diamond Mine: Caribou Crossing Photo and Road Features Analysis - 2011 to 2015

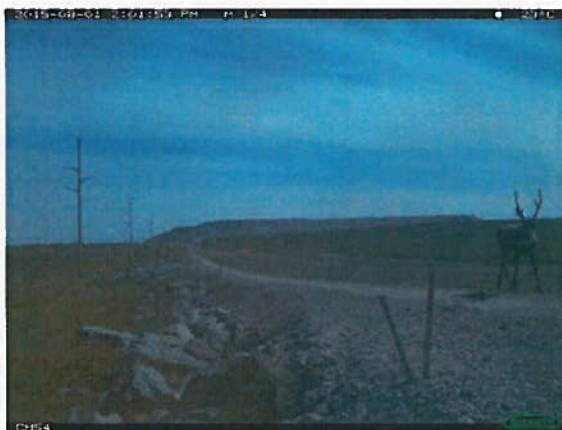
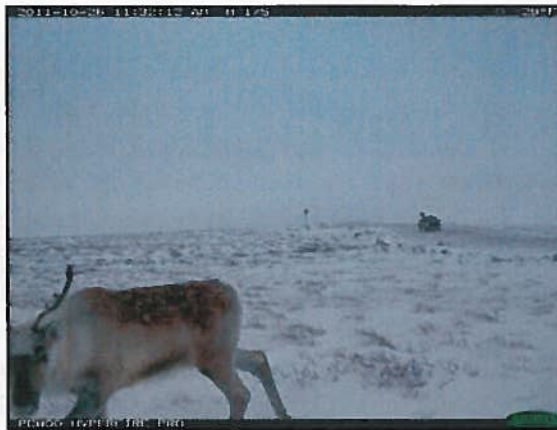
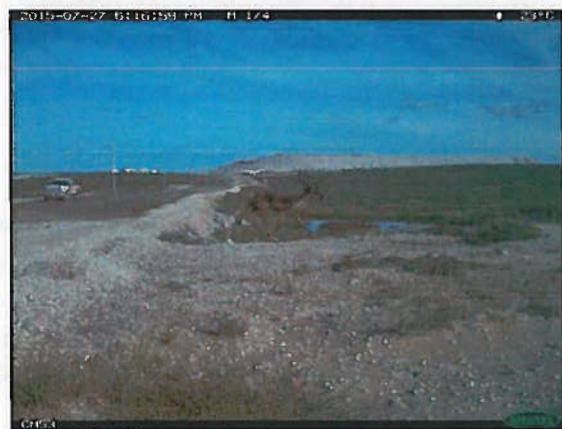
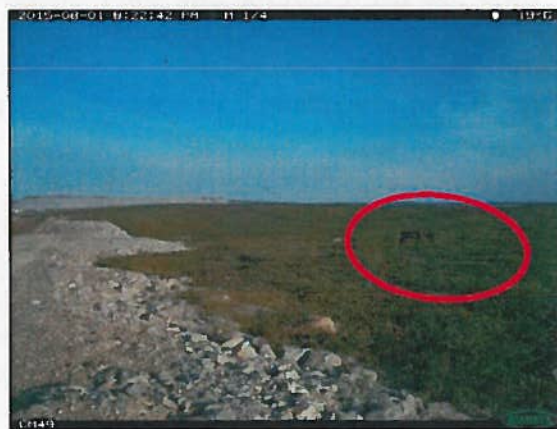
Plate 2-1. Examples of behaviours: crossing, investigating, running, and foraging.

Crossing/crossed road
(Misery Road camera # 54, August 1, 2015)

Investigating camera
(Misery Road camera #5, October 26, 2011)

Running on / off road
(Misery Road camera # 53, July 27, 2015)

Foraging near road (red circle)
(Misery Road camera # 49; August 1, 2015)

Animal behavior was quantified from the motion-triggered cameras, including the number of caribou and their dominant behaviors. When possible, individuals were classified by age (adult or juvenile) and sex (male, female, unknown). The dominant behaviour of each caribou group was determined (Table 2-2; Plate 2-1). Categorizing road usage and road avoidance was prioritized. Additionally, each individual that was exhibiting alert behaviour was noted (e.g., body oriented towards a potential stressor, ears erect and pointed in a particular direction, or remaining motionless in an alarm posture throughout several consecutive motion-triggered photos). Potential stressors, such as vehicles traveling along the road, were also recorded whenever evident in the photos. As a conservative estimate of behaviour frequency, calm behaviours (i.e., foraging, bedded or standing) had the lowest priority in terms of scoring the dominant group behaviour (Table 2-2).

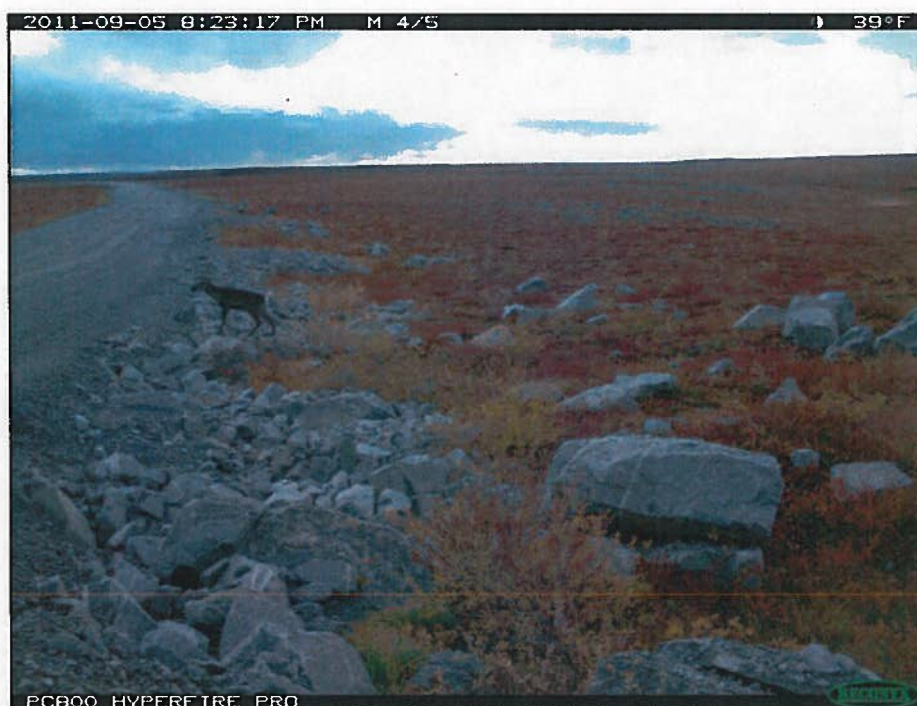
Plate 3-1. One juvenile caribou crossing at location with moderate grain size (0.1 m to 0.3 m) at Camera 1 on September 5, 2011.

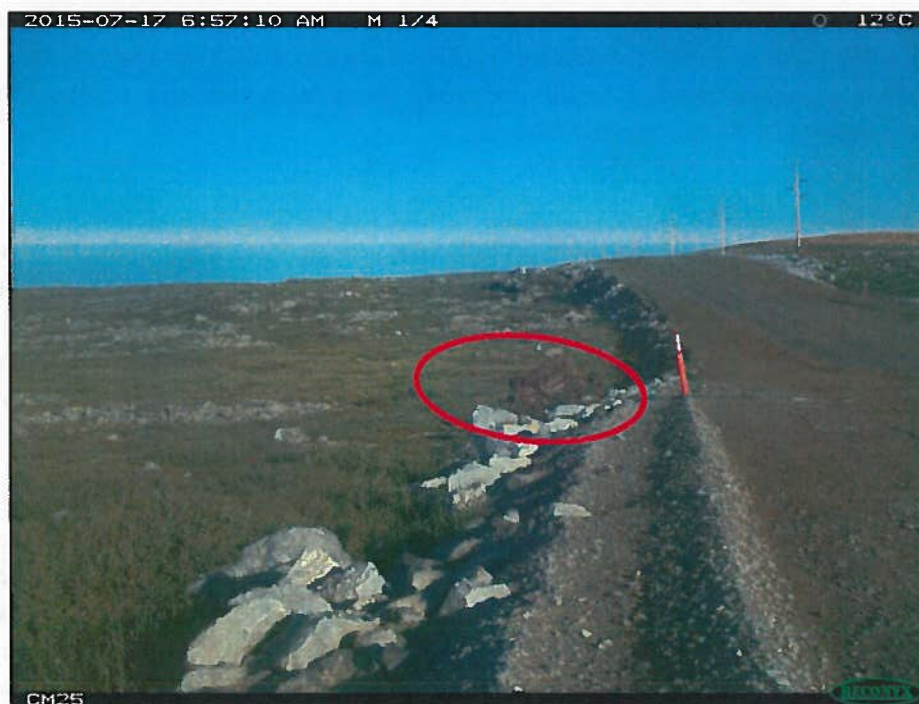
Plate 3-2. Two caribou (red circle) crossing at location with moderate grain size (0.1 m to 0.3 m) at Camera 25 on July 17, 2015.

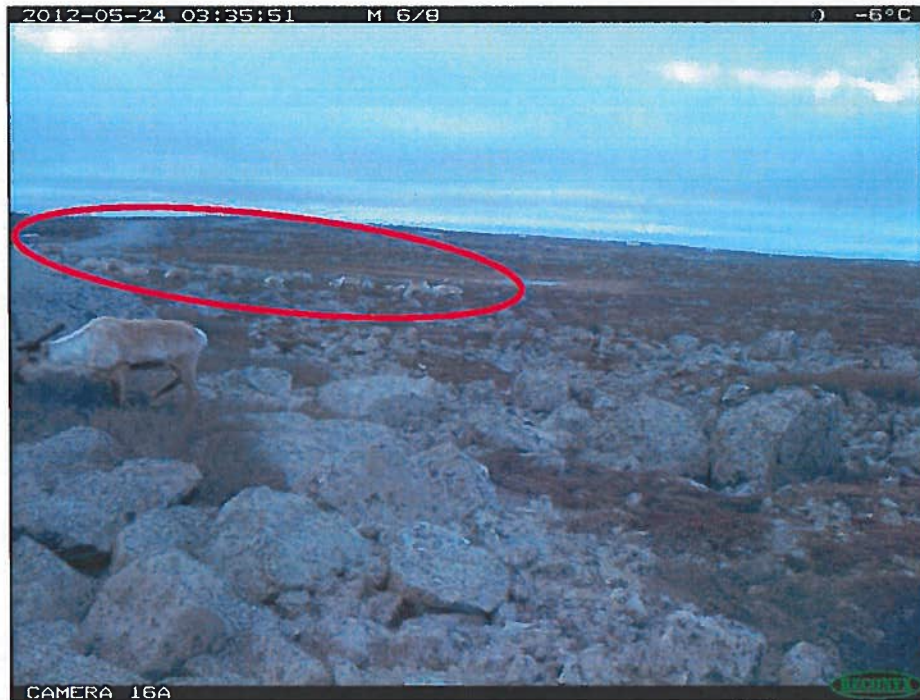
Plate 3-3. Caribou group (red circle) crossing at location with smaller grain size (< 0.1 m) at Camera 16 on May 24, 2012.

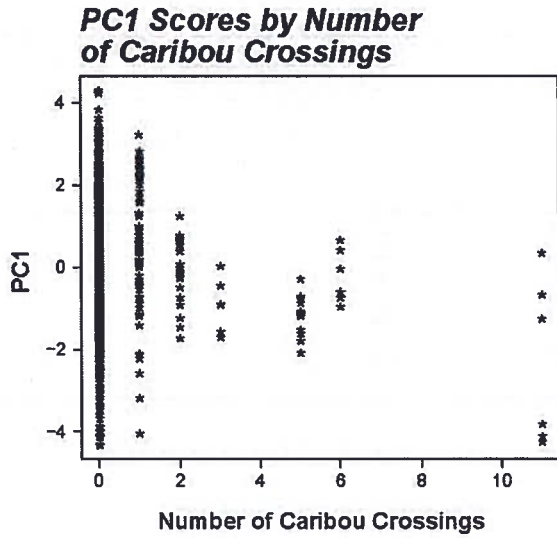
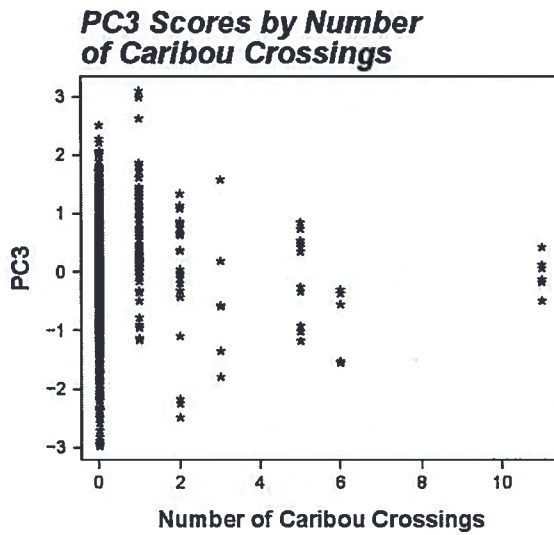
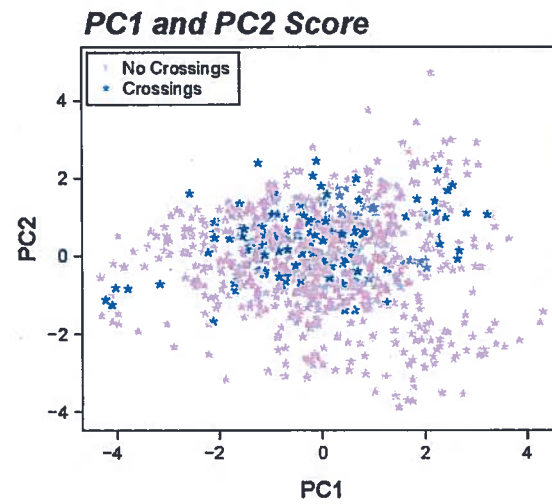
Figure 3-3
Principle Component Scores by Number
of Caribou Crossings

Variable	PC 1	PC 2	PC 3
logHypotenuse	0.84	-0.27	0.04
Height (m)	0.67	0.63	-0.12
Slope (degree)	0.17	0.88	-0.28
log Number of Small Rock, Grain Size (< 0.1 m)	0.54	-0.35	-0.65
Number of Moderate Rock, Grain Size (0.1 m to 0.3 m)	0.67	-0.41	0.07
Number of Large Rock, Grain Size (0.3 m)	0.60	0.20	0.65
Proportion of Variation Explained	0.38	0.26	0.16
