NWT Water Monitoring Bulletin

– May 29th, 2024 at 15:00

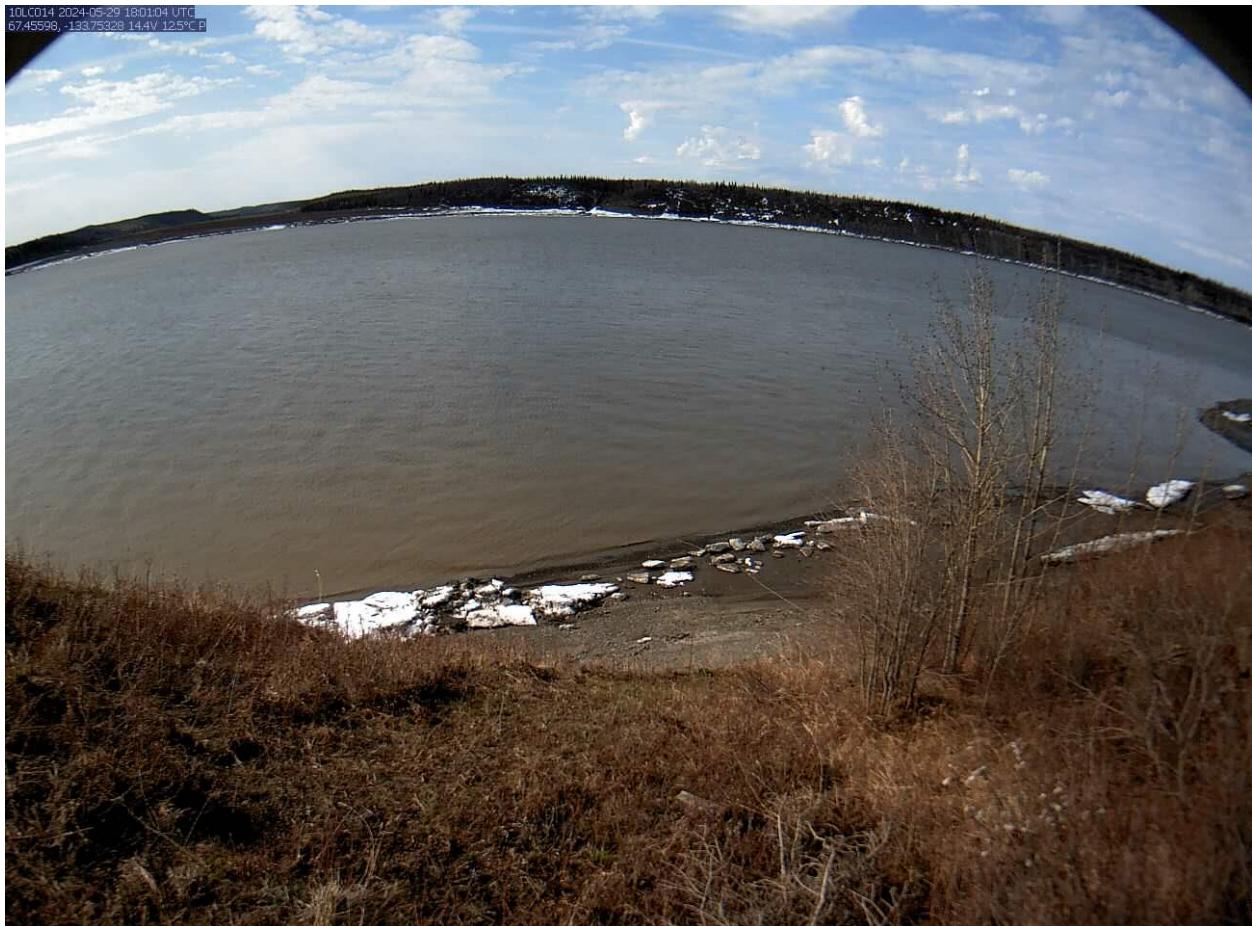
Above – Mackenzie River at Arctic Red River hydrometric gauge photo from May 29th at 12:00. Photo courtesy of Water Survey of Canada and GNWT.

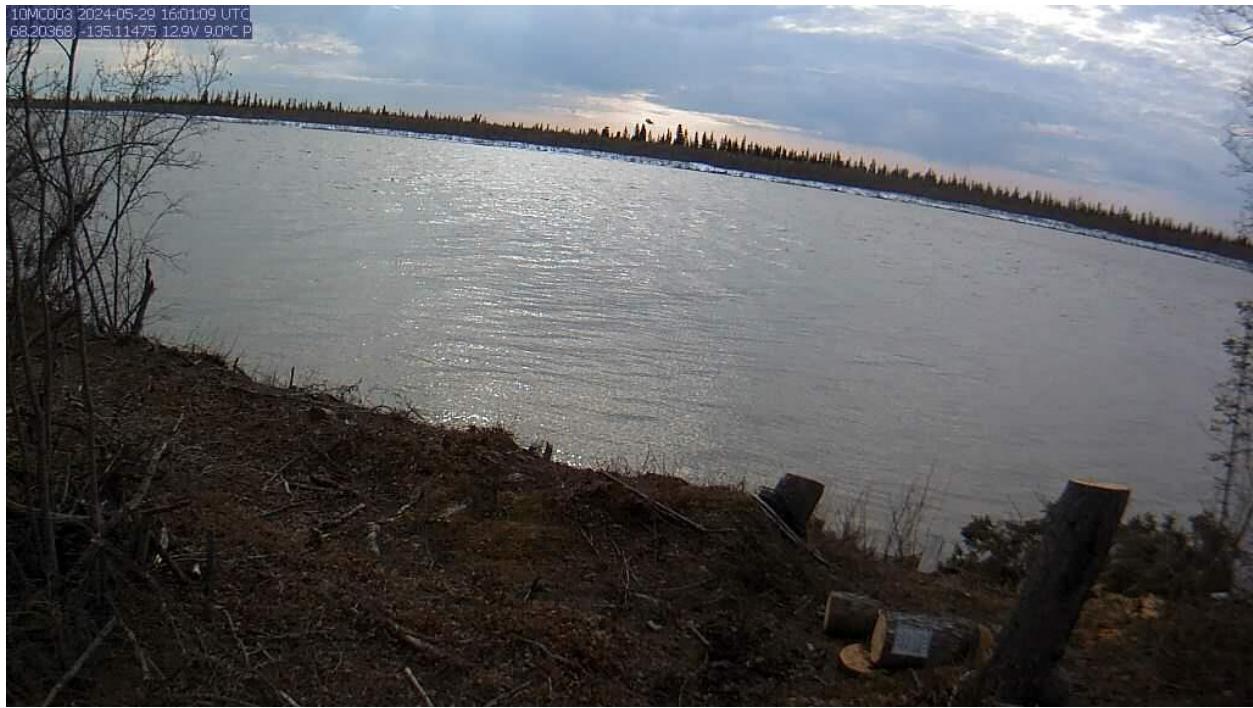
Above – Mackenzie River (Peel Channel) above Aklavik hydrometric gauge photo from May 29th at 10:00. Photo courtesy of Water Survey of Canada and GNWT.

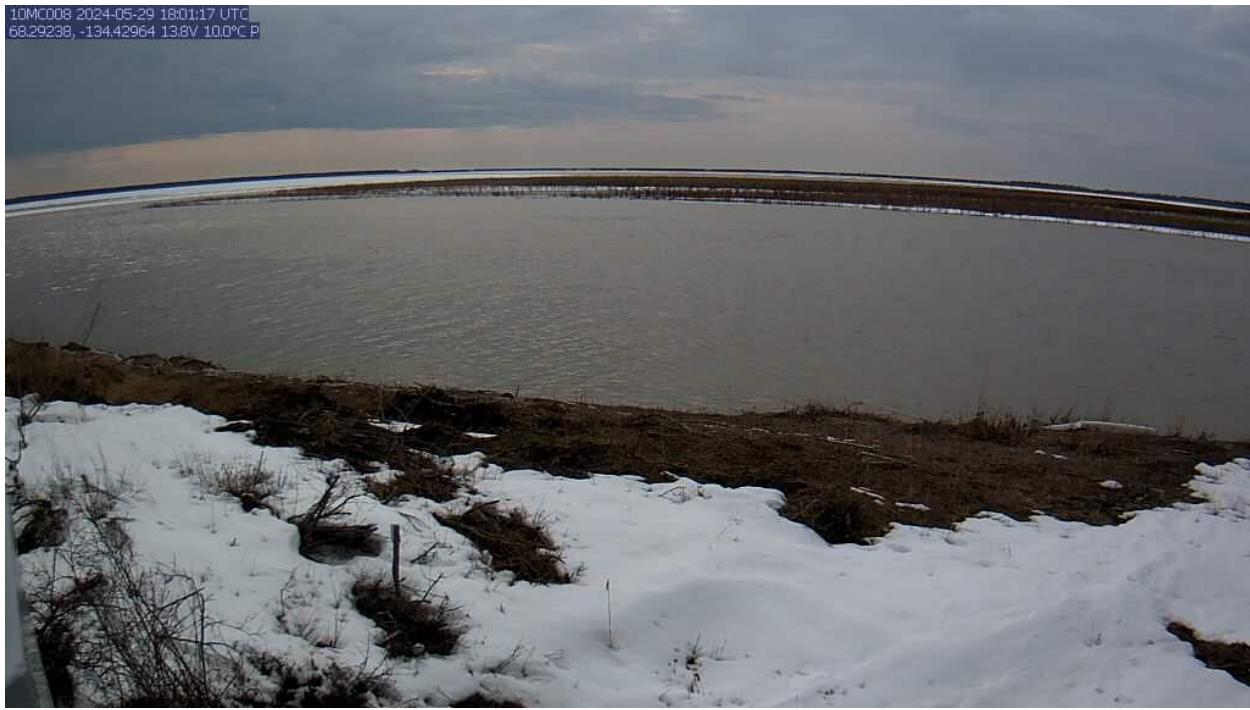
10MC008 2024-05-29 18:01:17 UTC
68.29238, -134.42964 13.8V 10.0°C P

Above – Mackenzie River (Middle Channel) below Raymond Channel hydrometric gauge photo from May 29th at 12:00. Photo courtesy of Water Survey of Canada and GNWT.
